**Departmental investigation
into the structural failure of a cargo crane
on the vessel
LODZ 2
in the port of Melbourne on
7 March 1997**

Report No. 110

Australia
Department of Workplace Relations
and Small Business

Published: April 1997

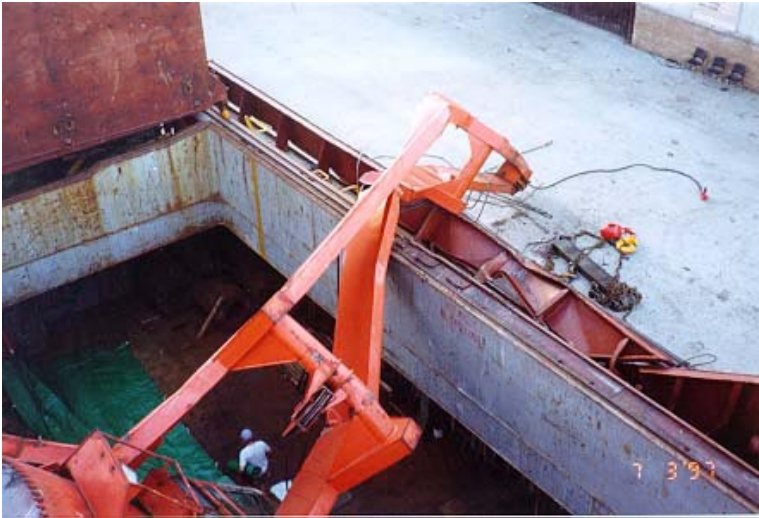
The jib of the crane was extensively buckled and had to be cut up in order to be removed. (See photo, next page.) Its lower end had parted from the trunnion bearings on the body of the crane during the incident. The exterior fittings on the body of the crane had suffered extensive damage, but it was not possible to

Jib of no. 1 crane lying over the port side of the vessel

Evidence of earlier repairs was found, where steel doublers had been welded to the jib. This was at a critical load area of the jib, approximately 2 m from the trunnion bearing or hinge pin. This may indicate that a significant force or tipping moment had been placed on the slew ring bearing at some time before the incident under investigation, although it would not have been the immediate cause of the crane's collapse.

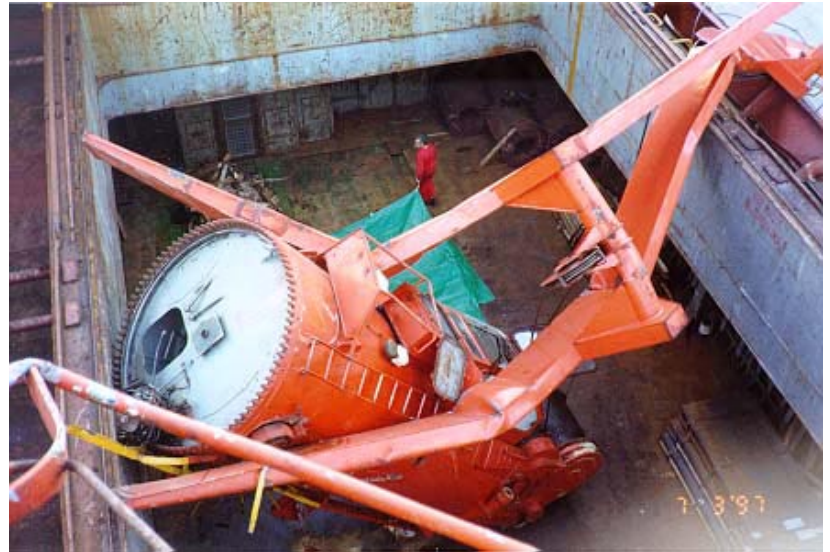
Body of no. 1 crane lying upside-down in no. 2 port tweendeck

assess what damage had occurred to the machinery or to the structure of the crane body itself, although it was evident that the crane's slew ring bearing had experienced a catastrophic failure.

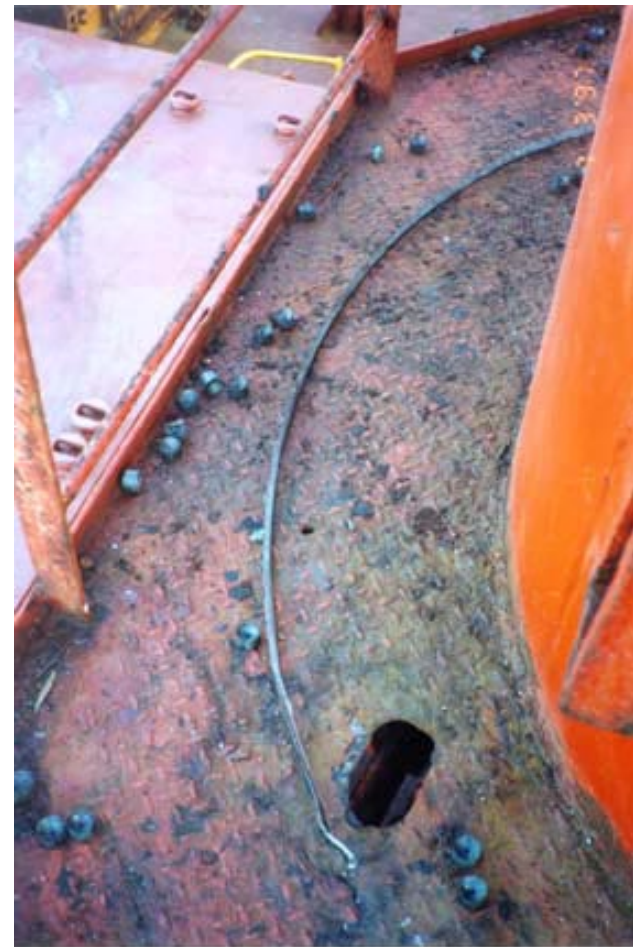
Bearing debris
Lower edge of outer race, sheared off,
surrounded by balls and spacers from
the bearing

The evidence indicated that the surfaces of the grooves in the bearing had been wearing over a considerable period of time. A secondary roller path had been formed in the outer race indicating that the crane had been operating for an extended period of time in a very badly worn condition. Wear eventually progressed to the point where there was insufficient material remaining at the lower edge of the outer race to withstand the upward forces generated during normal crane operations. What remained of the lower edge had finally been sheared off.

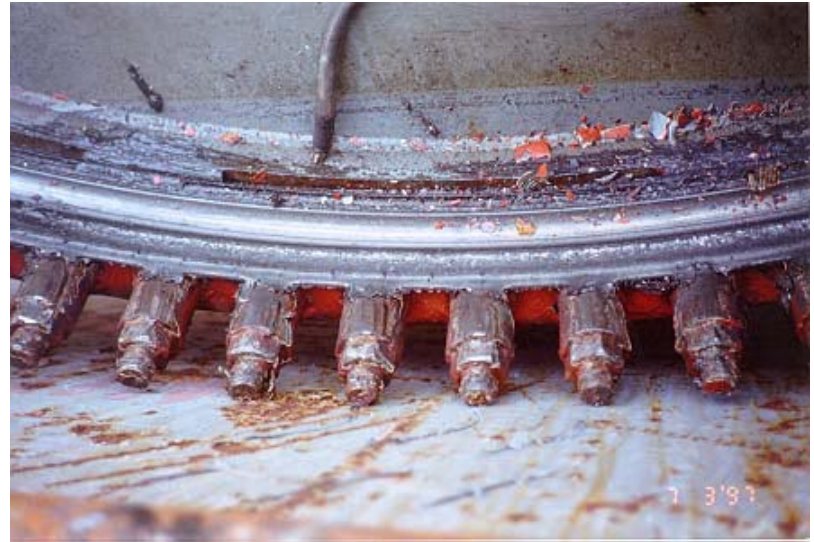
Outer race bearing

Note secondary roller path, the result of extreme wear, and absence of grease

The severe wear observed in the outer race appeared to be due to a complete absence of proper lubrication.

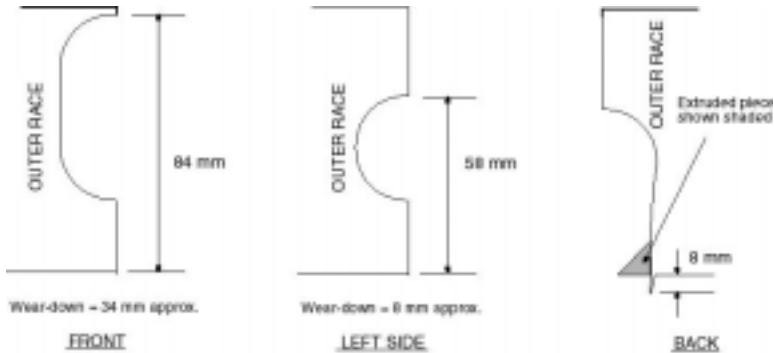
Wear down of the outer race

At the front of the crane the outer race wear down amounted to some 34 mm. At the left side, on the “neutral axis” where the loading is not so severe, it was 8 mm and at the back the lower edge had gone. The right-hand diagram, below, depicts the position from which the strip, found on the platform around the pedestal, had been sheared and extruded. Once the hardened surface of the grooves had been worn away, the wear would have progressed comparatively rapidly through the underlying, unhardened, steel.

Wear-down of the bearing should be monitored as part of normal planned maintenance and survey procedures. The degree of bearing wear-down, with the resultant excessive clearance between the bearing elements, found in the no.1 crane, would have been immediately obvious during a proper routine examination. No manufacturer’s handbook, or other information giving the allowable wear tolerances and detailing the procedure for measuring this clearance, was held on board *Lodz 2*.

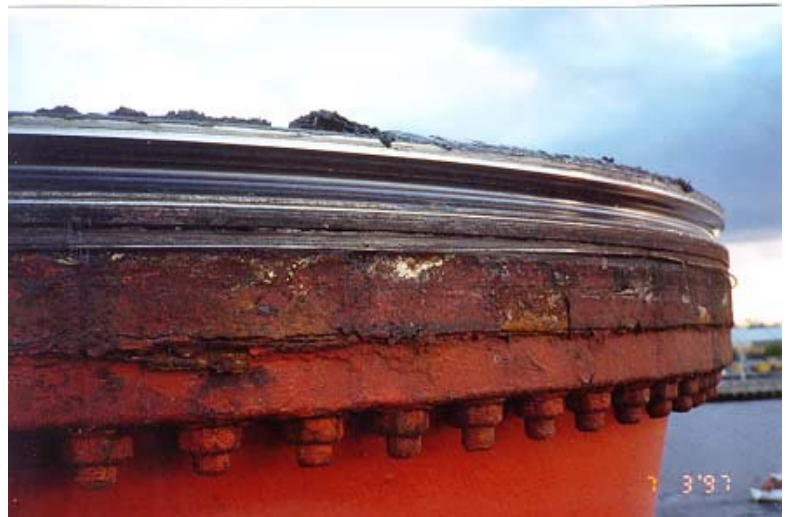
Inner race of bearing on crane pedestal

Note absence of lubricant in groove (grease on top has been extruded from internal ring gear)

The cranes showed evidence of sufficient grease having been applied to the sheaves, wires, hook swivels, and other components, but not to the slew ring bearings. The slew ring gear teeth, on the inside of the inner bearing race of the no. 1 crane, were greased but the 12 grease nipples and the grease passages in the outer race were quite dry. It was evident that these grease nipples had been neglected for a long period of time.
