MAN B&W Diesel

Key Components, Tegholmen Works

MC fuel pump

Fuel Pump Top Cover Fractures

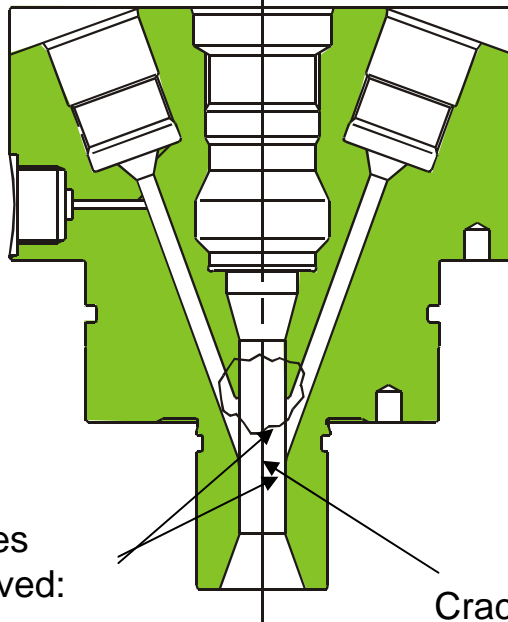
Previous

Crack initiation area

The fractures have been experienced on small and medium bore engines. The fractures were initiated at the position where the inclined drillings for the high-pressure pipes intersect with the central bore. The cause of the failure has in all cases been related to roundings which did not fulfill our specifications.

Sharp edges
to be removed:
R1-R10

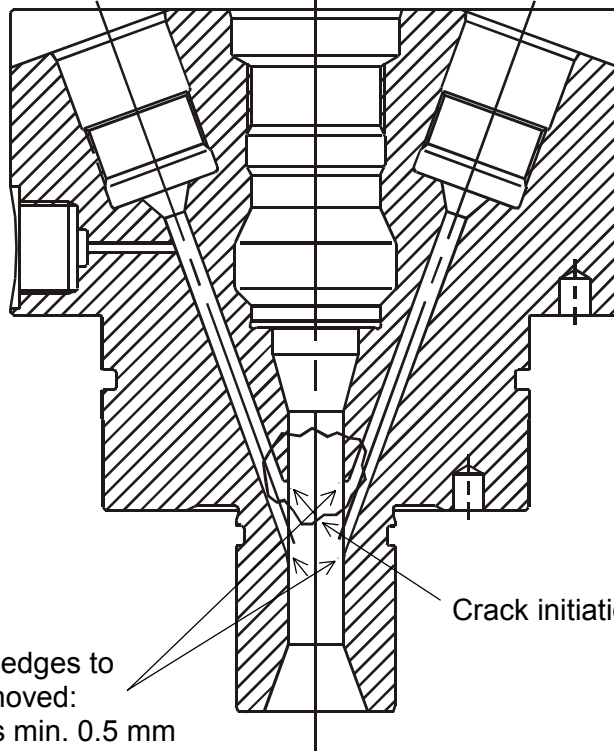
*Fig. 1:
Previous design*

The cracks are initiated at the edge between the central bore and the inclined bores, due to the lack of the specified manual finishing of the transition edge between the central bore and the inclined bore. The crack-initiated area is shown in Fig. 1.

Crack initiation area

We recommend checking whether the spare cover is of the original design. If this is the case, please check the transition between the vertical bore and the inclined bores. The transition area must have a radius of min. 0.5 mm. On the spare top cover, the sharp edge must be removed and a rounding of min 0.5 mm must be made.

Sharp edges to
be removed:
Radius min. 0.5 mm

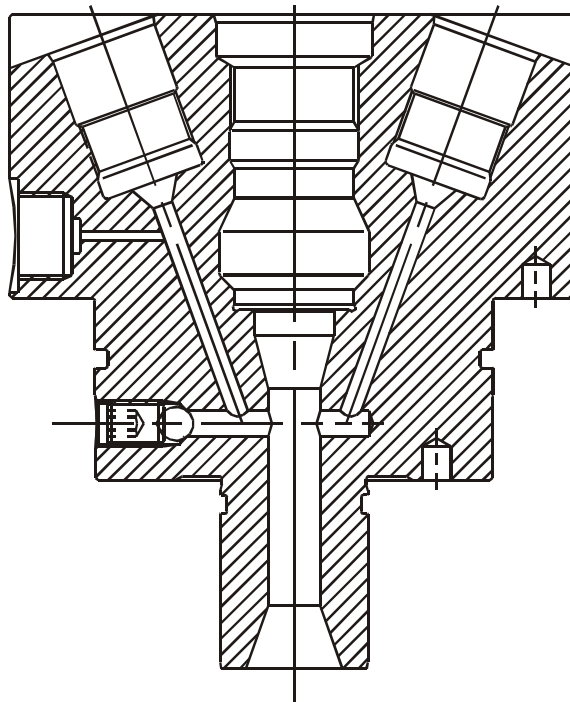
*Fig. 2:
Modified design*

In order to eliminate the need for manual finishing during production, and as an alternative to this, we have introduced a modified design for future top covers. The design is shown in Fig. 2.

The modification involves the introduction of a horizontal bore connecting the vertical central bore and the inclined bores.

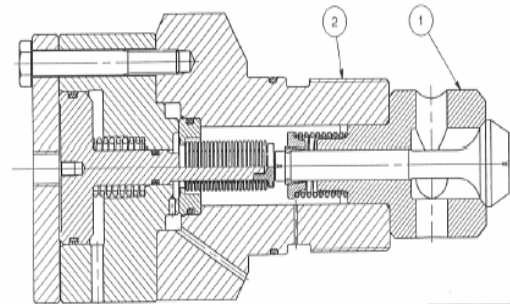
Previous design with bellows

Due to cracked bellows, the design has been changed.

Unit item 2 from modified design is interchangeable with unit item 2 from previous design.

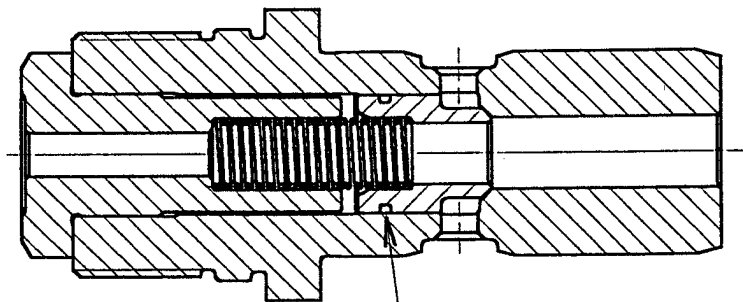
ORIGINAL SUCTION VALVE
FOR Mk 3 & 5 FUEL PUMP
WITHOUT UMBRELLA

We have recently experienced incidents in which damage has occurred to the sealing ring on the fuel pump suction valve slide.

As a damaged sealing ring might lead to malfunctioning of the suction valve, we have made investigations and tests on suction valves without a sealing ring.

The results of these tests revealed that the suction valve can operate satisfactorily without the sealing ring, and we therefore recommend that the sealing ring be removed at the next suction valve overhaul.

SEALING RING TO BE REMOVED
ON ENGINES IN SERVICE

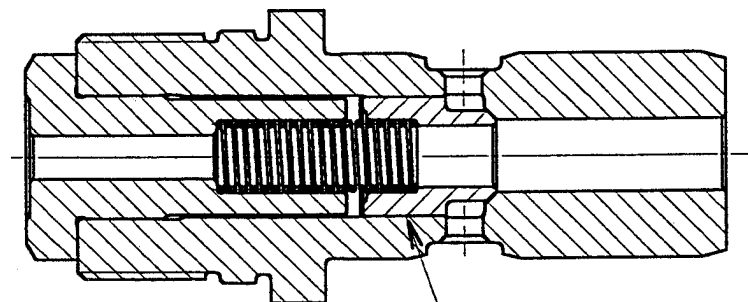
NEW SUCTION VALVE
FOR Mk 3 & 5 FUEL PUMP
WITHOUT UMBRELLA

SLIDE WITHOUT GROOVE
AND WITH REDUCED CLEARANCE

As for future spare parts deliveries, this suction valve slide will be specified without the sealing ring groove, and with a slightly reduced clearance between the slide and the valve housing, please see Enclosure 1.
