Service Experience 2006, ME and MC Engines

MAN B&W Diesel A/S, Copenhagen , Denmark

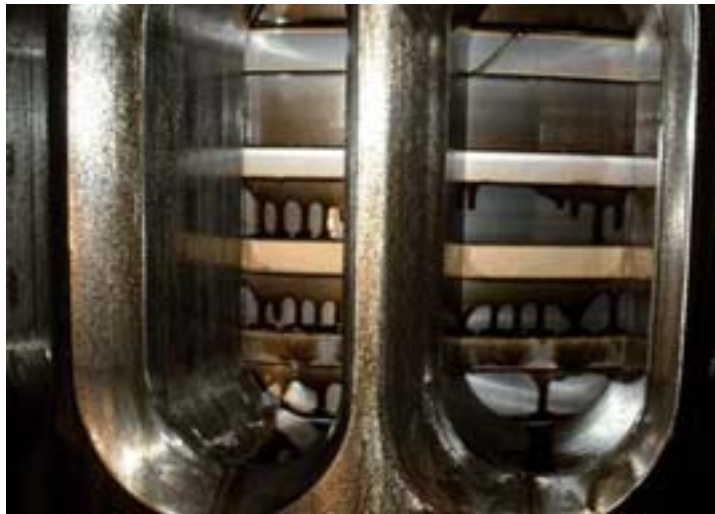
Fig. 12: 12K98ME, port inspection shows excellent condition

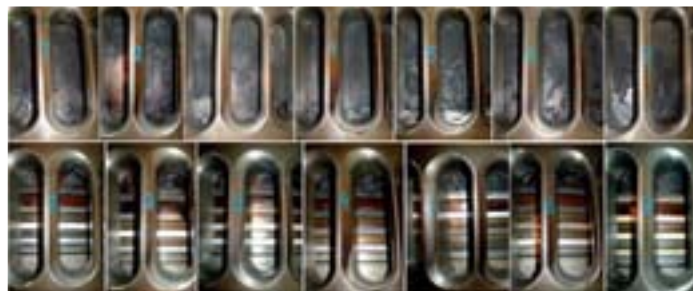
Fig. 11 demonstrates the cylinder condition on the first 7S50ME-C after 10,717 running hours, and the condition is perfect. As regards the cylinder condition, in particular, observations

Fig. 11: 7S50ME-C, cylinder condition after 10,717 running hours

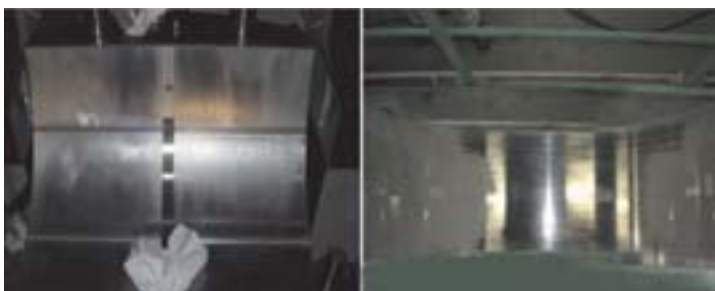
Fig. 13: 12K98ME, crosshead bearing and main bearing

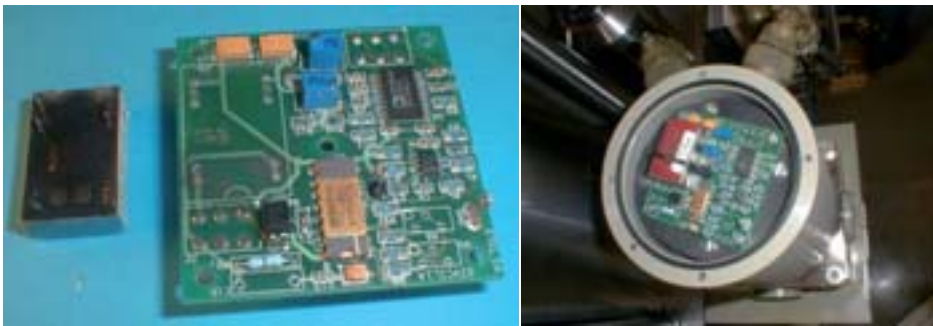
On the Print Circuit Board (PCB) components have come loose due to vibrations. Fig. 14 shows a DC-DC converter which has come off. Improvements by means of resilient mountings have been introduced on all vessels in service with ELFI valves, and performance has been good hereafter, see Fig. 15

Fig. 14: ELFI valve, DC-DC converter coming off due to vibration of PCB

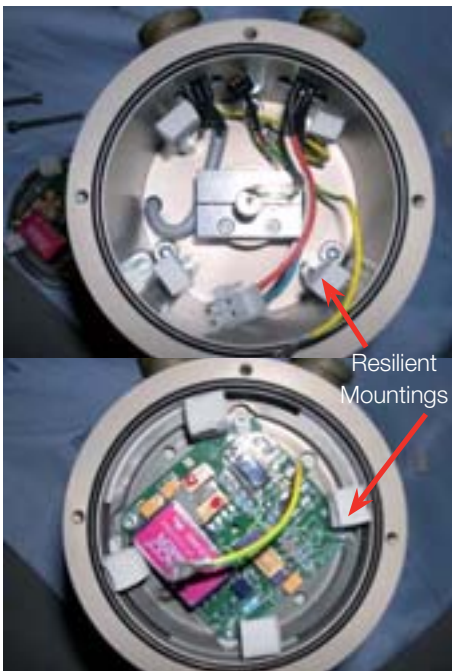
Fig. 15: ELFI valve, PCB secured by resilient mountings

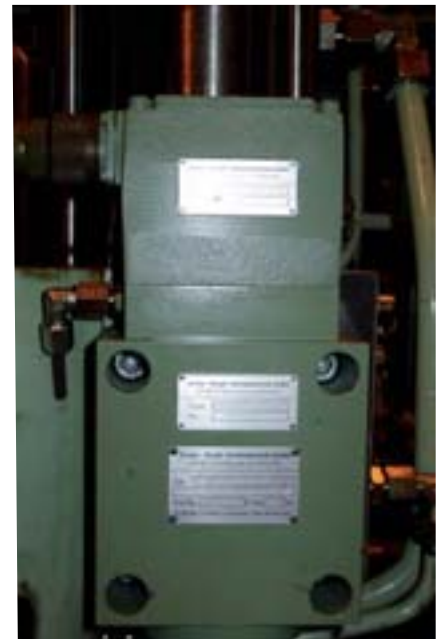
Early service experience proved that low ambient temperatures, as often experienced during shop tests in the winter season, gave rise to sticking high-response valve spools in the ELVA valve due to low hydraulic oil temperatures. The diameter of the spool was reduced in order to obtain correct functioning of the high-response valve as shown in Fig. 16.

Fig. 17: ELVA valve, sticking high- response valve spool

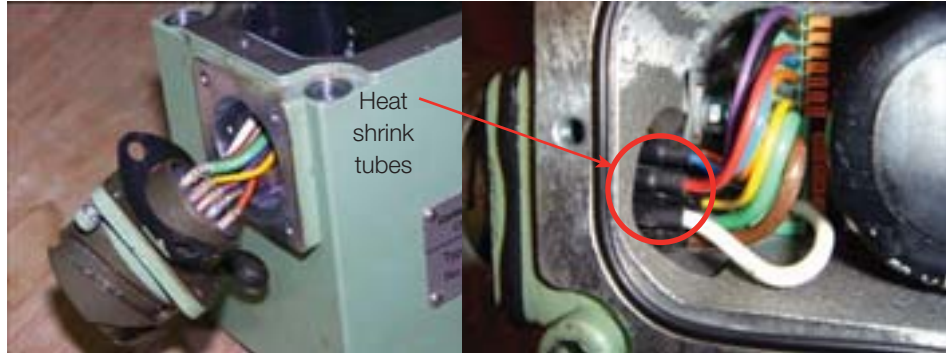
Fig. 19: ELVA valve, reinforcement by heat shrink tubes

pin is reinforced by a heat shrink tube, Fig. 19.

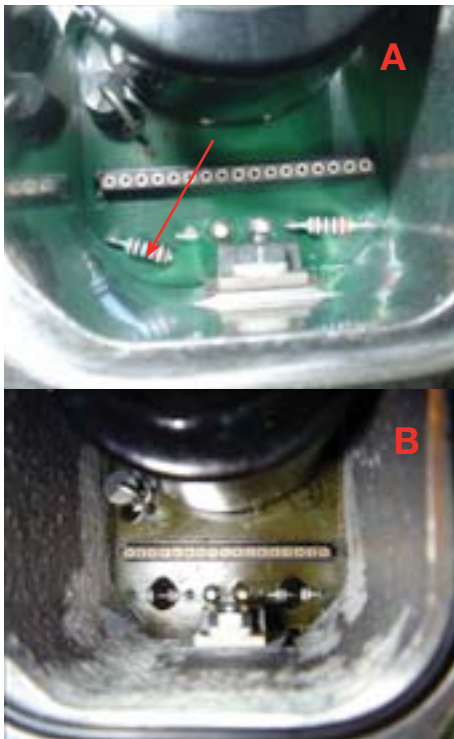
Fig. 18: ELVA valve,
A: resistor broken due to vibrations
B: damping secured with silicon glue

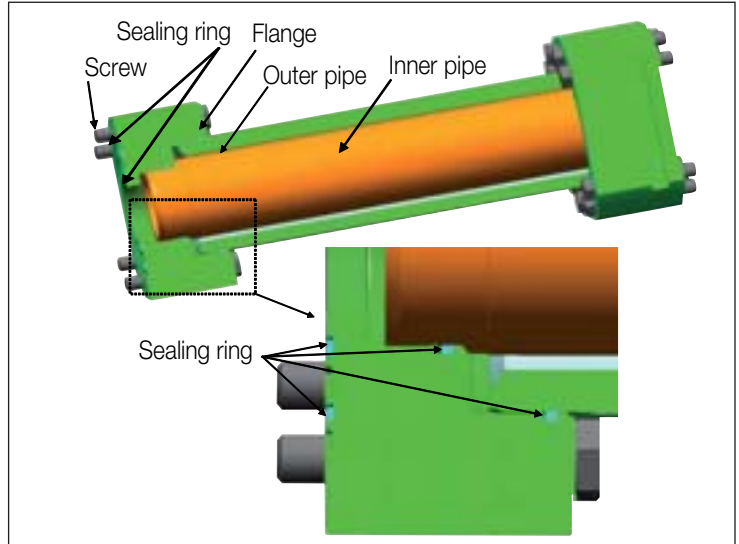
Problems with hydraulic oil leakages have been seen during shop tests on the largest engines because of seal damage. The main reason for these problems was lack of quality from a new sub-supplier of these sealings. In any case, it was decided to upgrade the seal design for the 80-98 bore engines, see Figs. 24 and 25.

Fig. 24: Double-wall piping, old sealing arrangement

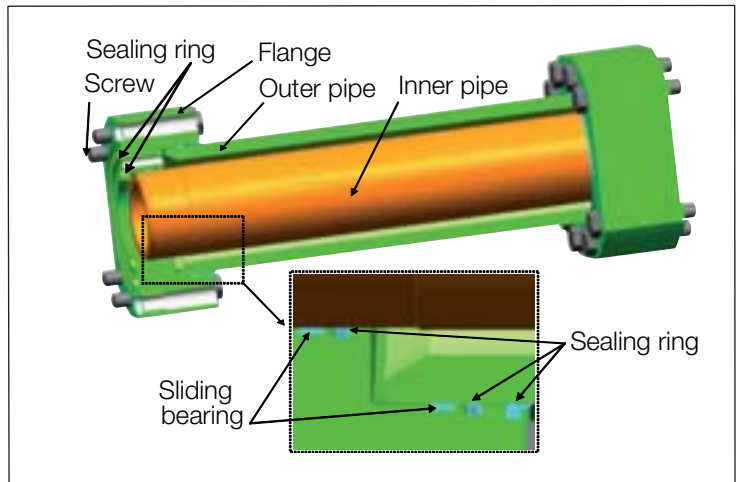
Fig. 25: Double-wall piping, new sealing arrangement

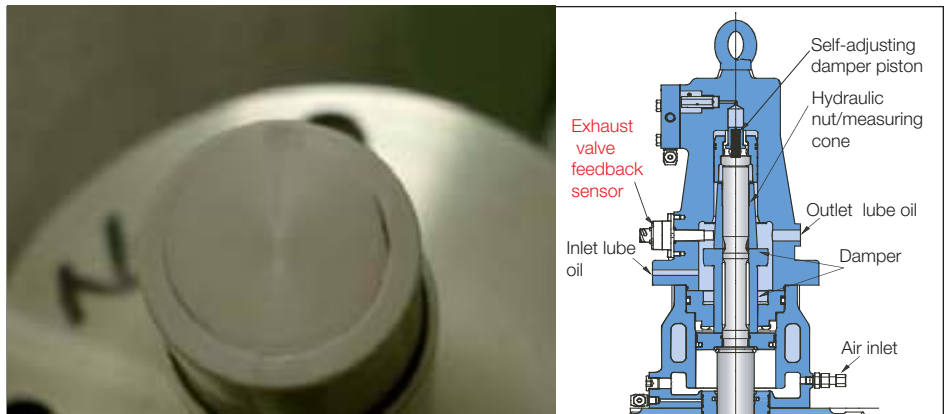
The plastic sensor tip has broken loose or it has been pressed in, Fig. 23. The tip has been reinforced and the internal moulding in the tip has been improved by process improvements.

Fig. 23: Exhaust valve feedback sensor

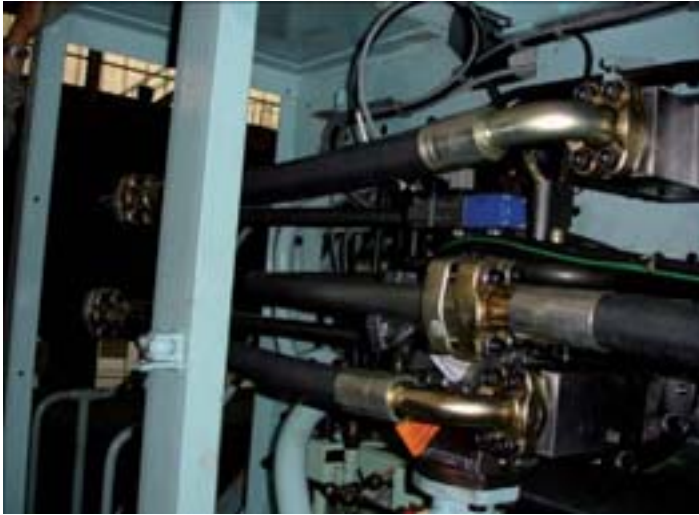
Fig. 28: Flexible hoses on K98

Cases of cracked hydraulic pipes for the servo oil to the swash plate pumps have been seen, and investigations have proved these cracks to occur due to vibrations. To avoid this, the pipe dimension has been changed and flexible hoses have been introduced as an extra precaution, see Fig. 28.

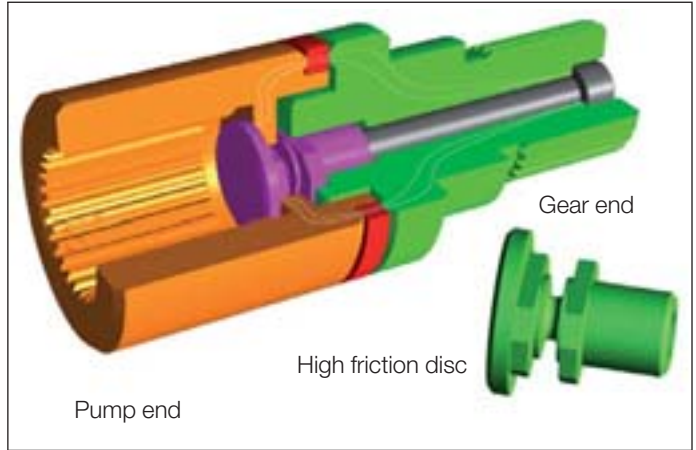
Fig. 31: Pump safety shaft, new shaft assembly with central bolt

Besides this, we have introduced forced lubrication of the shaft assembly to counteract cases of wear of the splines for the shaft and gear wheel. Splines are now also hardened.

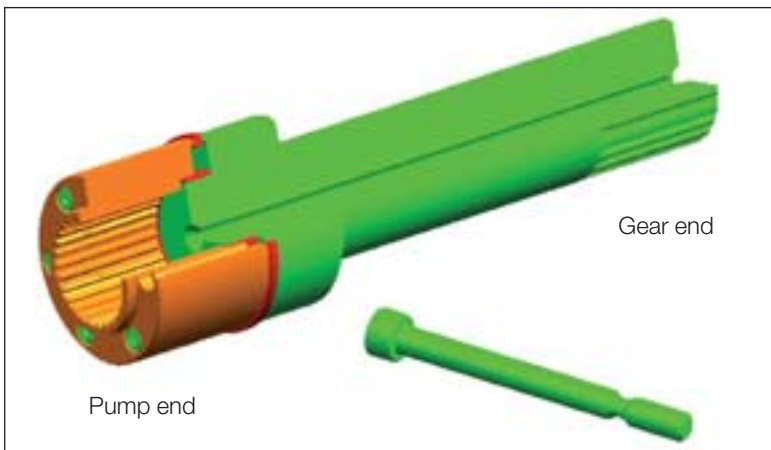
Fig. 30: Pump safety shaft, initial design

shown in Fig. 30 featured six studs and a frictional connection, and the bolts were sheared at a too low torque.

The purpose of the shaft design is to set an upper limit to the transferred torque, so as to safeguard the common gear in the event of damage to a pump. However, the shafts broke due to a too low torque capability.

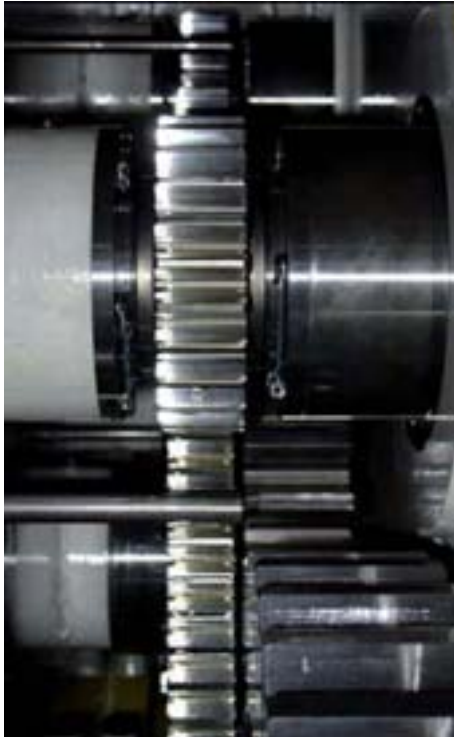
Fig. 32: 7S50ME-C, gearbox for engine-driven hydraulic pumps

Fig. 32 shows an example of an inspection of the gearbox for the pump drive after 3,000 hours. The condition of the gearbox was found to be excellent. The only modification introduced is a tip relief on the teeth in order to prevent initial running in marks.

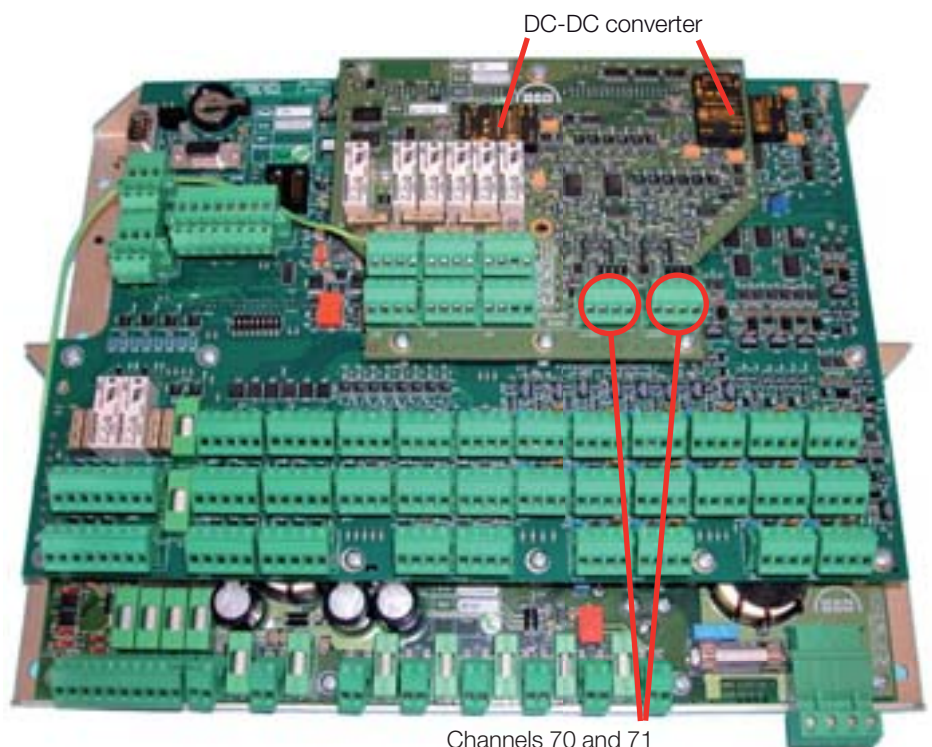
On the MPC, channels 70 and 71 have been damaged in some cases. This was caused by wrong or fluctuating signals at the outputs. Consequently, a breakdown of a capacitor in the DC-DC converters (Fig. 33) took place. This was determined to happen when 24V or higher voltages (noise, etc.) were applied backwards into the terminals

Fig. 33: MPC board, failure of channels 70 and 71

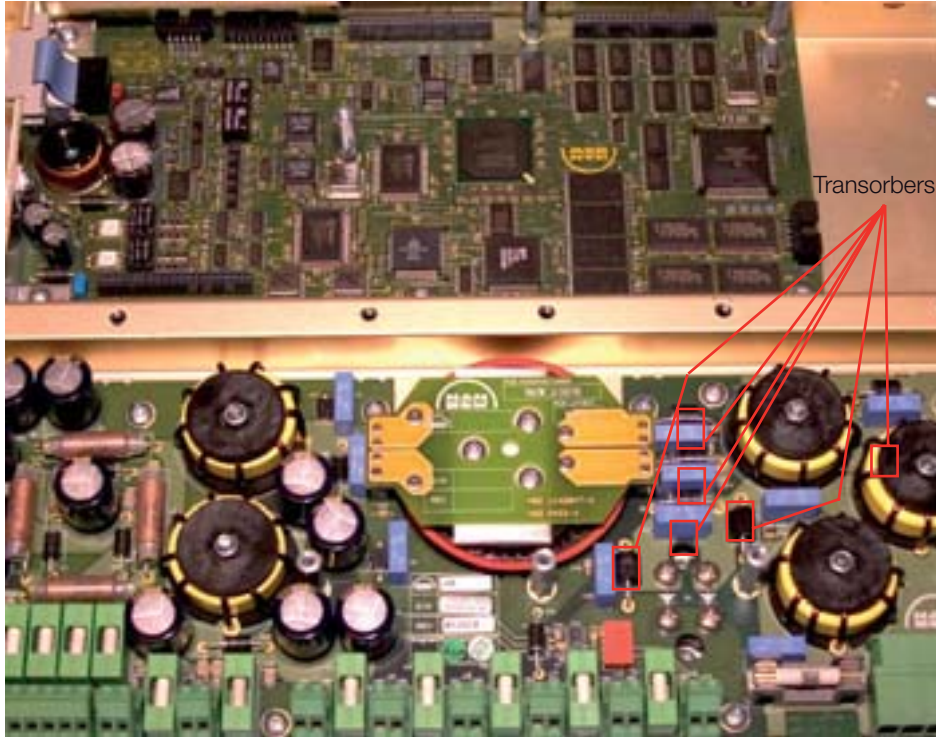
Fig. 34: MPC board (Power Filter Board) isolation failure

Due to inferior quality of a component (a transorbtor) used in the power filter board of the MPC, Fig. 34, isolation failures were experienced. Certain situations caused too high 'leak-currents' through the transorbtor. Manufacturers of the transorbtor have been black-listed and transorbtor from reliable manufacturers have been applied.

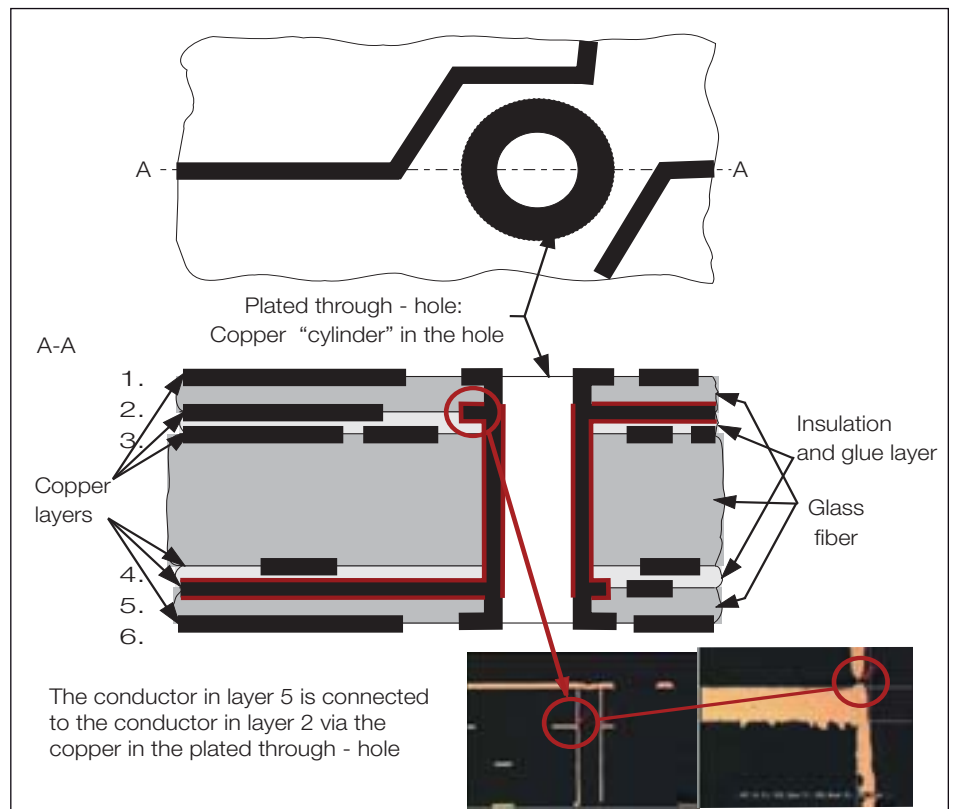
Production failures in the Printed Circuit Boards (PCBs) have caused broken connections in the inner layers, Fig. 35. The PCB base material has been changed to a type with a lower thermal expansion coefficient in the cross-sectional direction. Furthermore, the copper layer thickness in plated-through holes has been increased to fulfil the specification.

Fig. 35: PCB, broken copper layers

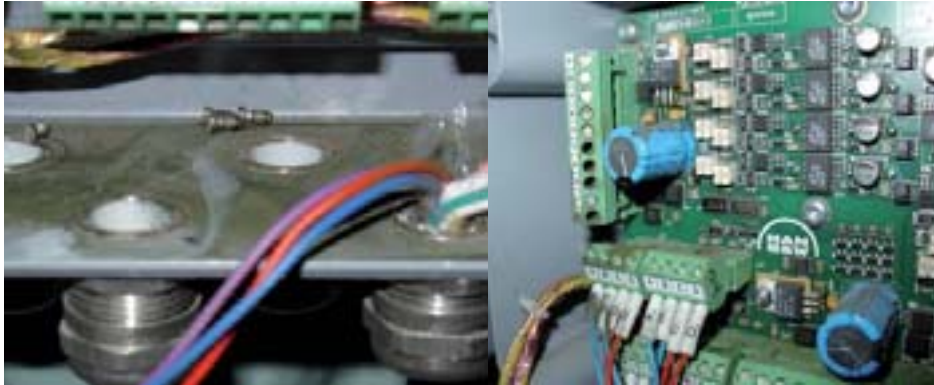
A general problem has been that loose, unused screws in terminals on PCBs mounted on the engine are worn by vibrations, thereby causing emission of metallic dust in the area near the terminal involving a risk of causing short circuit, Fig. 36. Instructions have been released requiring that all screws, also unused, must be tightened with at torque screwdriver.

Fig. 36: PCB, metallic dust from untightened (unused) screws

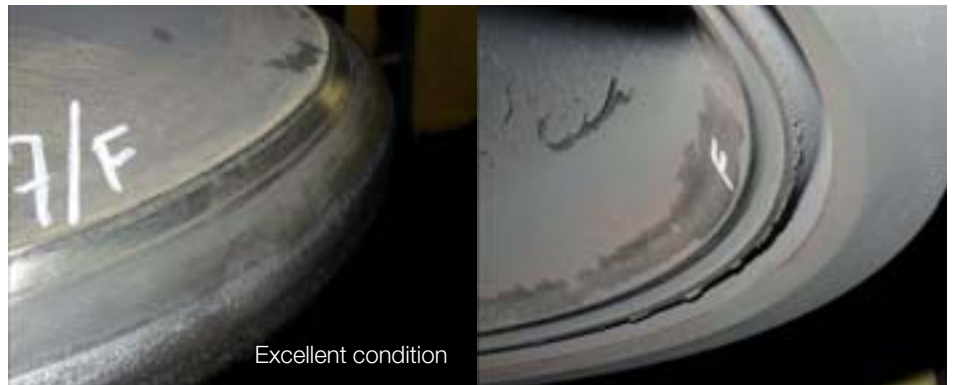
The exhaust valve condition also gives rise to optimism with respect to the increase of TBOs. Fig. 48 shows a bottom piece of the W-seat design in combination with a nimonic spindle on a K90MC engine inspected after 36,400 hours without overhaul.

Fig. 48: Nimonic exhaust spindle and W-seat bottom piece

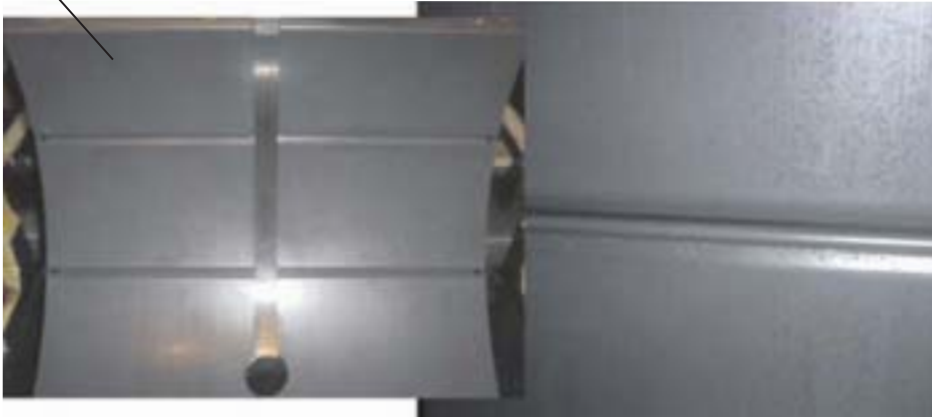
Service tests for crosshead bearings with new synthetic coatings based on polymer, molybdenum disulphide/graphite are ongoing and showing good results, Fig. 63. This technology can be spread to other bearings than crosshead bearings where static friction is a limiting factor.

Fig. 63: Synthetic overlay on AlSn40 crosshead bearing shell

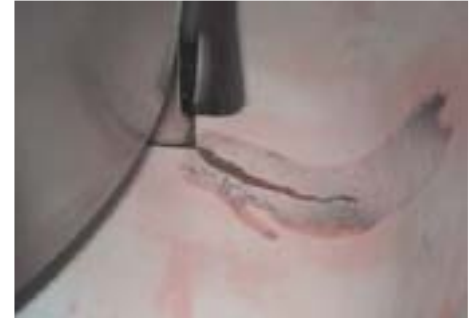
Fig. 66: Crack in camshaft bearing pedestal

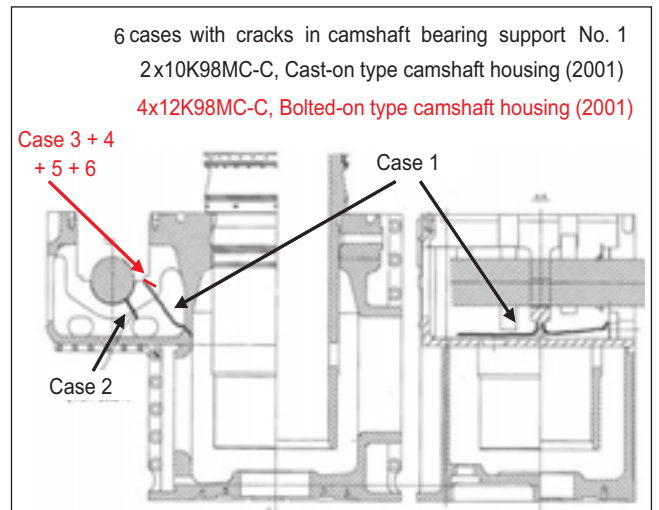
Fig. 65: Crack paths in camshaft bearing pedestals

4. For engines with cracks propagating in the main cylinder frame structure (Fig. 65, case 1), a new one-cylinder frame block has been prepared. This block will be exchanged when the vessel docks in August 2006.
5. Fig. 65, case 2 shows a crack in a cylinder frame with an integrated camshaft housing. However, the crack has only propagated in the bearing pedestal No. 1 in the camshaft housing. Fig. 71 shows the principle of two hanging bearings installed hanging from cylinder No. 1 base plate. This will completely offload the camshaft bearing pedestal No. 1 when the bearing shell is removed. Installation of this solution

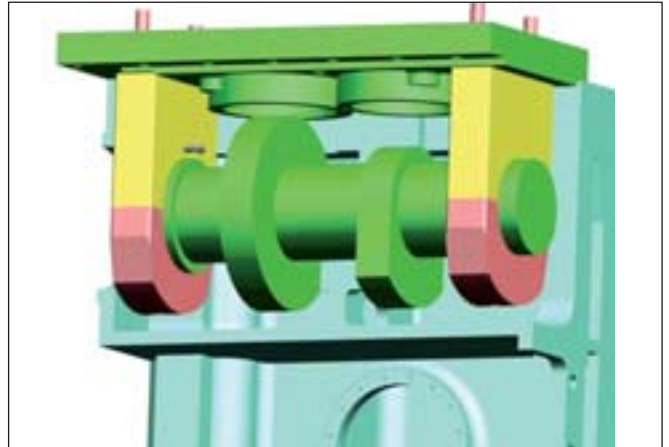
Fig. 71: Repair of cracked bearing support, 'two hanging camshaft bearings'

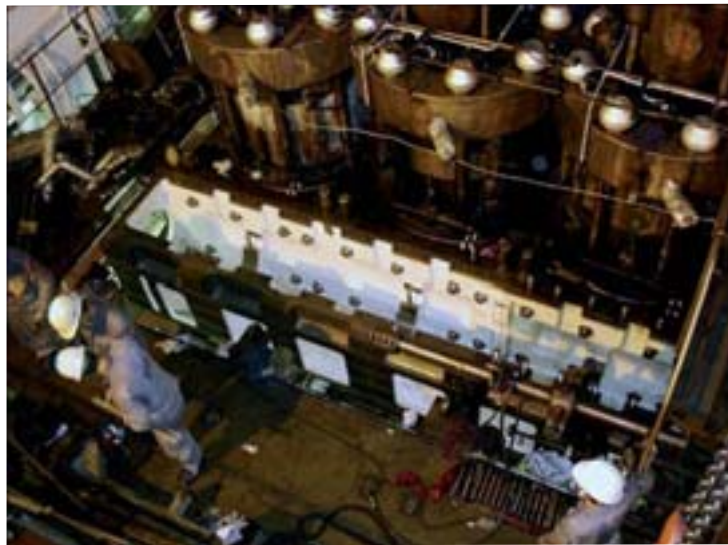
Fig. 72: Exchange of cracked two-cylinder camshaft housing section

6. Exchange of two separate cylinder camshaft housing sections are planned on four (4) vessels. Fig. 72 shows the work done on the first vessel on which such operation has been carried out during scheduled docking.
