Service Experience 2008, MAN B&W Engines ME/ME-C and MC/MC-C Engine Series

MAN Diesel • Copenhagen, Denmark

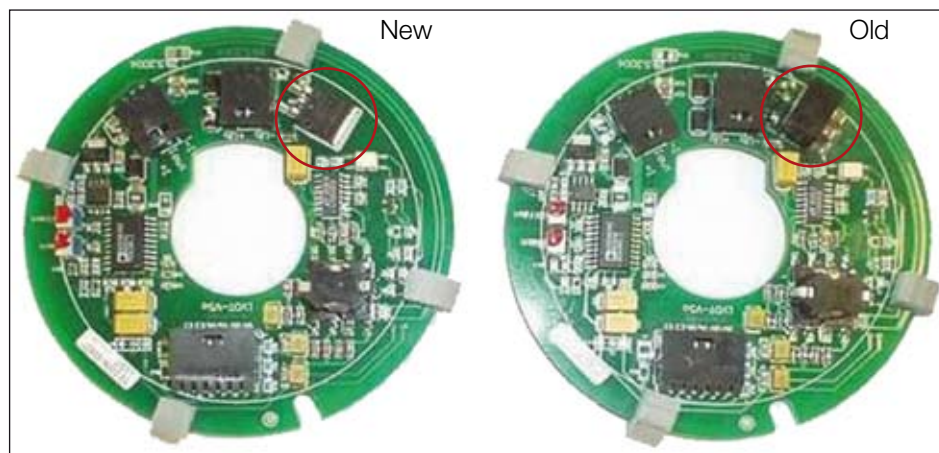
In the original version, the electronics on the printed circuit board (PCB) in the Curtiss Wright FIVA valve showed thermal instability causing untimed actuation of the valve. The reason was an analogue voltage regulator generating

Fig. 8.4: FIVA valve feedback failure: exchange of analogue voltage regulator with switch mode voltage regulator

an excessive amount of heat raising the temperature by 35°C on the PCB. In some cases, this caused a temperature shutdown of the LVDT converter in the feedback loop, resulting in the above-described unstable function of the FIVA valve. The solution was to exchange the analogue voltage regulator with a switch mode regulator, Fig. 8.4. Hereby, the temperature of the PCB was lowered by approx. 35°C.

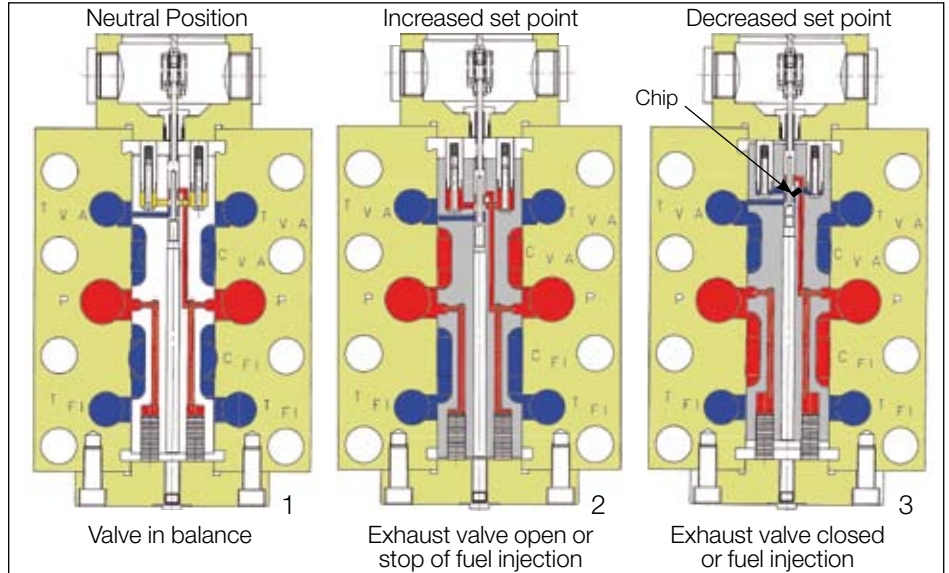
Fig. 8.6 gives an explanation of what happens if a loose drilling chip is stuck between the pilot slide and the main slide.

Fig. 8.6 (left hand side) shows the valve in balance. This means that the constant pressure on the bottom of the main slide is balanced by a pressure creating a similar force in downward direction, thus keeping the slide in neutral ("zero") position.

In order to open the exhaust valve or to stop fuel injection (Fig. 8.6, centre), the pilot slide should be moved downward, thereby increasing the pressure on the top of the main slide and moving the main slide downward. This will result in exhaust valve opening or stop of fuel injection.

When the pilot slide is moved upward (Fig. 8.6, right hand side), pressure on the top of the main slide is decreasing and the main slide is moved upward enabling closure of the exhaust valve or fuel injection. If a drilling chip is stuck in between the pilot and the main slide when the exhaust valve is closing, there is a risk of fuel injection just after closing of the exhaust valve. This will create an excessive pressure build-up in the combustion chamber and a risk of cylinder cover lifting. This was the cause

Fig. 8.6: CWAT FIVA valve: Movement of pilot valve and main slide

of the two cylinder cover lifts on the 6S70ME-C engines on testbed in 2007.

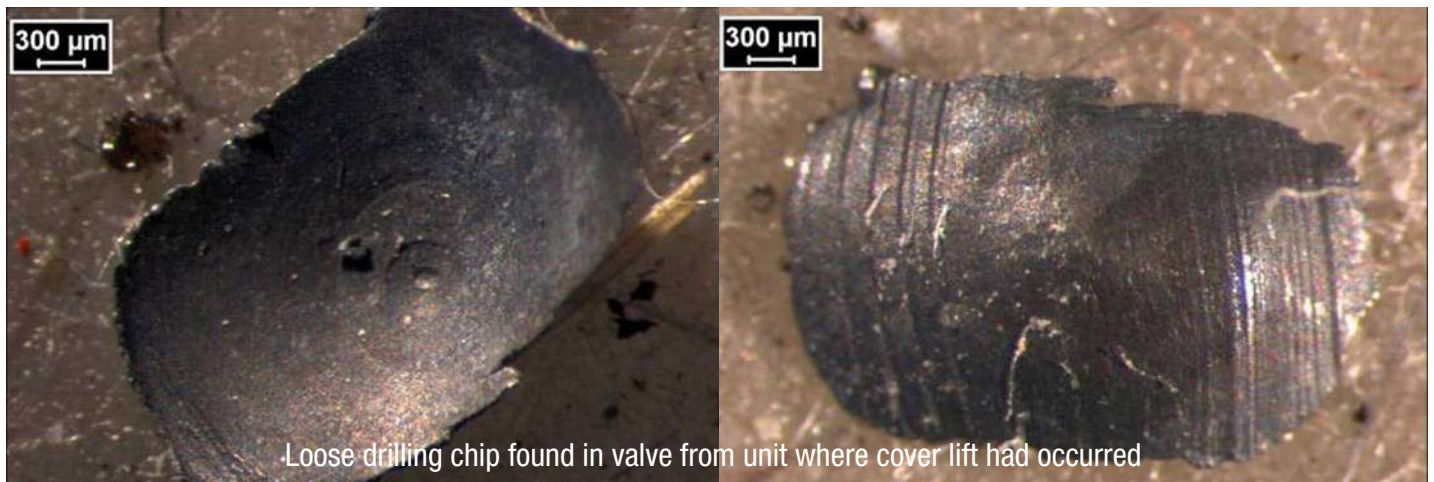
In 2007, we experienced a cylinder cover lift twice on testbed with 6S70ME-C engines. The reason for these incidents was untimed movement of the FIVA valve main slide owing to a drilling chip left inside the main slide during production, Fig. 8.5. After discovering this production mistake, we have, together with the sub-suppliers, cleaned/re-machined approx. 500 main slides to avoid loose drilling chips inside the FIVA valves.

Fig. 8.5: CWAT FIVA valve: chips found in main slide

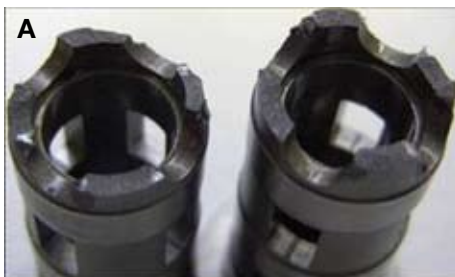
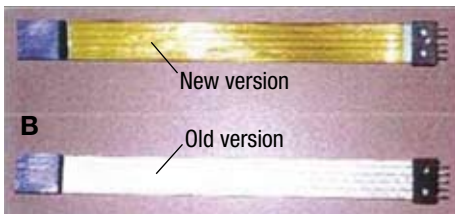
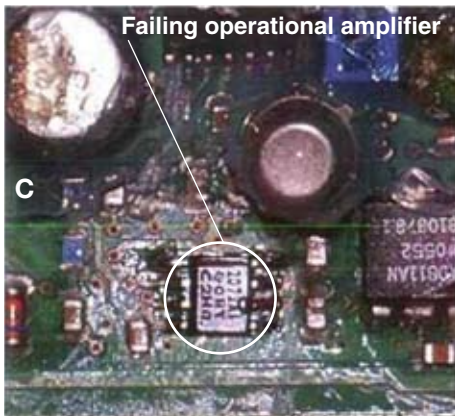
- A: Broken bushing for the pilot slide, Fig. 8.8a. This item was rectified during the prototype testing period
- B: Earthing failure owing to damage of a flexible wire strip inside the valve, Fig. 8.8b
- C: Malfunction owing to failing operational amplifier, Fig. 8.8c

Fig. 8.8a: Broken bushing, b: Damaged wire strip, c: Parker valve

Parker valves with certain serial numbers have been replaced in service.

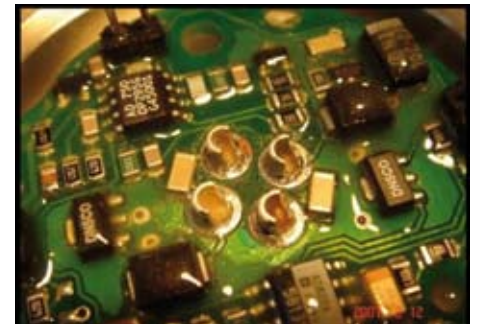
- A: Breakage of the rod in the sensor. The rod in the sensor has been redesigned, Fig. 8.9a
- B: Broken or loose connection between the print board and the external connector (type: Canon), Fig. 8.9b. Redesign of the connection has solved the problem.

Fig. 8.9b: Connector breakdown, H.F. Jensen feedback sensor

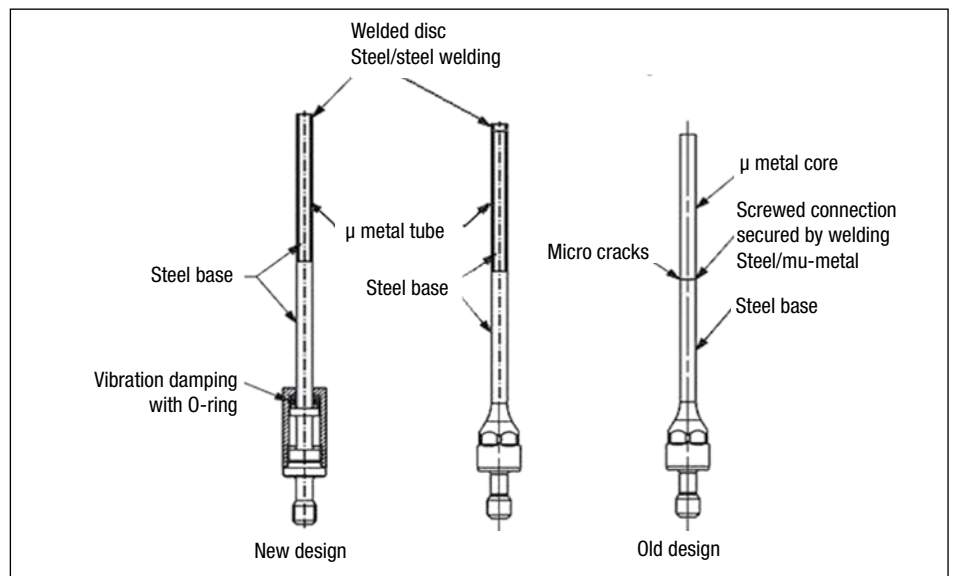
Fig. 8.9a: Redesign of rod for sensor in H.F. Jensen feedback sensor

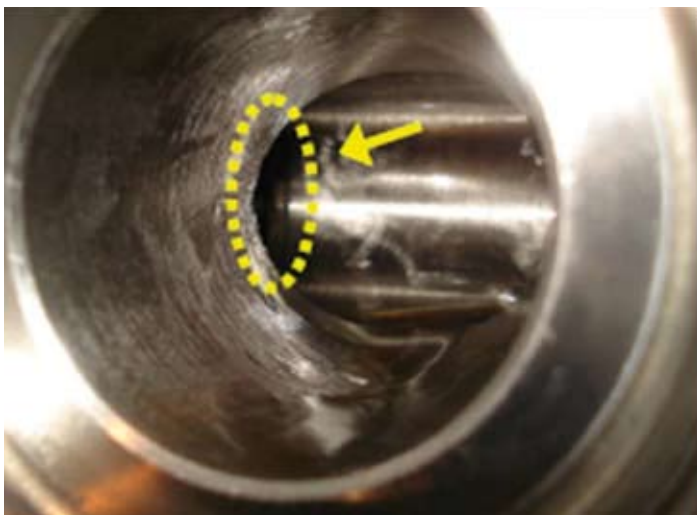
Cavitation in the exhaust valve actuation system has been seen in the exhaust valve top part, Fig. 8.11a, as well as in the exhaust actuator top cover, Fig. 8.11b.

Fig. 8.11a: Cavitation in exhaust valve top part

An orifice in the drain line from the FIVA valve, Fig. 8.12, has been introduced to reduce the acceleration of the actuator piston and hereby eliminating cavitation on the actuation side.

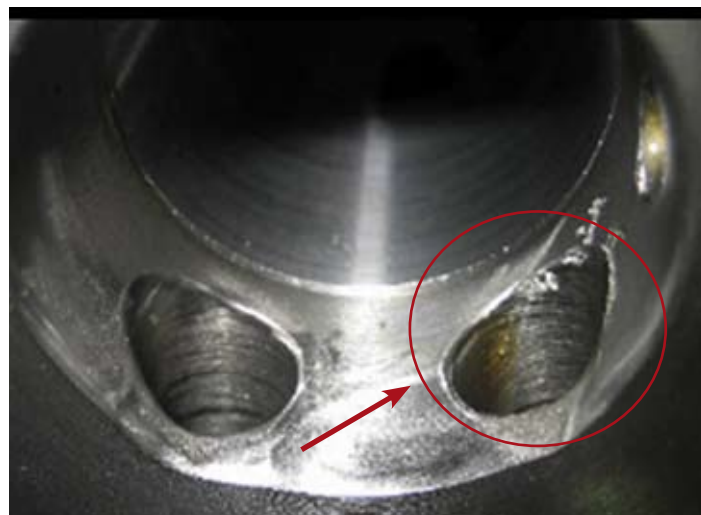
Furthermore, damage to the oil inlet non-return valves on the actuator top cover indicates excessive pressure fluctuations in the exhaust valve actuation system.

Fig. 8.11b: Cavitation in exhaust actuator top cover

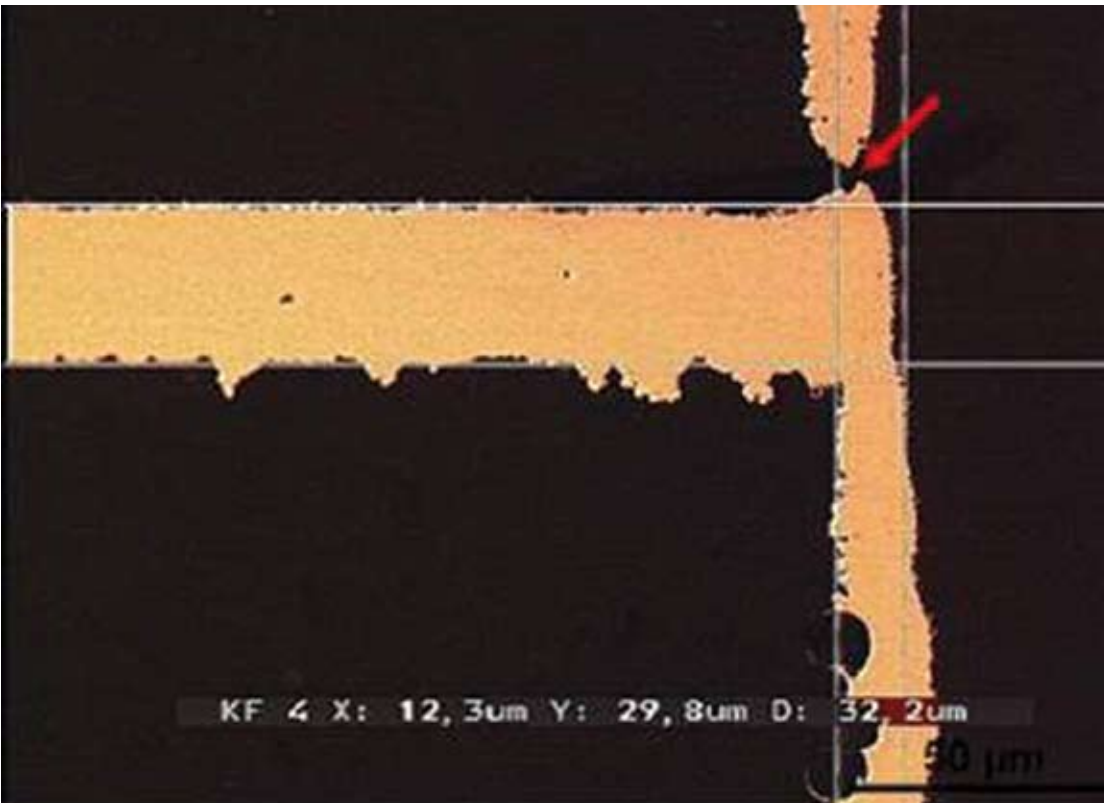
In 2007, we experienced one severe case of cylinder cover lift on a 6S60ME-C engine in service. After investigations into the parts involved on the cylinder unit in question, it was concluded that the reason was an error in the feedback loop for the FIVA control, Fig. 8.3. However, in this case the error was in the MPC part of the feedback loop. A loose/broken connection in the feedback circuit of the MPC was found during the investigation, see Fig. 8.15.

Fig. 8.15: Broken/loose connection in the MPC

Firstly, a circular letter warning against a specific alarm sequence was issued in order to exchange MPCs with similar potential defects. This circular letter was sent to all operators of ME engines.

Based on this knowledge, it was decided to invert the feedback signal, Fig. 8.16. By doing this, a frozen low value feedback signal will result in a FIVA main slide movement towards untimed opening of the exhaust valve. This is considered to be “failing into safe mode”.

Thirdly, in order to safeguard further against similar incidents, a new software version with closer supervision of the feedback signal [1] and additional supervision of the fuel plunger movement [2] has been introduced, Fig. 8.17. Control processes including the supervisions [1] and [2] are seen in Fig. 8.18.

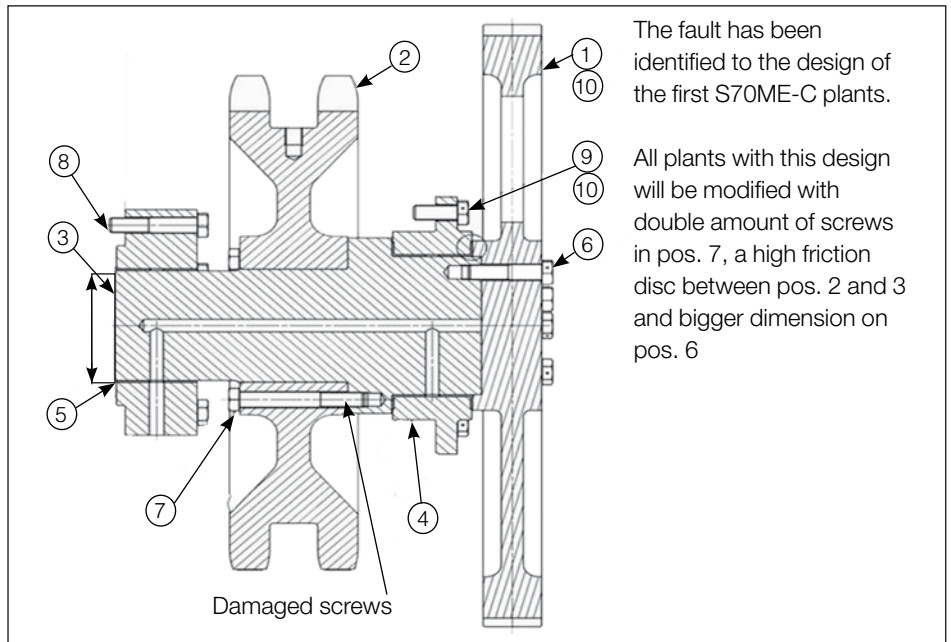
Fig. 8.19: S70ME-C assembly of shaft for hydraulic pump

For a series of the first S70ME-C plants, the chain wheel and gear wheel assembly on the HPS common shaft has shown to be under-dimensioned, Fig. 8.19. An upgrade of the bolt connections has been introduced on the concerned vessels in service.

The fault has been identified to the design of the first S70ME-C plants.

All plants with this design will be modified with double amount of screws in pos. 7, a high friction disc between pos. 2 and 3 and bigger dimension on pos. 6

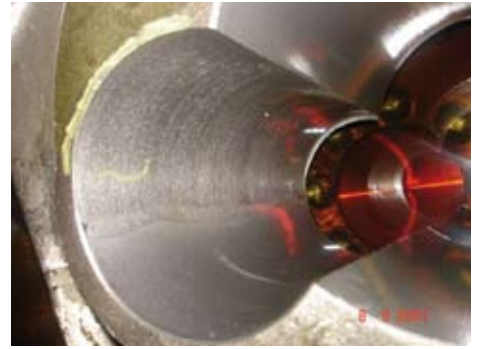
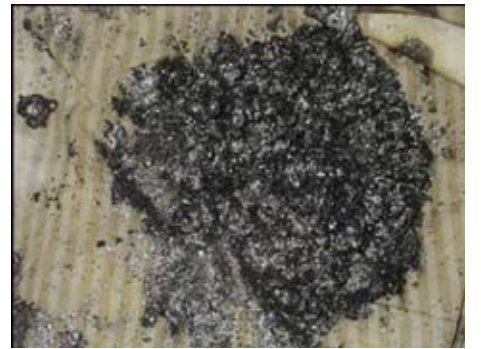
During 2007, we experienced one case of severe contamination of the servo oil system owing to a breakdown of the ship side transfer pumps. This happened on an installation equipped with a separate servo oil system (B).

Fig. 8.21: Breakdown of transfer pumps

Apparently, the screw type pumps produced the contaminating products rather quickly and, therefore, a lot of debris ended up inside the ME control valves, see Fig. 8.21.

After this incident, we have revised our specification for the separate servo oil system, Fig. 8.22. The important change is that a 6 µm full-flow fine filter has been introduced, also on the separate servo oil system.

For engines in service with a separate servo oil system, we recommend to add a “water-in-the-oil monitor”, connect the oil temperature measurement to the alarm system and install a metal detector just before the hydraulic power supply.

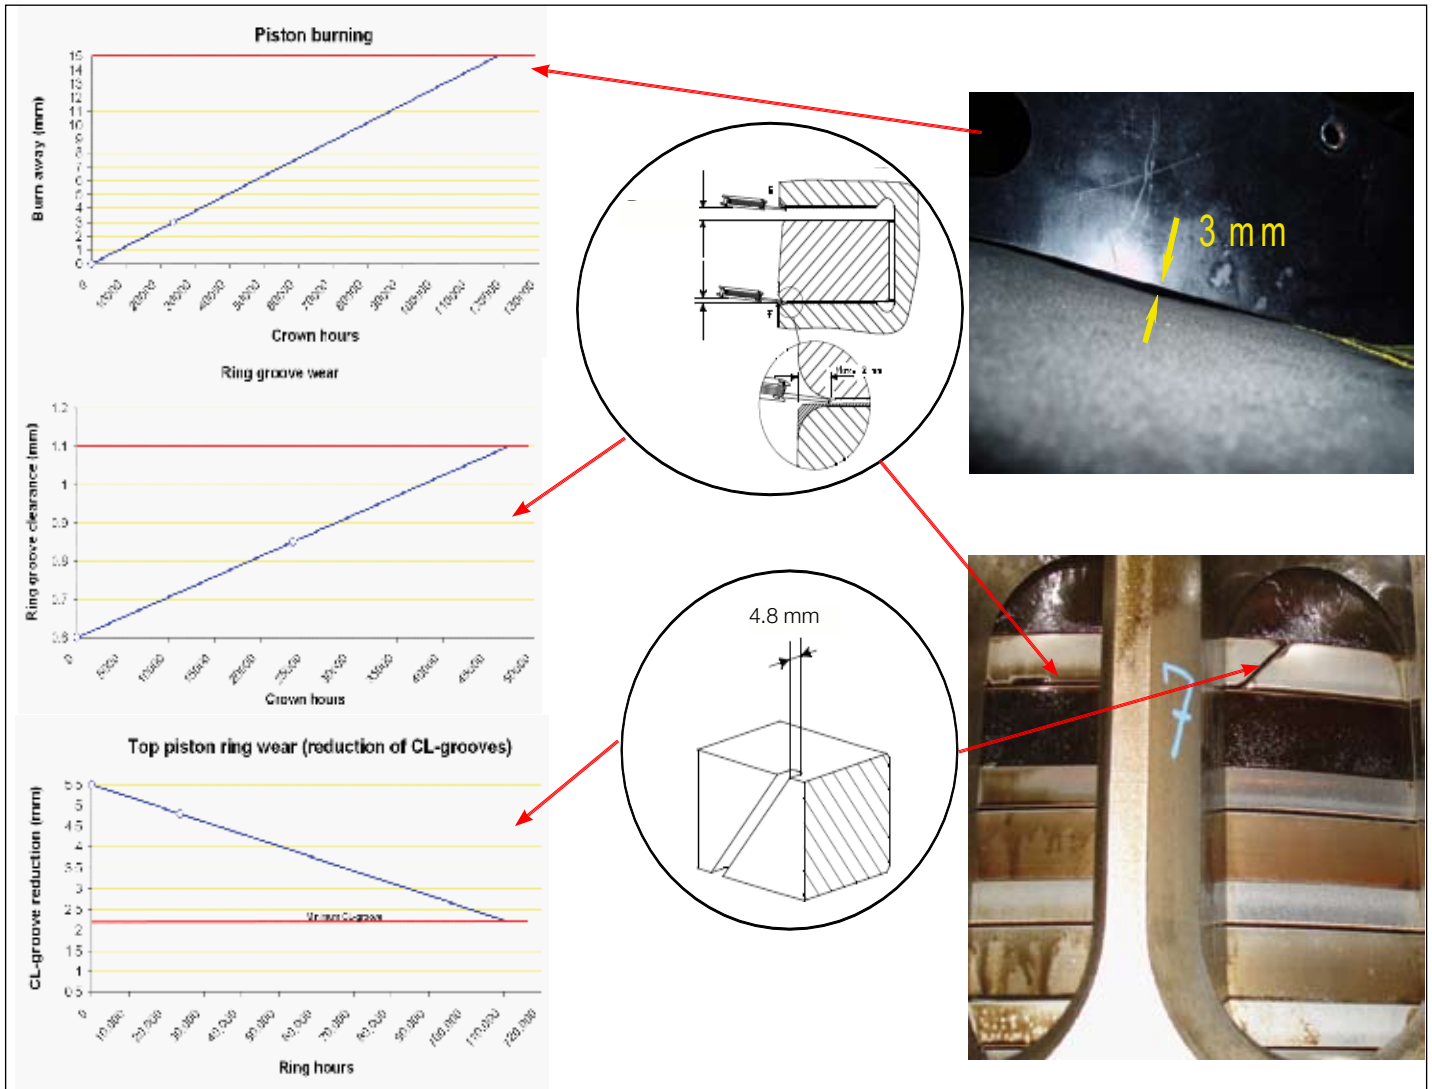
Fig. 8.24: 10K98MC-C, unit no. 7, at 23,500 hours without overhaul. The condition does not call for piston overhaul

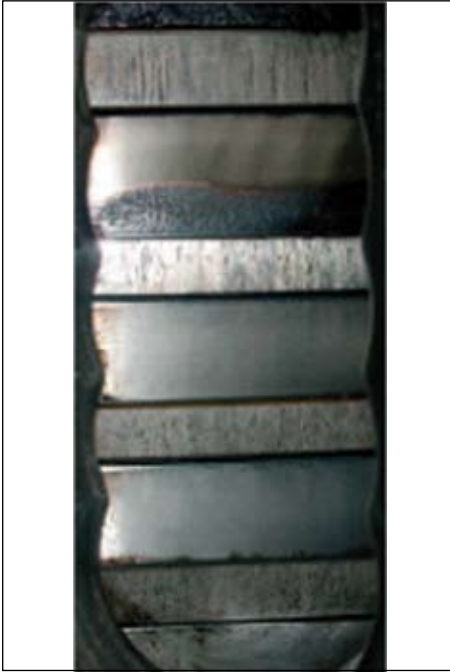
Fig. 8.25: Totally scuffed unit. Lubrication should be increased to maximum until overhaul is convenient with regard to the schedule of the ship. Due to the friction heat developed, the piston rings get hardened and the wear rate of the liner increases significantly. However, the hardening protects the rings, which is why operation may be continued safely until next convenient port stay.

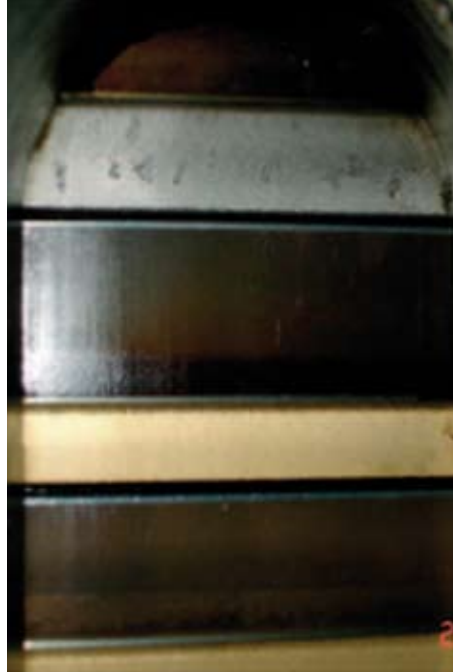
Fig. 8.26: Unit with micro-seizures on the top ring as a result of metal-to-metal contact. Should be counteracted by temporarily increased lubrication. It is important to lower the lubrication to normal as soon as the active mz-attack is stopped. Note that old, not active, mz-marks remain visible long after the attack has stopped and do not call for increased lubrication.

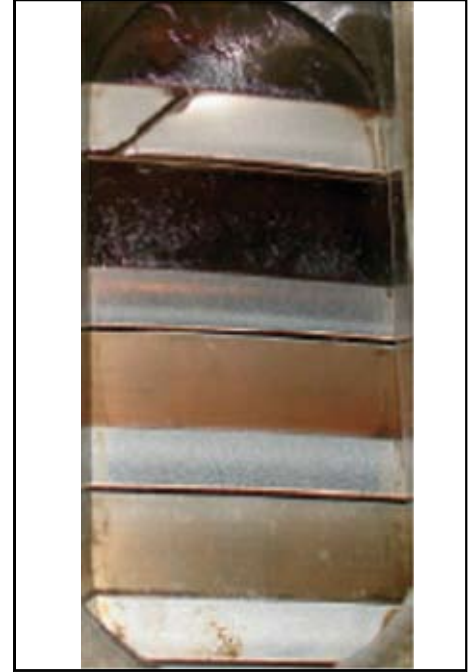
Fig. 8.27: Unit with 23,500 hours without piston overhaul. Note that most of the rounding is still intact, indicating that only 1/4 of the wear potential is used. Further, the measurements above from the same unit show that only 1/2 of the ring groove wear potential is used, and the rate of burnings on the piston top is insignificant. Consequently, overhaul of that unit is not needed at this stage.

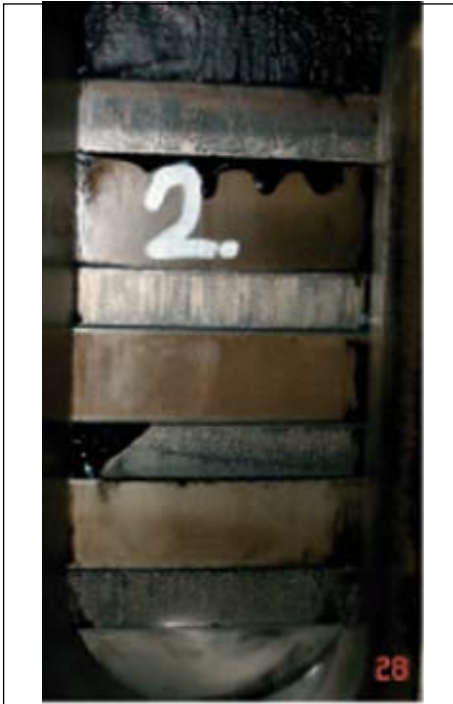
Fig. 8.28: Totally scuffed unit. Lubrication should be increased to maximum until overhaul is convenient with regard to the schedule of the ship. Due to the friction heat developed, the piston rings get hardened and the wear rate of the liner increases significantly. However, the hardening protects the rings, which is why operation may be continued safely until next convenient port stay.

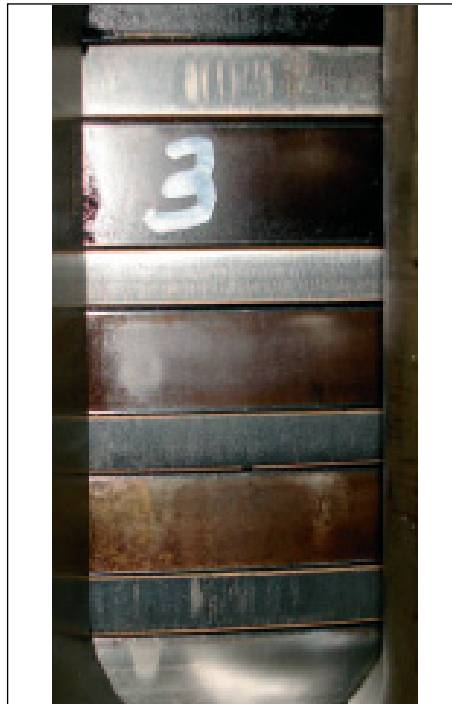
Fig. 8.29: Unit with micro-seizures on the top and bottom rings as a result of metal-to-metal contact. Should be counteracted by temporarily increased lubrication. It is important to lower the lubrication to normal as soon as the active mz-attack is stopped. Note that old, not active, mz-marks remain visible for a long time and do not call for increased lubrication.

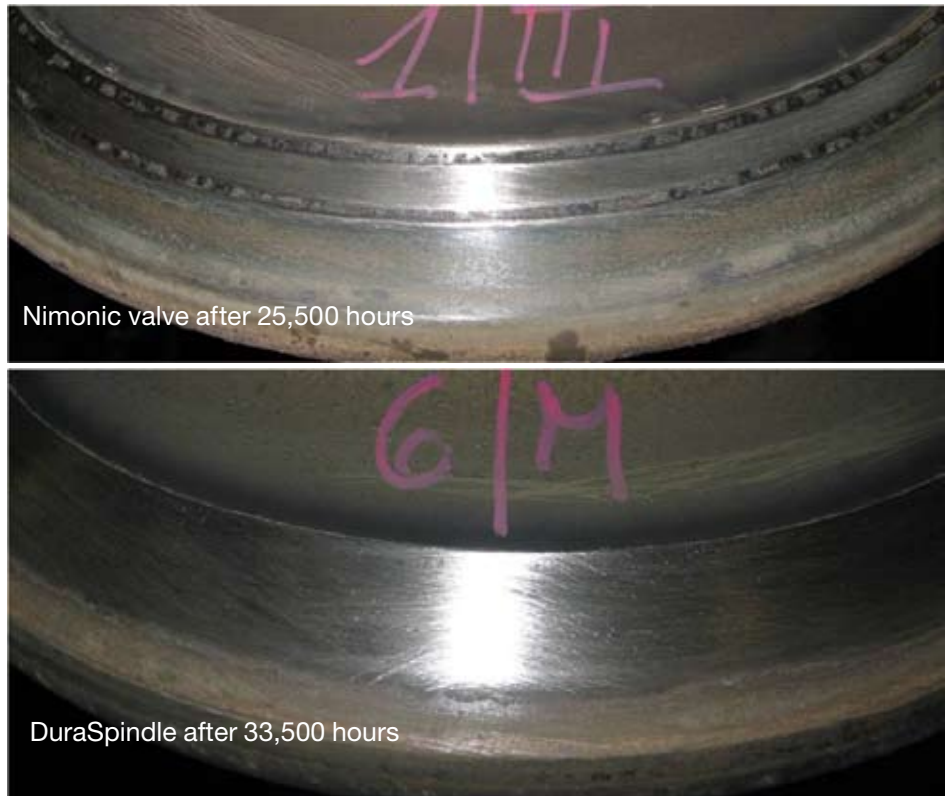
For the exhaust valve, the use of W-seat, Fig. 8.31, and either nimonic valve spindle or DuraSpindle has improved the overhaul intervals to longer than 32,000 hours. Fig. 8.32 shows examples of an excellent condition without overhaul with combinations of a W-seat/nimonic spindle and a W-seat/DuraSpindle achieved on an S60MC engine after 25,500 hours and 33,900 hours, respectively.

Fig. 8.32: W-seat in combination with nimonic spindle and DuraSpindle

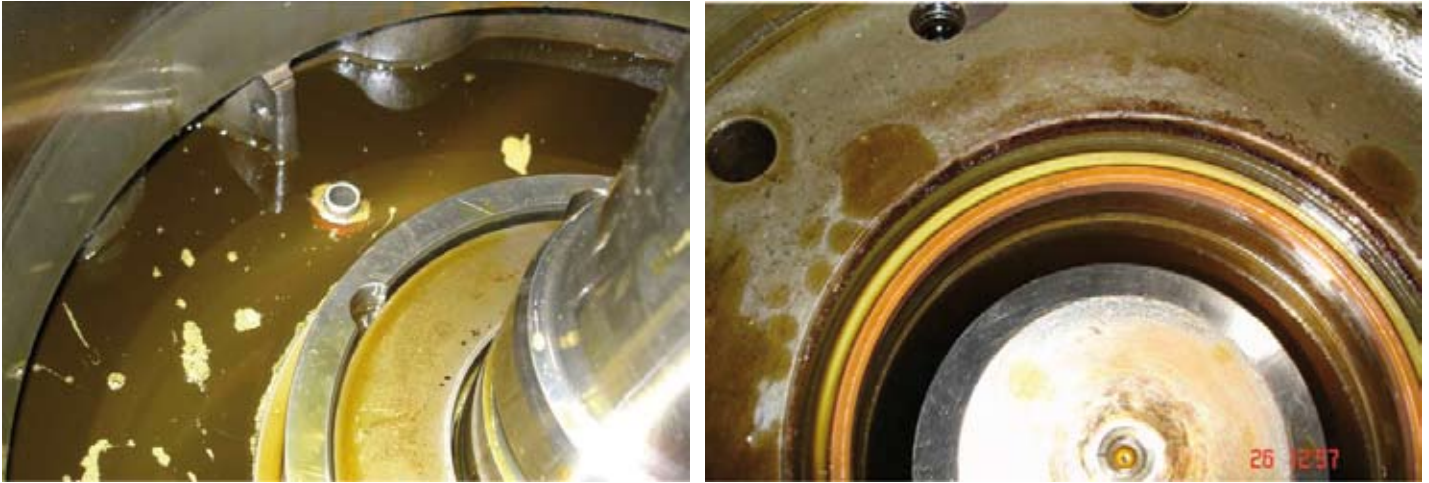
7K98MC: COL test unit, inspection after running hours 20,468 hours

30,000-35,000 hours, based on results from several test units on 98, 90 and 60 bore engines. This illustrated by Fig. 8.34 showing an open-up inspection on a K98.

Clean lubricated spindle guide and a sealing ring with a wear profile which well indicate running up to 30,000-35,000 hours

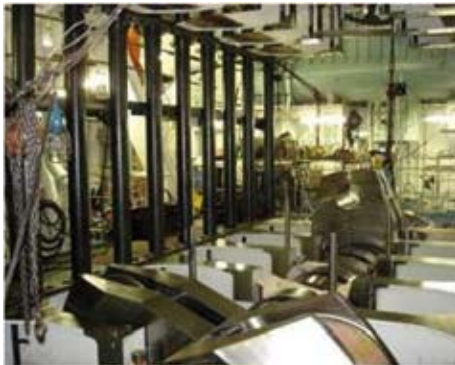
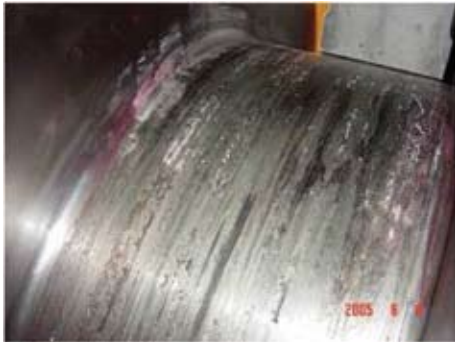
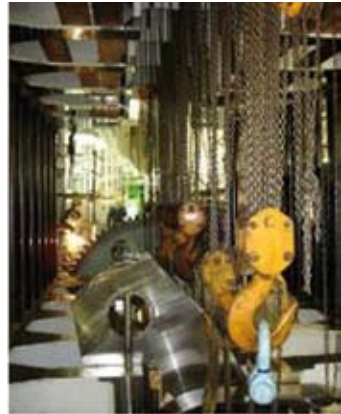
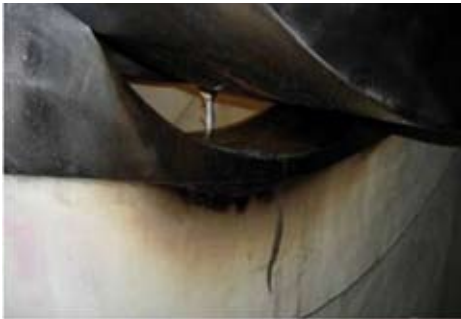
Fig. 8.37: Main bearing damage on 6S70MC-C

However, in a few cases we experienced severe damage causing long-term off-hire periods involving also costly repairs of the bedplate and/or the crankshaft. An example is shown in Fig. 8.37. In this case, the reason for the damage was incorrect assembly after an open-up inspection of a main bearing after sea trial. This sequence of events following open-up inspections of bearings is unfortunately being reported from time to time. We have therefore changed our instruction material, not calling for open-up inspection at regular intervals. In parallel, we have made so-called bearing wear monitoring (BWM) systems a standard on engines ordered in 2008. BWM systems can also be retrofitted on existing engines

- 6S70MC-C on maiden voyage
- Continued running for 1½ hrs after 1st alarm
 - Main bearing incorrectly assembled after inspection
 - 3½ month repair
