# Service Experience

MAN B&W Low Speed Diesel Engines

# Service Experience of MAN B&W Low Speed Diesel Engines

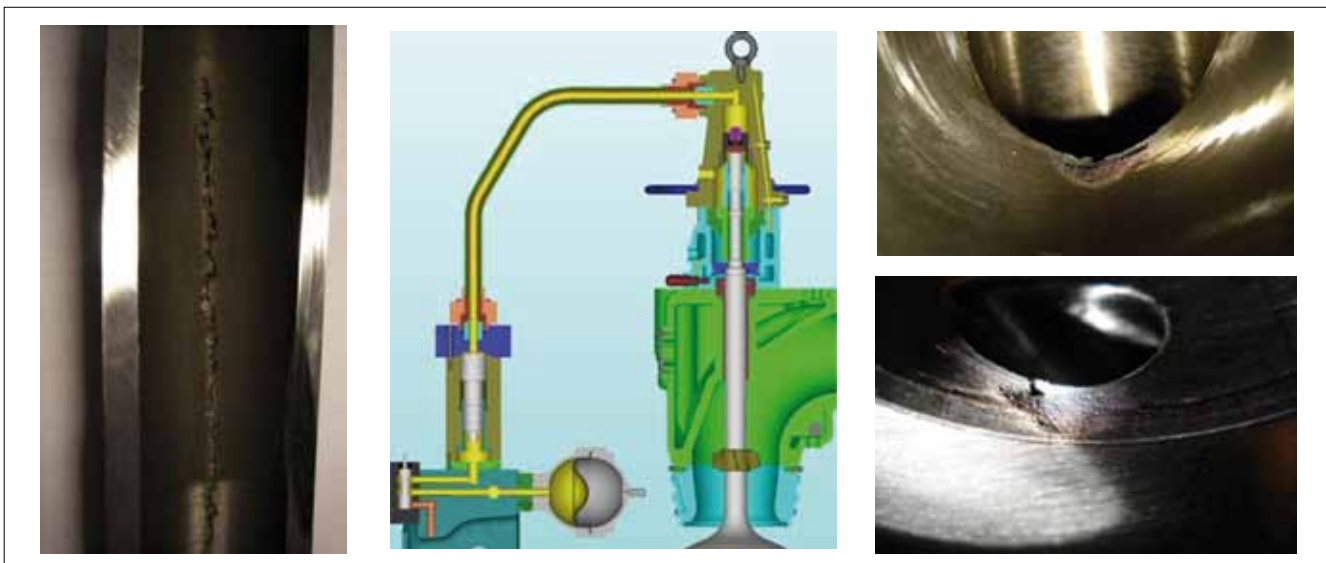
Fig. 1: Cavitation in hydraulic exhaust actuation system

Fig. 1 shows cavitation damage in the high pressure pipe between the exhaust actuator and the exhaust valve. Also cavitation damage in the actuator top cover and in the top of the exhaust valve can be seen. This kind of damage is seen on the large bore versions of the ME engine (80, 90 and 98-cm bore),

however, not to the same extent on all units on the engine. Therefore, damage can be counteracted by relatively small changes.

big changes can be seen. However, the oil pressure fluctuations in the actuator system are modified to some extent, and we expect that this will reduce/eliminate the cavitation damage in the exhaust actuation system.

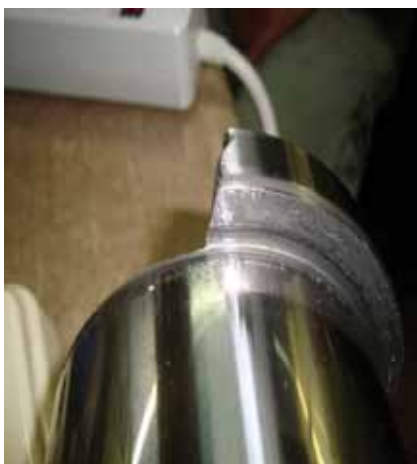
Fig. 4: Piston collar breakage

On a few actuators for the original 200 bar hydraulic system, we have seen breakage of the step 1 piston collar, Fig. 4. We are convinced that this problem relates to delayed “take-off” of the step 1 piston from the bottom position, Fig. 3 (A). This is caused by a “glue” effect, which exists from time to time. When the step 1 piston is delayed it will create very high pressures in the “damper” chamber and hereby increased load on the piston collar is generated. Various means to avoid the “glue” effect can be introduced by generating a force by the oil pressure under the step 1 piston. An example of retrofit is illustrated in Fig. 5. Such design modifications will eliminate the trouble with step 1 piston breakage.

Problem	Countermeasure
“Glue” effect between piston step No. 1 and distributor block, causing a launch delay for piston No. 1.	Grinding grooves in piston No. 1 for easy relief. Grooves: 8 x R 0.5 mm w. depth of approx. 0.3 mm.

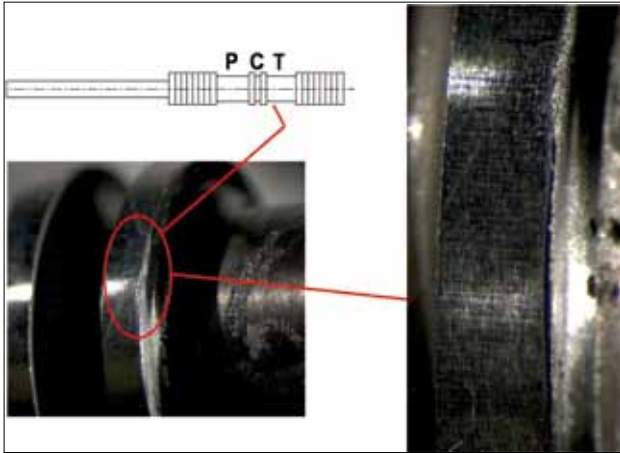
Fig. 6: Curtis Wright FIVA: cavitation on pilot spool

We have seen cavitation attacks on the pilot spools of both the Curtis Wright

FIVA valve, see Fig. 6, and the Parker valve on the MAN B&W FIVA valve, see Fig. 7. Presently, this limits the overhaul intervals of the FIVA valves to some 8,000-10,000 hours. Our goal for overhaul intervals on FIVA valves is 32,000 hours.

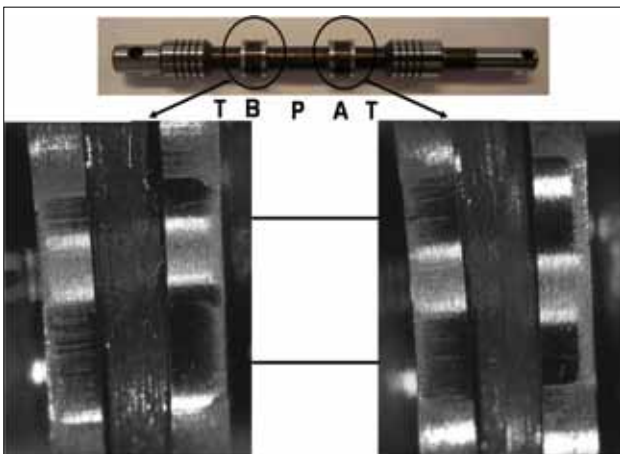
Fig. 7: MAN B&W FIVA: cavitation on Parker valve pilot spool

The cavitation damage on the Parker spools is mainly related to the tank ports for the pilot step. We have therefore designed two (2) service tests, which are currently accumulating hours on two (2) 12K98ME plants. Fig. 8 shows the test

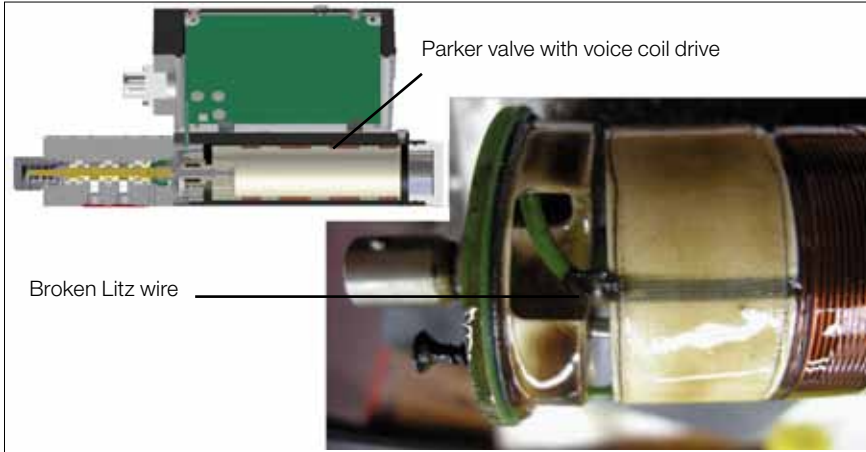
Fig. 10: Parker pilot valve

For the MAN B&W FIVA valve, we have experienced an untimed injection in one single case on one cylinder unit on a 6S60ME-C engine in August 2009. The over-pressure in the cylinder resulting from the untimed injection did not cause any damage to the mechanical parts because of the built-in safety margin in the various components, such

as the piston rod, connecting rod and crankshaft. The failing FIVA valve was returned, and investigations showed that the problem was related to the pilot step, the Parker valve. Close investigations together with the sub-supplier revealed that a broken wire, a so-called Litz wire, had caused the malfunction of the Parker valve, see Fig. 10.

Tests also revealed that the broken Litz wire resulted in an overshoot and that explained the untimed fuel injection experienced in the vessel with the 6S60ME-C engine.

Production of the Parker valves was changed based on this experience, and zener diodes were included in the electronic control design of the Parker valve. These diodes eliminate overshoot in case of a broken Litz wire.

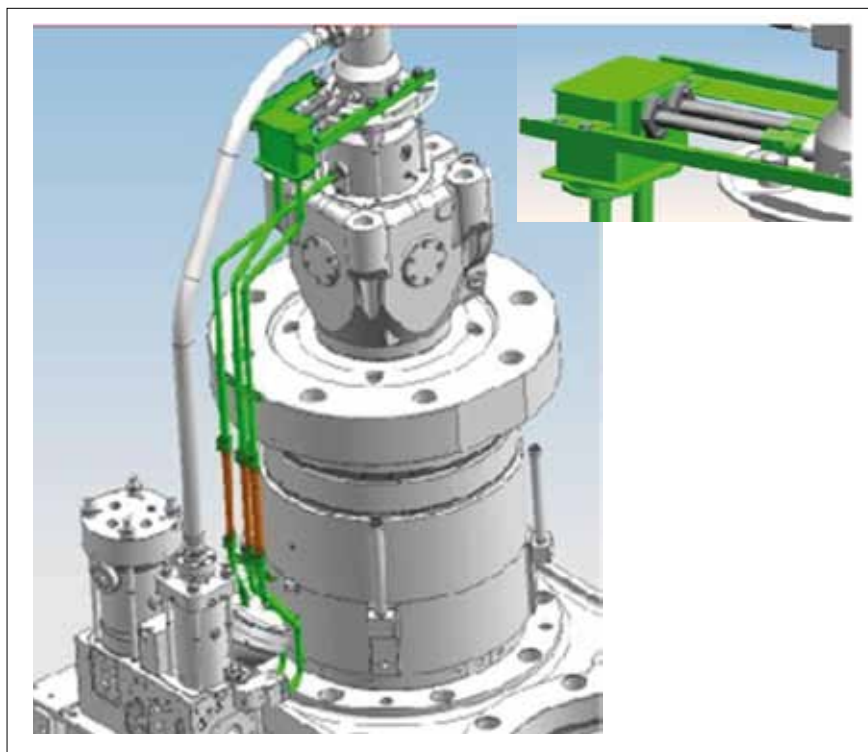
Fig. 14: Exhaust valve drain line with drain box

On 80-cm and 98-cm bore engines, we have seen breakage of the drain lines from the exhaust valve. A design with a so-called drain box, see Fig. 14, has been tested successfully. This design will counteract the trouble with drain line breakage.

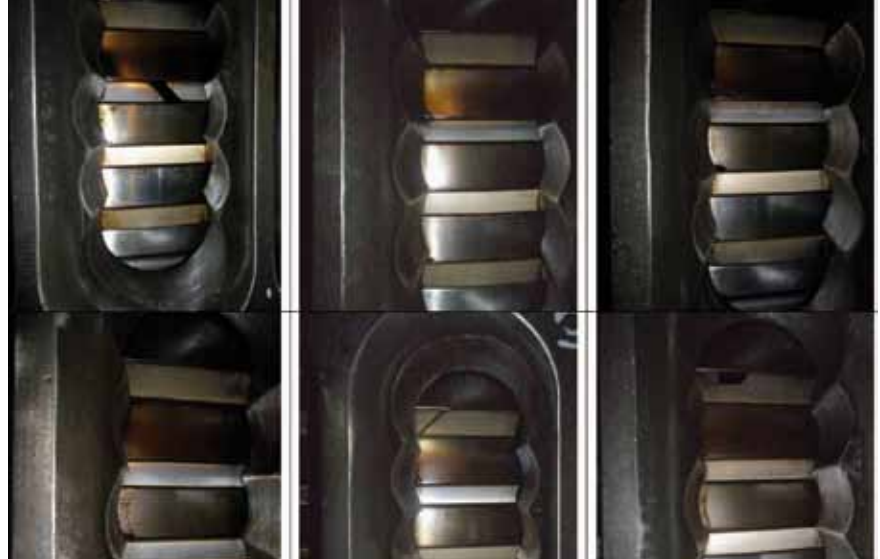
Fig. 15: Piston ring condition

Scavenge port inspection has been carried out after 1,842 running hours. The results can be seen in Figs. 15 and 16 for piston ring and piston skirt condition, respectively. Fig. 17 shows the pitch-honed liner from the scavenge ports. All inspection areas indicate that

very successful running-in has taken place and that the cylinder condition for all units is excellent.

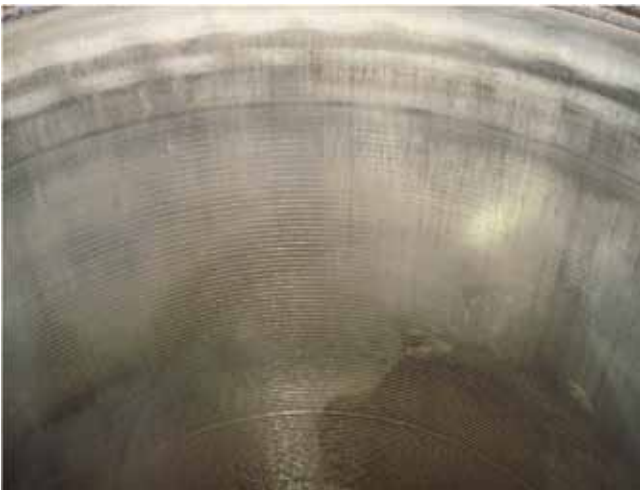
Fig. 18: Top of liner after 3,800 hrs.

A further inspection was carried out after 3,800 running hours. One cylinder unit was opened up for inspection and liner calibration. Fig. 18 shows the top of the liner. The max. wear rate is 0.037 mm/1000 hrs. at the top dead centre of piston ring No. 2. This wear rate includes initial running-in wear and is very satisfactory.

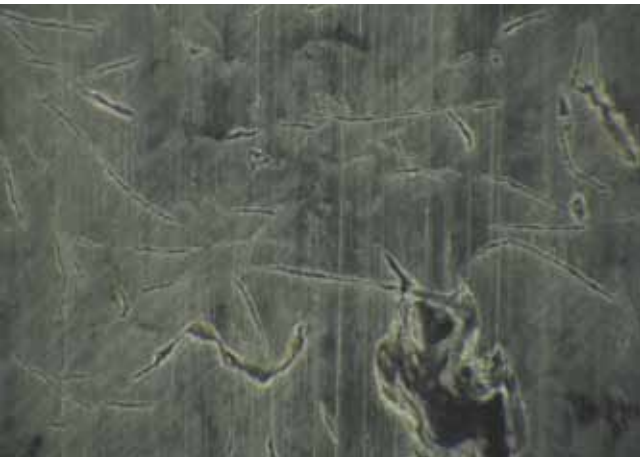
Fig. 19: Close-up of cylinder liner: open graphite structure visible

Fig. 19 shows a close-up of the cylinder liner surface. The open graphite structure is clearly seen. This surface structure indicates a successful temperature control on the liner surface and, hereby, a controlled acid corrosion level.

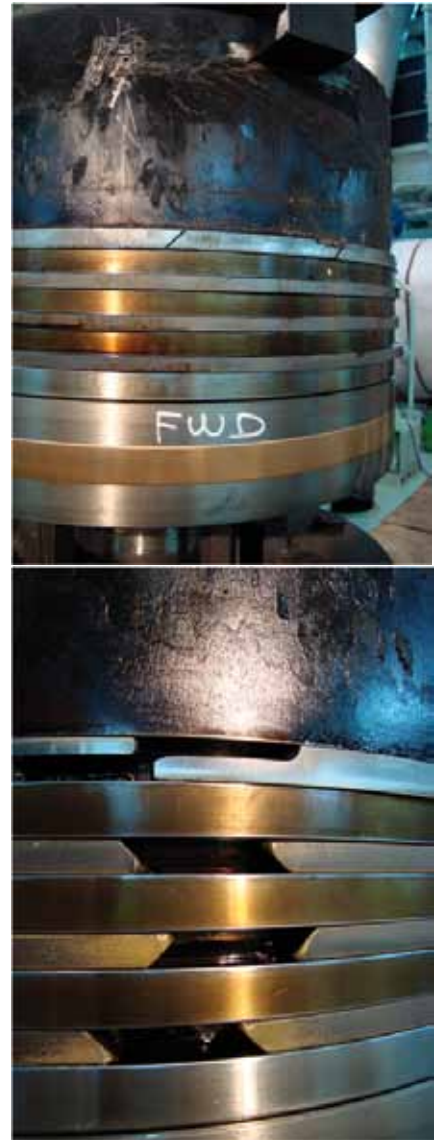
Fig. 26: ME-B9 piston after 4,000 hrs

A piston overhaul was carried out after 4,000 running hours to inspect the condition of the new piston design, see Fig. 25, applied on the S40ME-B9 engines. Fig. 26 indicates a very good condition of the piston topland (light deposits), piston rings (surface without any signs of seizures) and piston skirt (perfect condition of the bronze band).

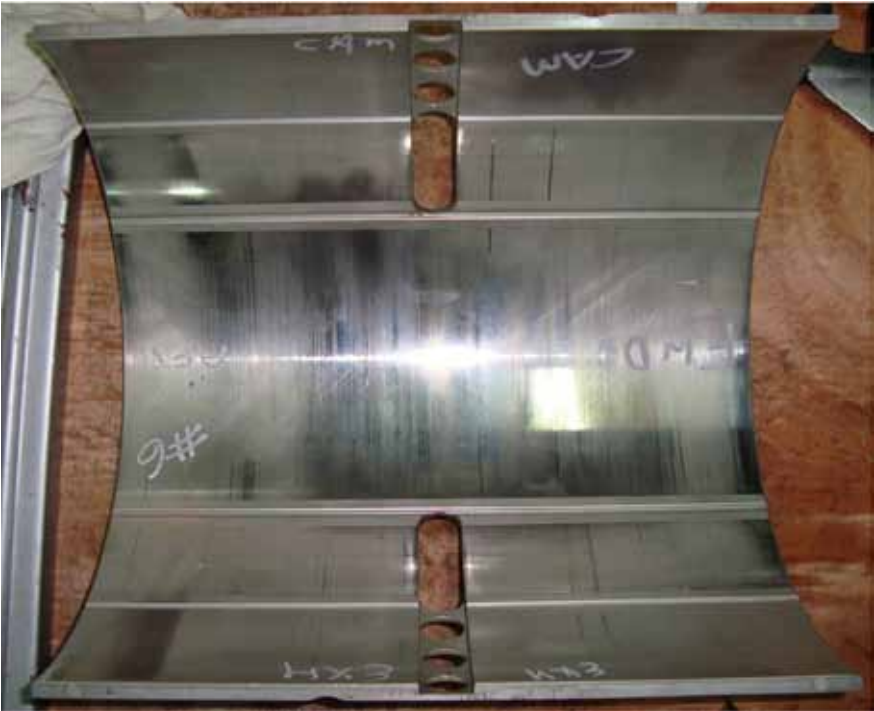
Fig. 28: ME-B9 crosshead bearing after 4,000 hrs.

A new design of the slim type connecting rod and the wide-pad crosshead lower bearing shell, see Fig. 27, has been introduced on the ME-B9 engines. Fig. 28 shows the lower crosshead bearing shell of unit No. 6 at an inspection after 4,000 running hours. The bearing imprint is, as expected, in good condition.

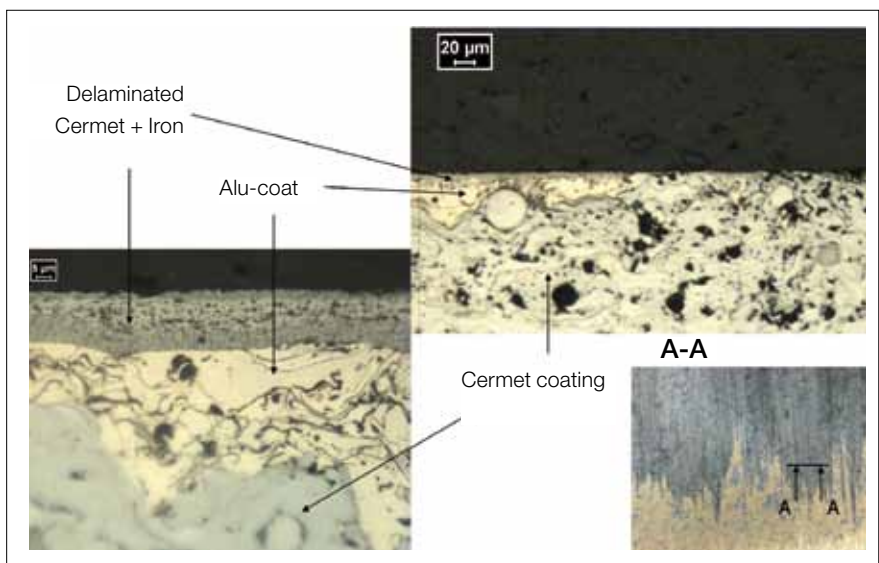
Fig. 30: Piston ring quality

Fig. 30 shows cross sections of piston rings with iron and cermet (delaminated) layers positioned on top of the alu-coat

layer during running-in, leading to unstable cylinder condition caused by the quality of the cermet coating.

During the last part of 2009 and the first part of 2010, we carried out a piston ring exchange programme where around 1,000 cylinder units of K98 and K90 engines were exchanged before ship delivery in order to gain control in relation to piston ring quality. The cermet coating specification and the quality of the cermet coating were reformulated. During this process also cylinder

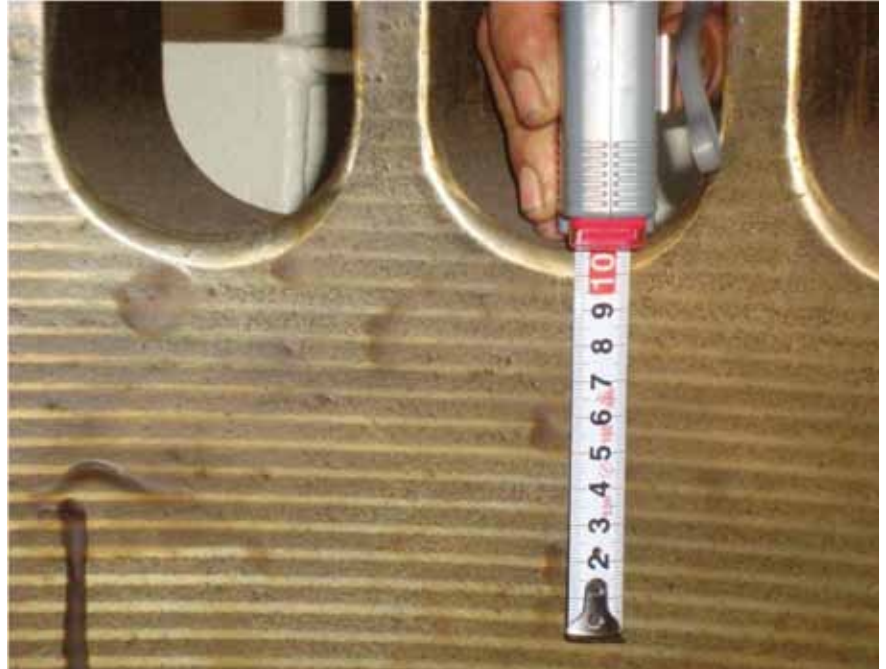
Fig. 31: Cylinder liner quality: insufficient plateau honing

Fig. 31 shows an example of off-spec. honing of the cylinder liner surface. The honed area must nominally be 50% of the liner surface. As can be seen on the photo, the honed area is much smaller resulting in much tougher running-in and an increased production of 'liner-iron'. The photo shows an unused spare cylinder liner on a vessel where cylinder liner scuffing has occurred.

liner machining was checked and re-honing was carried out in case of off-spec. condition.

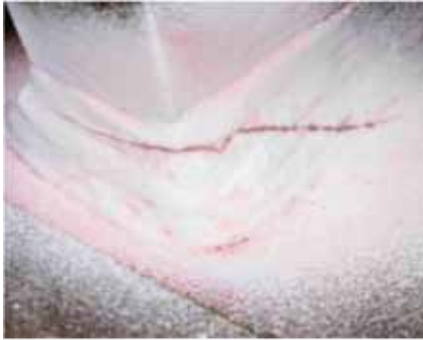
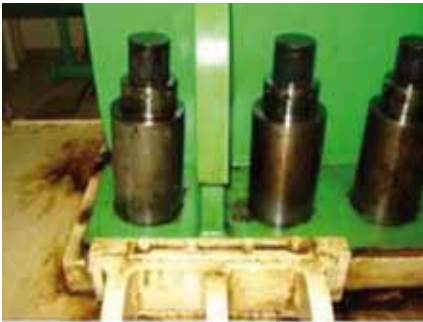
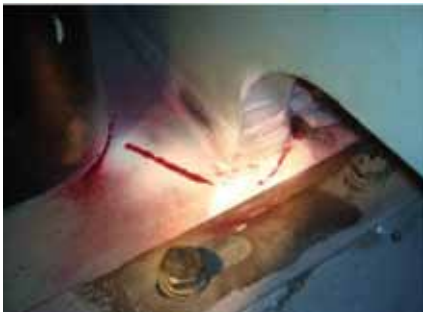
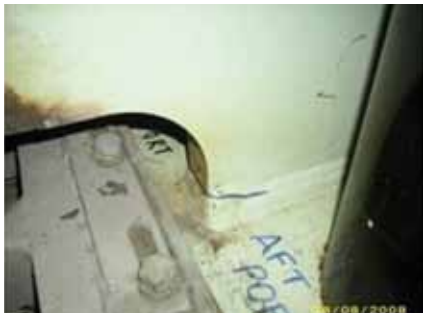
Fig. 35: Lifting bracket cracks

In 2008, cracks in the lifting bracket on K98 bedplates were discovered on engines produced 5-7 years earlier, see Fig. 35. Soon after the first cracks were discovered, a so-called 'Circular Letter' was issued to all owners/operators of K98 engines, see Fig. 36. In this letter we asked for help to inspect for lifting bracket cracks. Furthermore, we informed about preventive countermeasures, which were burr grinding of the weld seams on the aftmost and foremost brackets. Also, a repair procedure was developed when the cracks first occurred. A modified bracket profile has been designed for new engines, see Fig. 37.

Due to the high number of K98 engines in service, these rectifications are still ongoing and, fortunately, we are able to perform this work without disturbing the operation of the vessels involved.

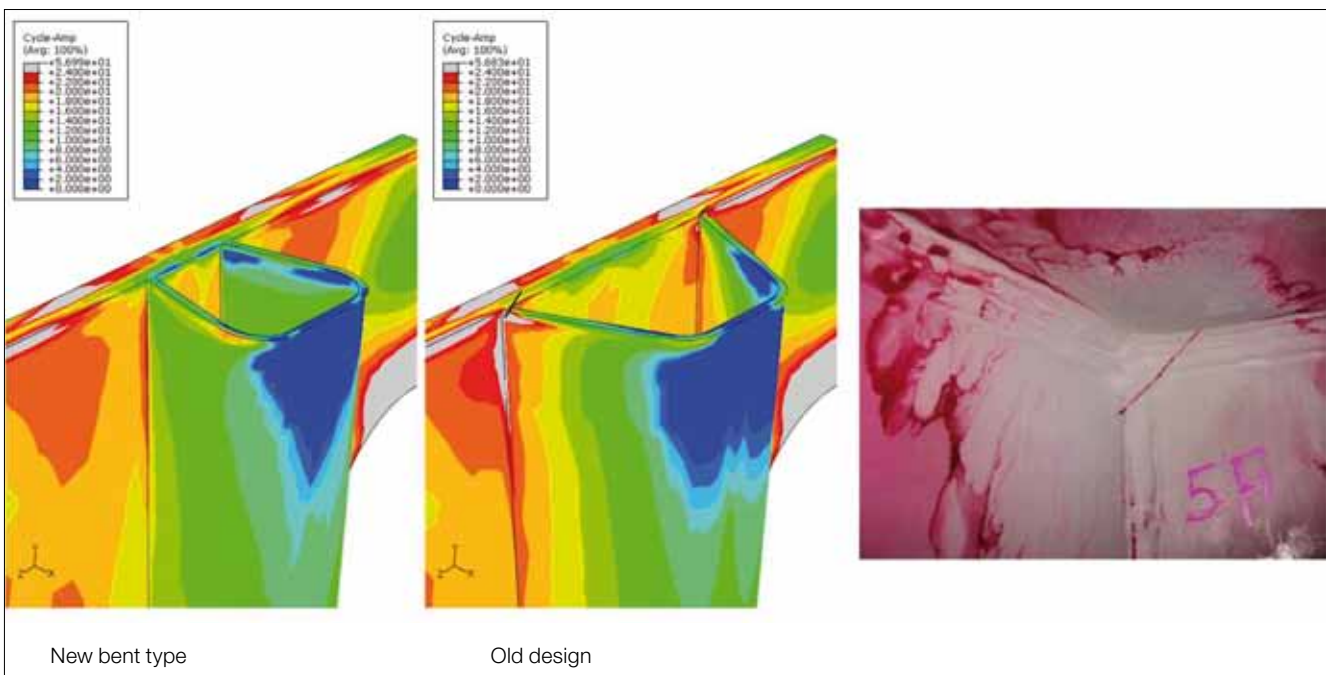
As an alternative to cast iron cylinder frames, a welded version of the cylinder frame has been introduced. Fig. 38 shows a 7-cylinder welded cylinder frame with an integrated scavenge air receiver. The first generation of the welded cylinder frame showed, in some cases, cracks originating from the stay bolt covers, see Fig. 39. A new bent type stay bolt cover has been designed, and attachment to the main cylinder frame structure at a position with a lower stress level has been realised.

Fig. 39: Welded cylinder frame: fatigue crack originating from stay bolt covers

We are confident that the crack problems related to the stay bolt cover plates have now been eliminated. For engines in service with first generation welded cylinder frames, repair work is in progress.

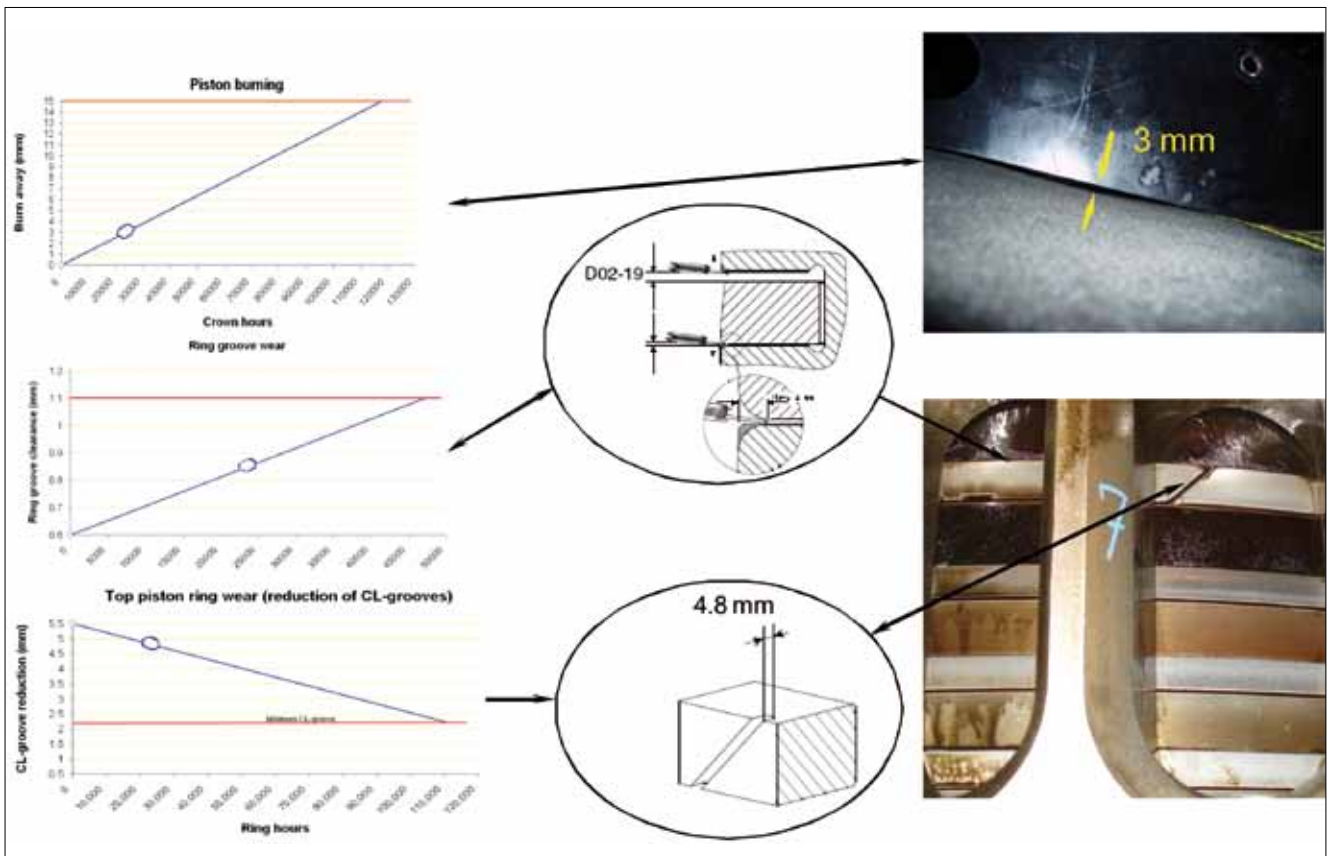
Fig. 42: 10K98MC-C, unit no. 7, at 23,500 hours without overhaul. The condition does not call for piston overhaul

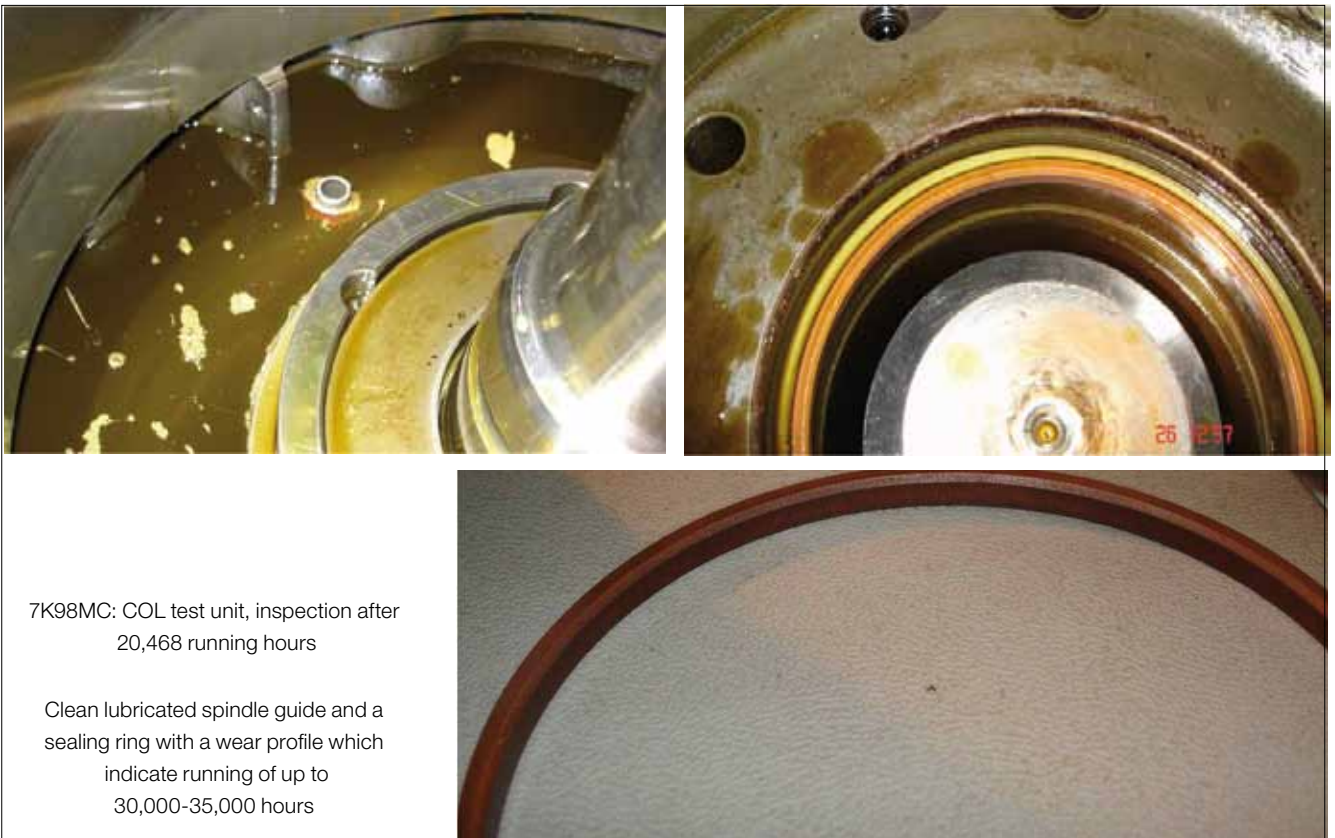
Fig. 46: Inspection of COL design on a K98MC

7K98MC: COL test unit, inspection after 20,468 running hours

Clean lubricated spindle guide and a sealing ring with a wear profile which indicate running of up to 30,000-35,000 hours

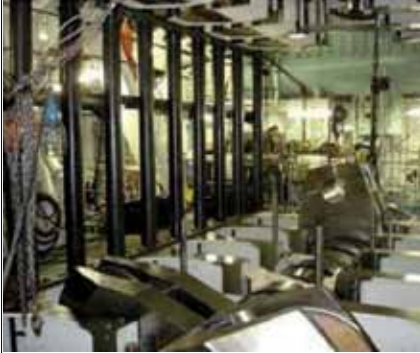
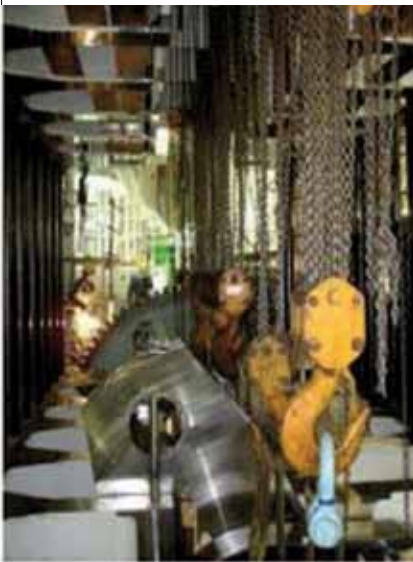
Fig. 49: Main bearing damage on a 6S70MC-C

crankshaft. An example is shown in Fig. 49. In this case, the reason for the damage was incorrect assembly after an open-up inspection of a main bearing after sea trial.

**6S70MC-C on maiden voyage**

- Continued running for 1½ hrs after 1st alarm
- Main bearing incorrectly assembled after inspection
- 3½ month repair
