Service experience

MAN Energy Solutions

Two-stroke technologies

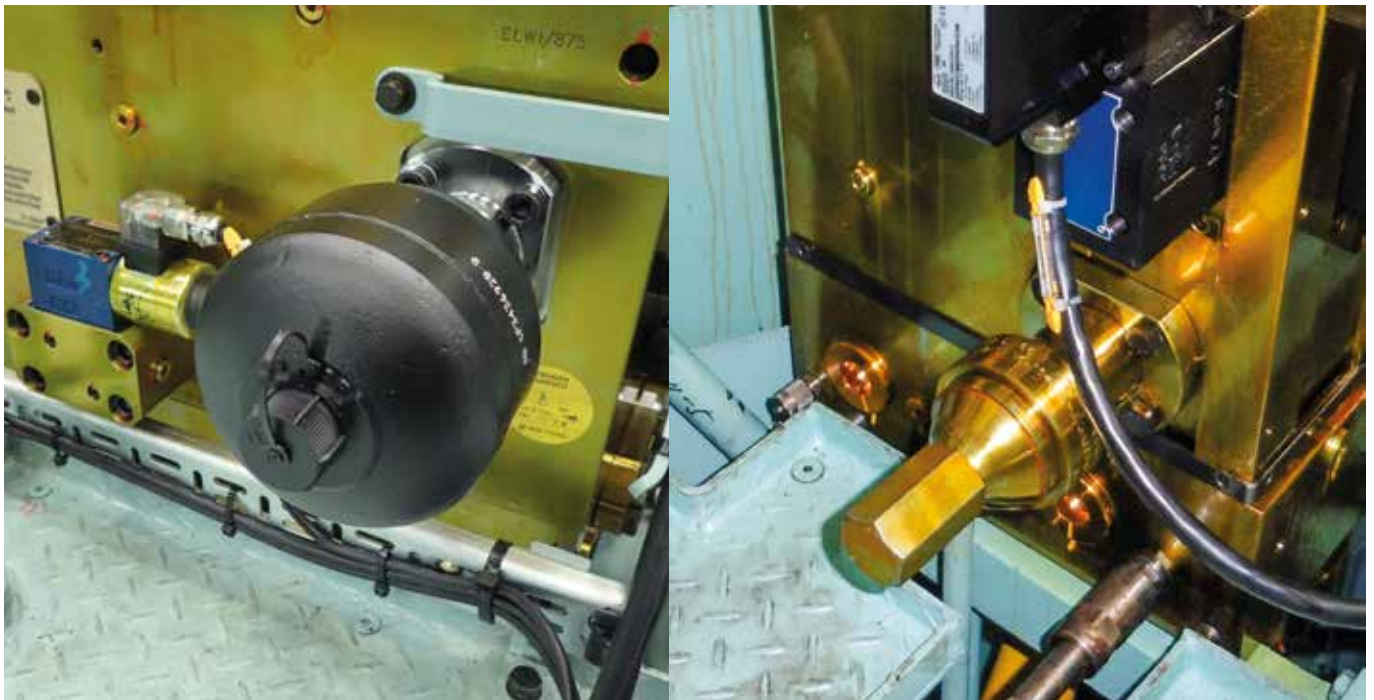
Fig. 3: Left: New 0.7 L accumulator, right: Old 0.2 L accumulator

has solved issues with damage to the accumulator diaphragms. Furthermore, the time between nitrogen re-charges has been increased to an acceptable level.

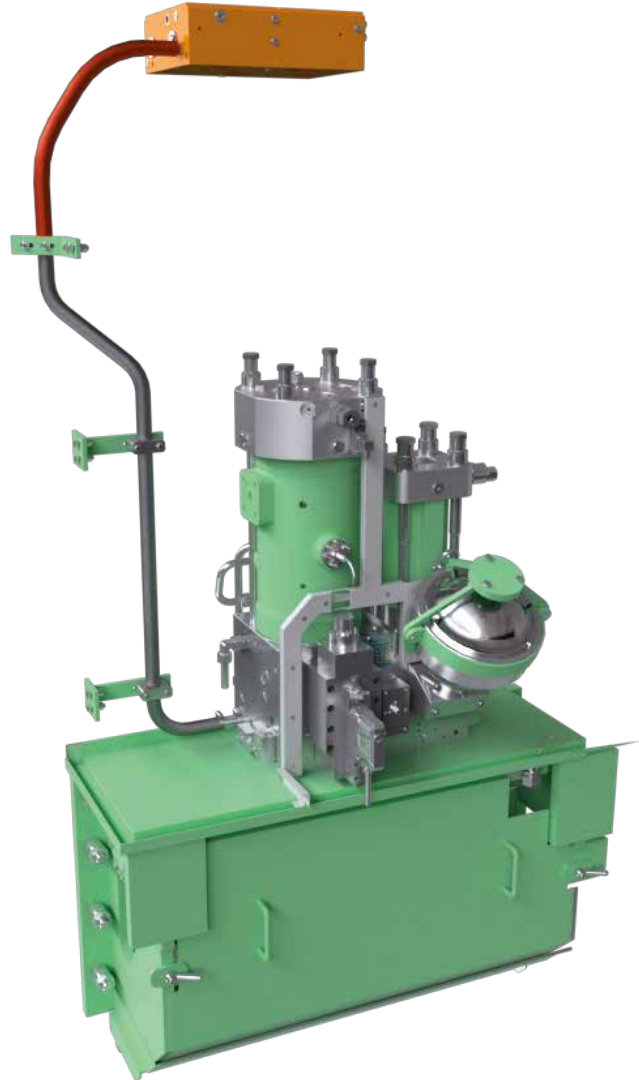
Fig. 4: Control oil pipe design with a combination of hose and pipe

A redesign of the control oil pipe from the HCU to the gas-block, by using a combination of hydraulic hose and pipe, has solved issues with broken control oil pipes, see Fig. 4.

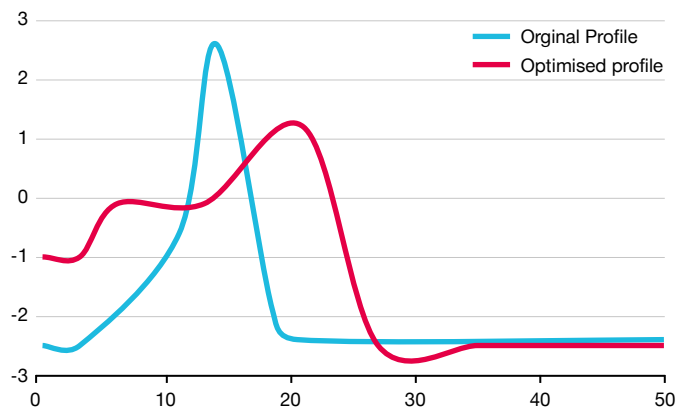
Fig. 5: Modification of the pilot oil profile

The new pilot oil profile shown in Fig. 5 has lowered the hydraulic peaks in the HCU block. After this change the solenoid valves for the cylinder oil lubricators stopped failing. Furthermore, the new profiles have improved air venting of the cylinder prior to injection. It is also possible to lower the SPOC further with the new profiles. Initial results show an improved condition of the fuel injection valves (FIVs), however, more operating hours are needed to confirm this.

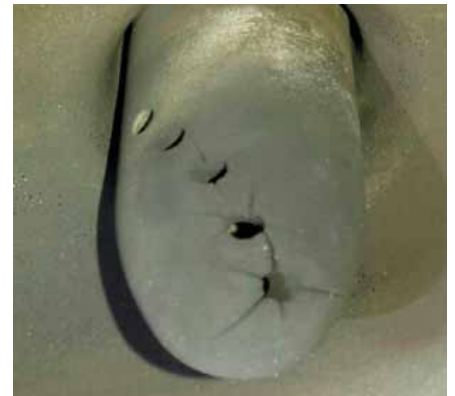
The GIV nozzles have been in focus since a few hundred hours of operation were obtained on the first ME-GI engines in service. Cracks were observed in the nozzles within a short period of operation, see Fig. 7.

Fig. 7: Cracks in the GIV nozzle

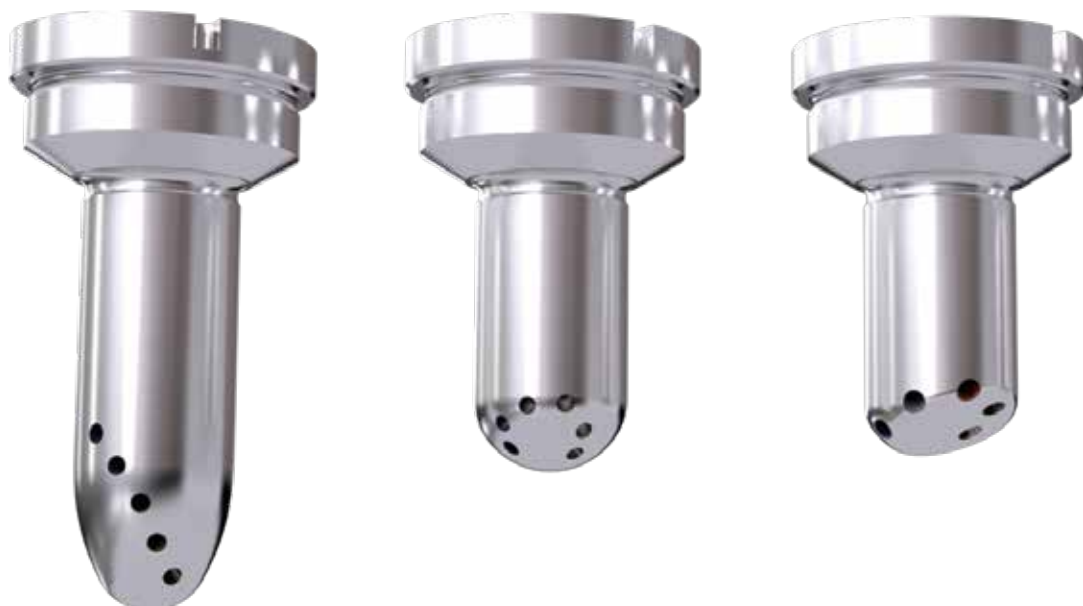
Fig. 8: Gas nozzle design development – latest design to the right

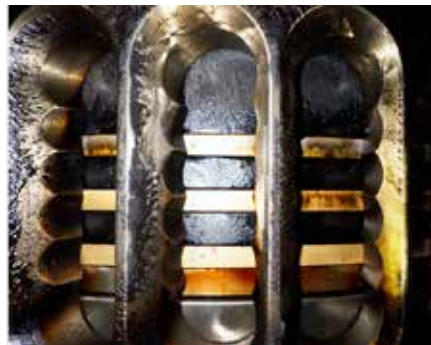
We have gained experience with the cylinder condition when the engine operates continuously on gas. The continuous operation on low-sulphur fuel has given us some ideas about the challenges we will encounter after 2020, when the global sulphur cap comes into force. We have experienced that low base number (low BN) cylinder oils, which should be optimal for continuous low-sulphur fuel operation, did not have sufficient detergency for such operation. A build-up of deposits was seen on ring lands and ring grooves as shown in Fig. 10.

Fig. 10: The continuous operation on low-sulphur fuel and the use of low-BN cylinder oils give insufficient detergency

To address this we issued a circular letter instructing operators of ME-GI engines to alternate between high-BN (100) cylinder oil for cleaning and low-BN (25-40) for counteracting the

too-high addition of calcium. We gave the instructions to operate about 24 hours on high-BN oil and 48 hours on low-BN oil. The intervals can be altered (extended) based on inspections. Clean ring lands and ring grooves can be maintained in this way, see Fig. 11, and a good cylinder condition is generally experienced on the ME-GI engines.

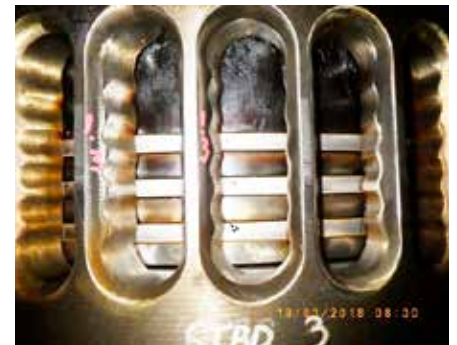
Fig. 11: The continuous operation on low-sulphur fuel and the alternating use of high- and low-BN cylinder oil give sufficient detergency

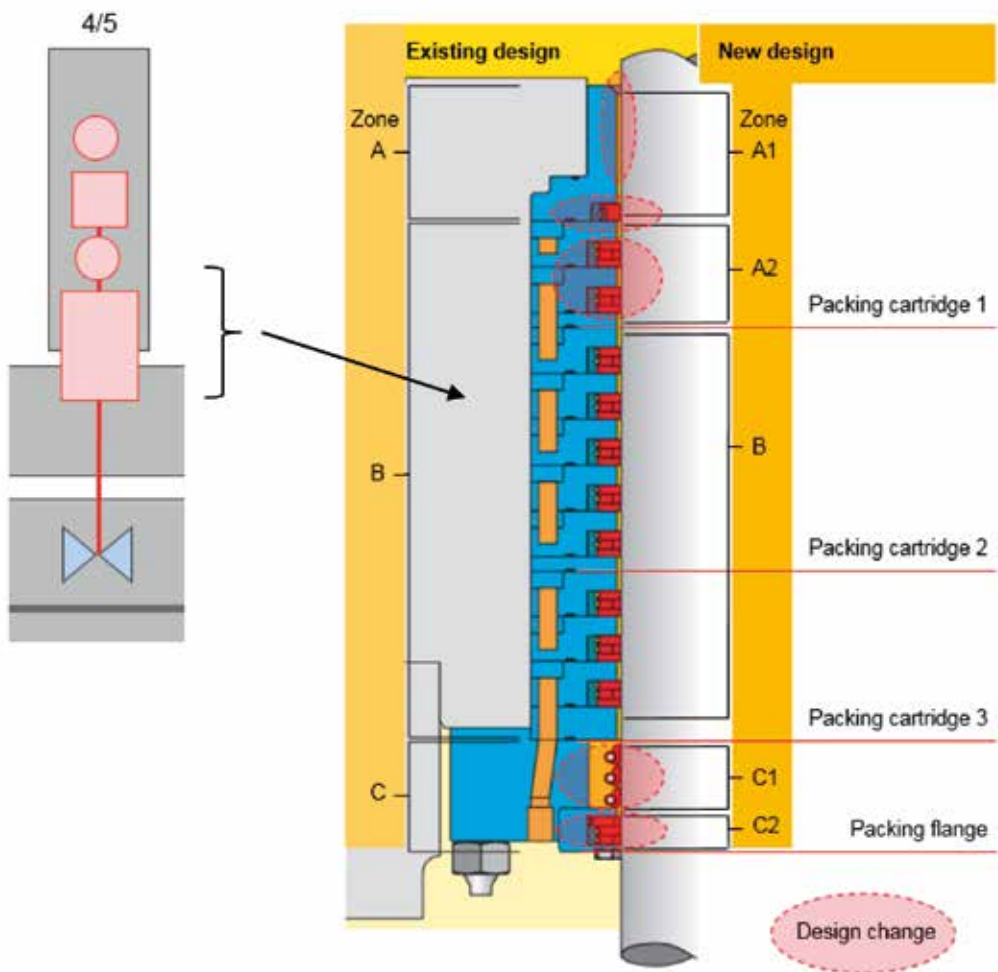
Fig. 15: Modified high-pressure packing

We have experienced a number of issues with these compressors that have been rectified. Wear of the high-pressure piston rod packing in stage 4/5 has been observed and the solution is replacement of the high-pressure packing, see Fig. 15 and the labyrinth piston rod glands.

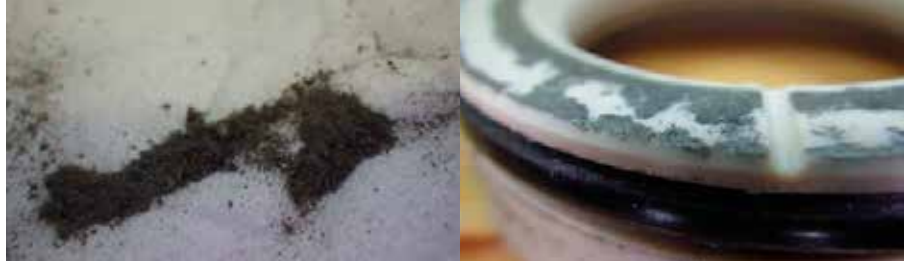
Increased wear occurred on the gas valve seats due to an excessive amount of particles in the gas piping after installation (Fig. 19), caused by the fact that gas supplied from bunker barges and trucks is not as clean as expected and that the valves in the GVT are sensitive to dirt. Because of this, larger 10 micron fine filters were introduced on the gas side before the GVT, see Fig. 20.

Fig. 19: Dirt particles in LNG

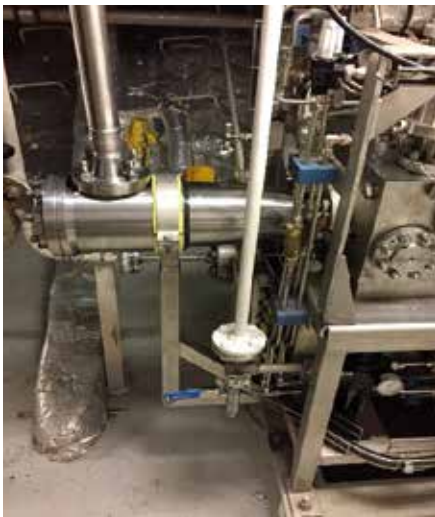
Fig. 20: 10 micron fine filter before the GVT

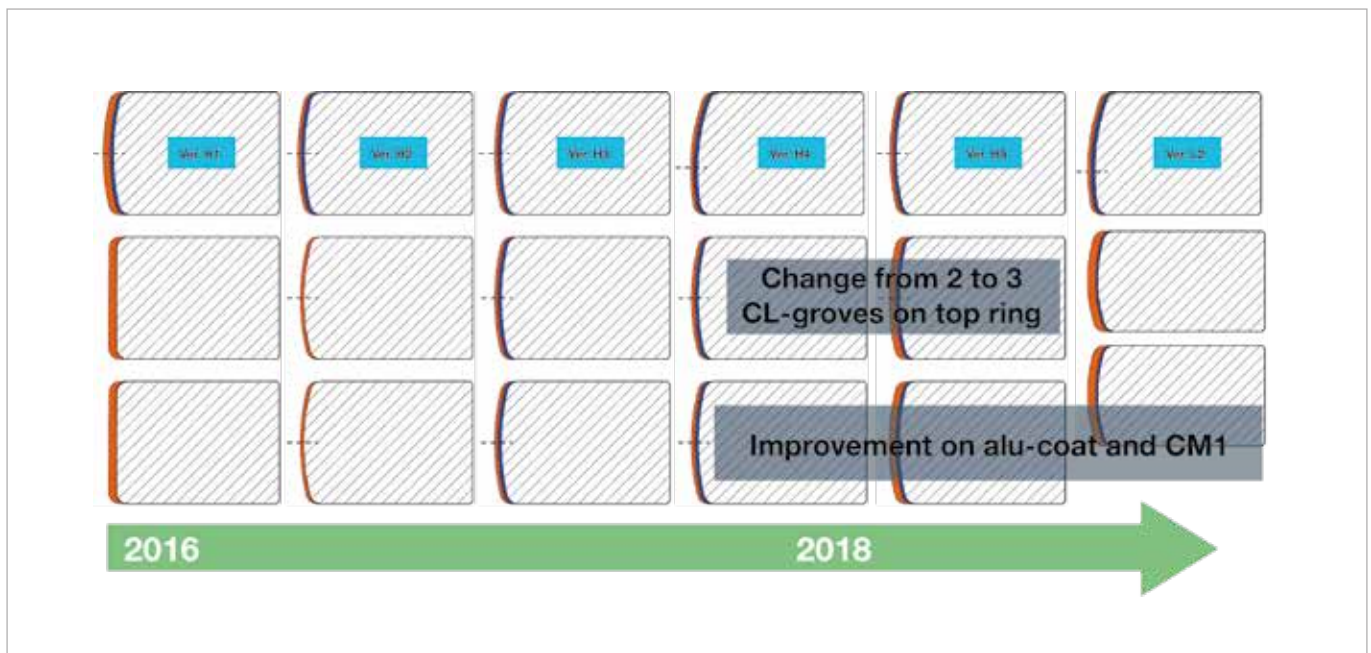
Fig. 24: Piston ring evolution

The first focus was the piston ring design, and this led to a number of changes, see Fig. 24.

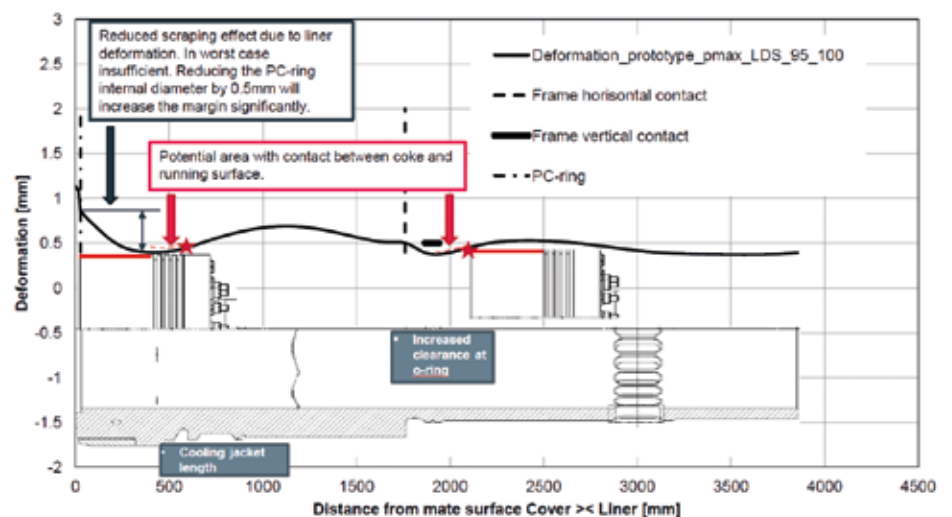
Four main design changes were introduced on the cylinder liners for the G95 engines. In the first inspections of the cylinder liner surface hard contact marks were found as indicated in Fig. 29.

Fig. 29: Cylinder liner deformation and potential contact positions

Firstly, reducing the inner diameter of the PC-ring solved the upper contact problem and increased the clearance between the O-ring and the cylinder frame at the lower contact point, which resulted in an increased PC-ring efficiency. Secondly, a longer liner cooling jacket was introduced to improve both the liner deformation and the cooling of the piston rings, see Fig. 30 (left side). As a third countermeasure the airflow path below the liner was

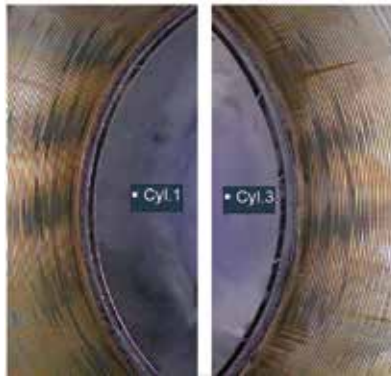
Fig. 31: Cylinder liner contact marks caused by bore distortion

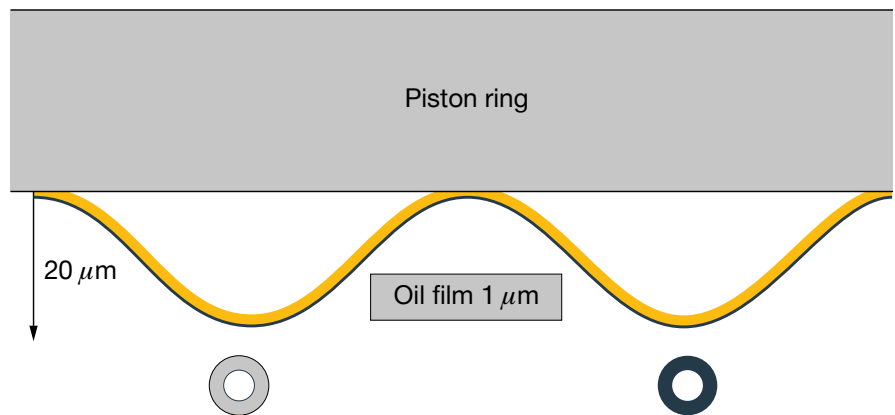
The scuffing observed on the test bed during the shop test is considered closely related to the low-rated RDL liners. The bore distortion of these liners is significantly larger than the oil film thickness, as depicted in Fig. 32. If it gets too large, the piston rings cannot properly adapt to the liner anymore, causing a gas leakage past the rings' running surface.

Fig. 32: Illustration of exaggerated bore distortion and piston ring interaction

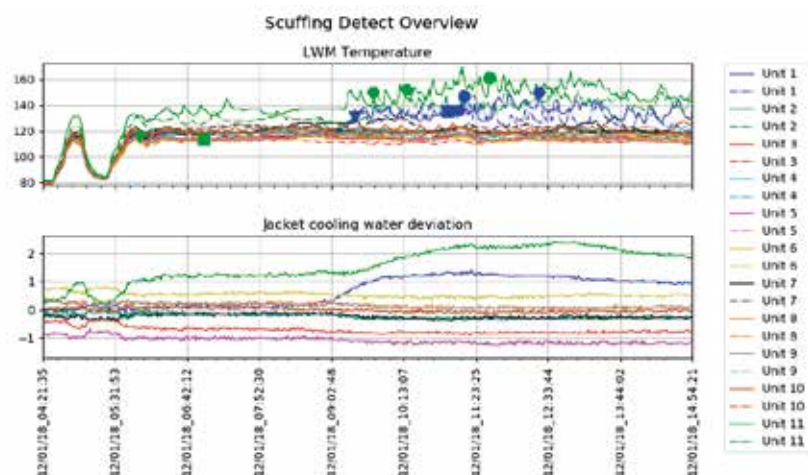
Fig. 33: Liner wall temperature during scuffing

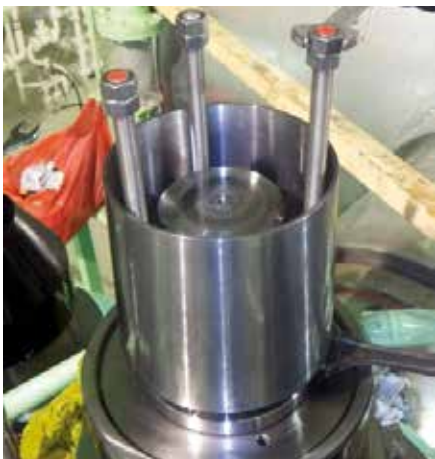
Fig. 54: Stuck measuring cone

The mentioned components have been improved on the Mk. 2 design where the flow area of the tank bores from injection and valve actuation have been increased. Additionally, the newest commercialised version of the TCEV has been improved by separating the injection and exhaust valve tank bores.

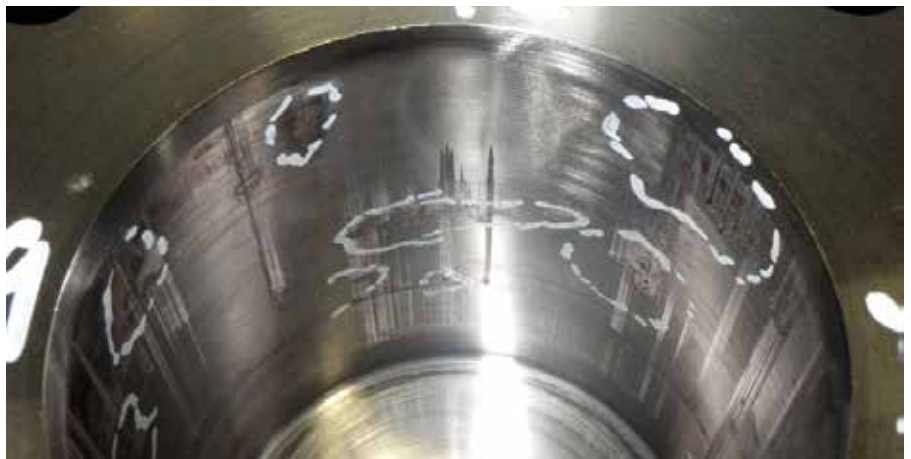
Fig. 55: Fretting inside the measuring cone

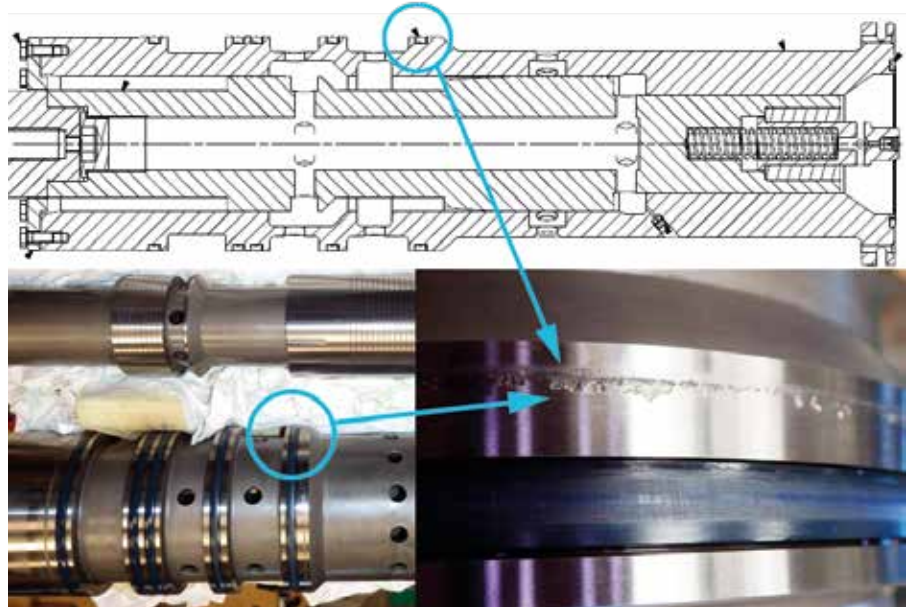
Fig. 56: Cavitation on the outside of the tank control bushing

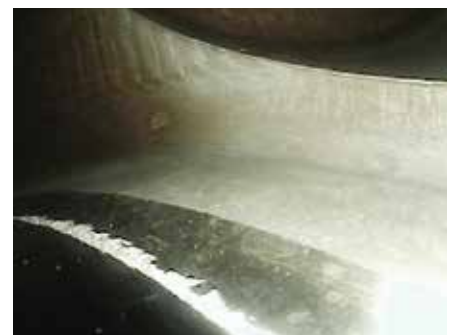
One of the more long-lasting and repetitive issues is PEVA feedback failure alarms, also referred to in Table 2, third inspection. This issue only pertained during ME manoeuvring, and it was concluded that cavitation and sticking of the PEVA main slide was the cause.

Fig. 59: Cavitation on the PEVA housing

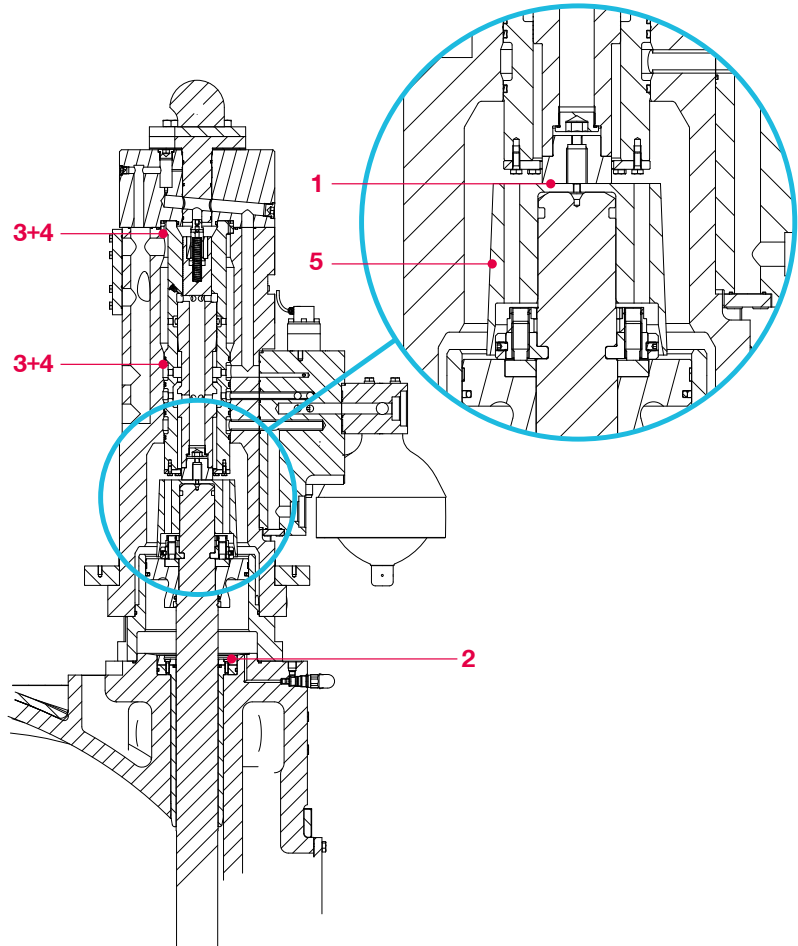
The stem seal was worn down by 23% during the clocked running hours. As a result, the amount of coke deposits inside the spindle guide and air spring chamber were higher than normal. A cause of ring wear can be a too small amount of oil in the controlled oil level (COL) and therefore a lack of preservation of the ring during operation. This may be solved by tuning the safety valve which controls the air

Fig. 60: Minor issues with TCEV Mk. 2

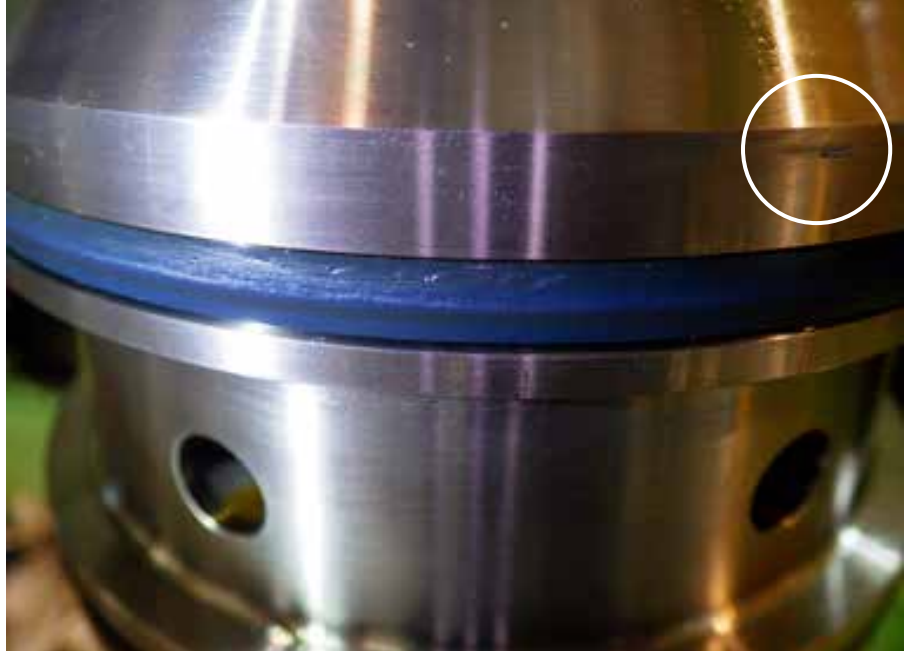
Fig. 64: Imprint from actuator slide pressure piece

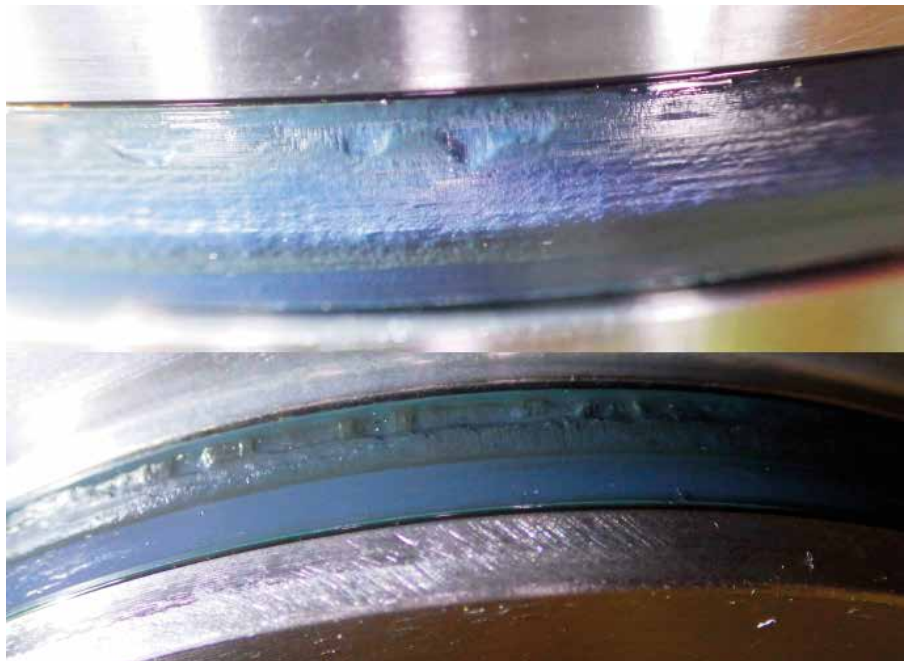
The radial sealing rings on the control bushing were found with some degree of wear, most likely due to the relative motion of the bushing. This is solved in the next iteration by fixating the bushing from the top of the TCEV oil cylinder. In the Mk. 2 version it is kept in place by the TCEV top cover allowing a few tenths of millimetres vertical motion. Fig. 65 displays the wear of the sealing rings.

Fig. 65: Sealing ring wear

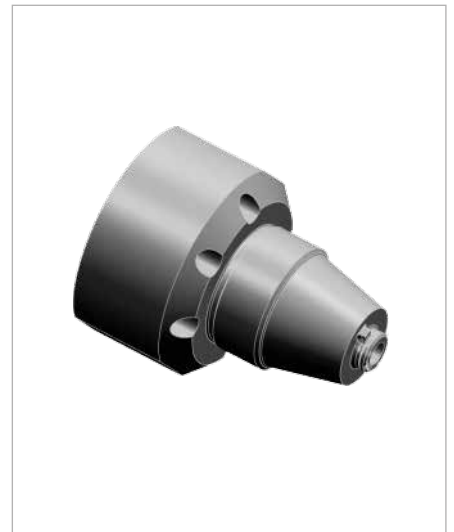
Fig. 73: Updated spindle guide knot design

The spindle guide is fabricated with a knot, see Fig. 73. The knot replaces the guide pin, which is prone to breakage. The new knot design has chamfered round edges, which creates a stronger and more resilient design. All of these changes will be implemented in the coming design.

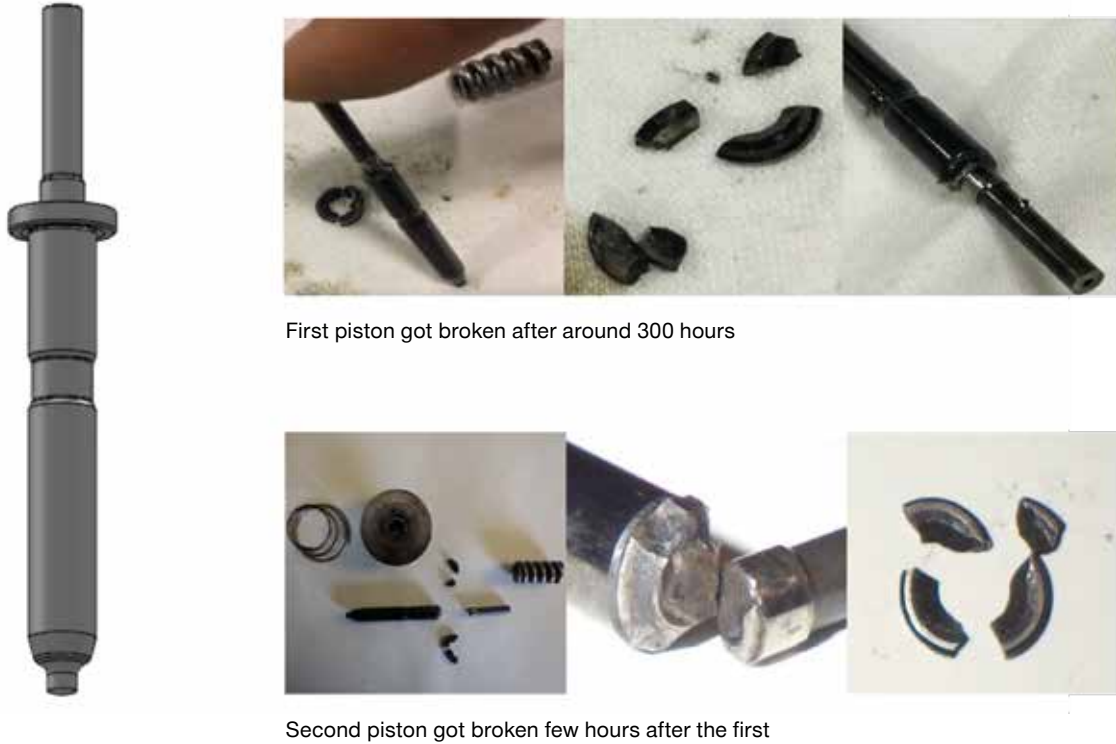
First piston got broken after around 300 hours

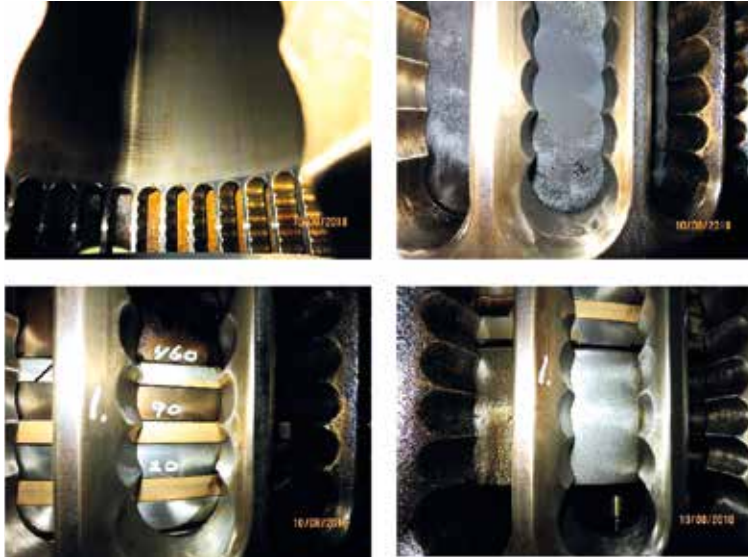
Fig. 85: 7G80ME-C9.5 EGRTC-Eco, good condition of cylinder No. 1

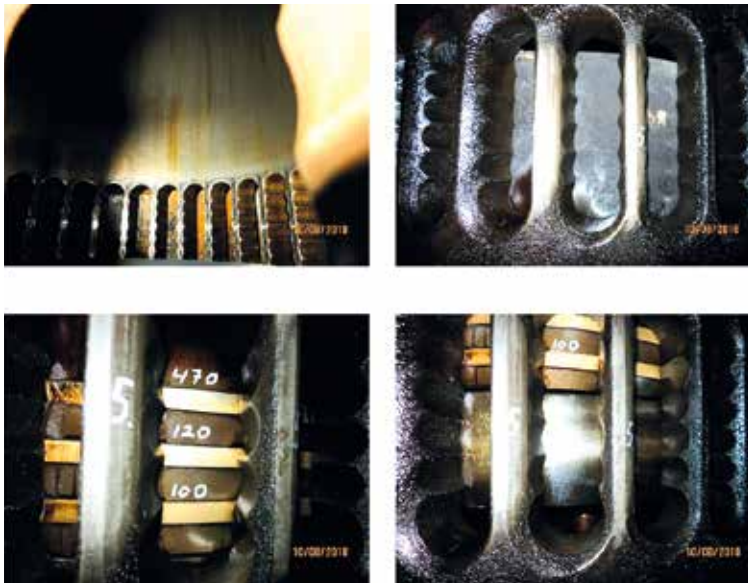
Fig. 86: 7G80ME-C9.5 EGRTC-Eco, good condition of cylinder No. 5
