Service Experience

Small Bore Four-stroke Engines

MAN Diesel & Turbo

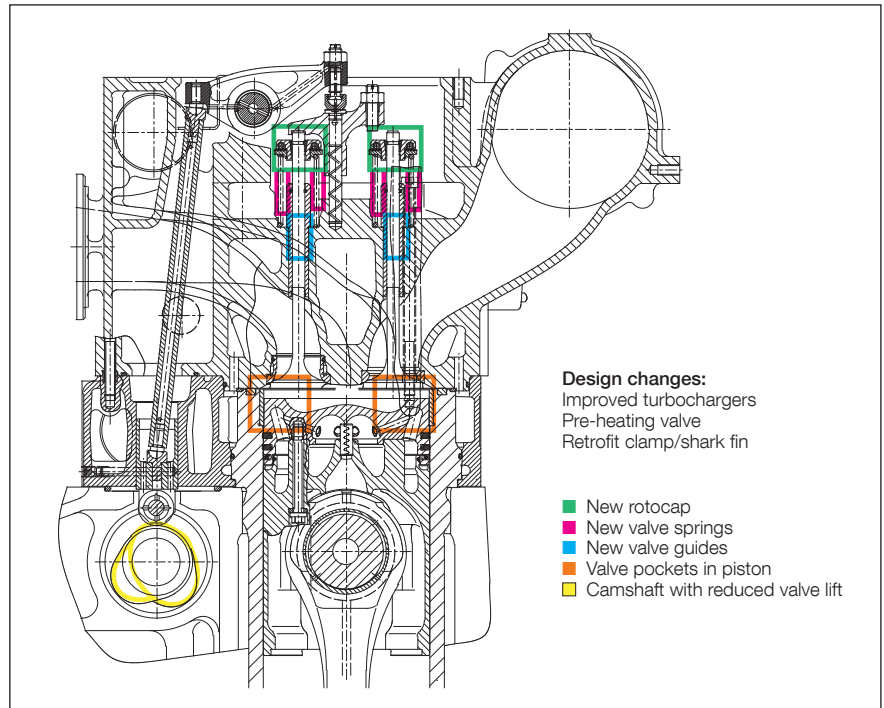
It is well-known that the L16/24 engine has experienced cylinder incidents over the last years. At the same time, similar engines have logged 50-80,000 running hours in service and never experienced such problems. The investigation of the incidents revealed that most cases were related to extremely low load operation in combination with fuel of poor ignition properties. Because the fuel fulfilled the standard, even with the poor ignition properties, we had to make some modifications. From the beginning, the modifications were concentrated on preventing sticking valves, better charge air preheating, better turbocharger and adjustment of valve stem clearance, see Fig. 1.

Fig. 1: L16/24: higher safety against sticking valves, i.e. sticking valves will not cause engine breakdown

With the low-lift cam, stronger spring valve, etc., the risk of collision with the piston has been eliminated. After the

introduction of the low-lift cam (Mk 2), we have not experienced valve damage related to sticking valves in service.

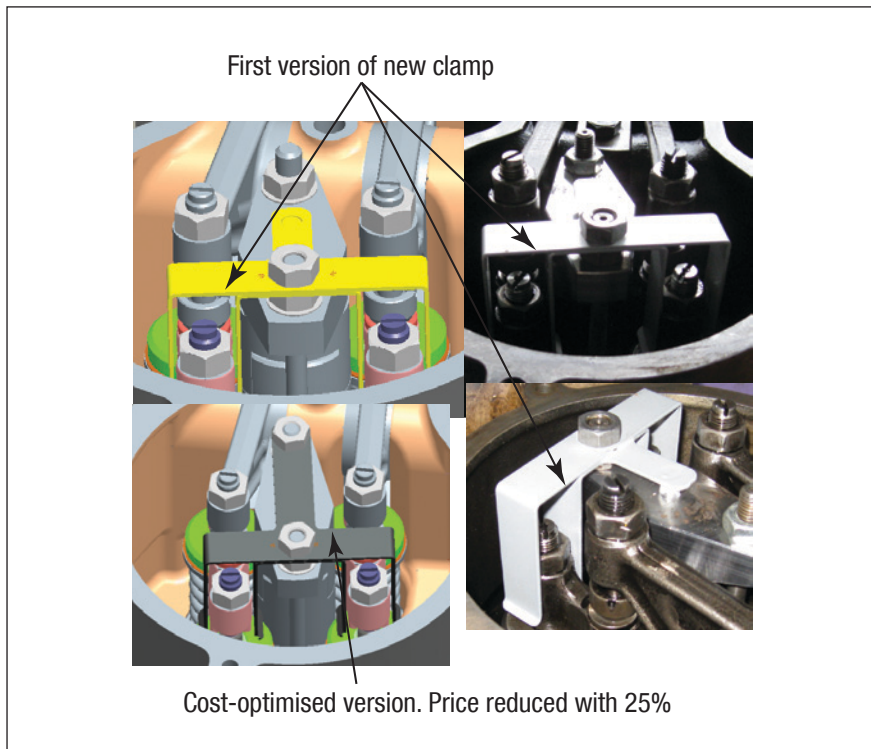
Unfortunately, incorrect valve adjustment still resulted in valve bridges getting out of place during operation of engines. Therefore, we recently introduced a valve bridge guide to align the rocker arm and valve bridge as a retrofit, see Fig. 2.

Fig. 2: L16/24: new rocker arm and self-aligning valve bridge introduced

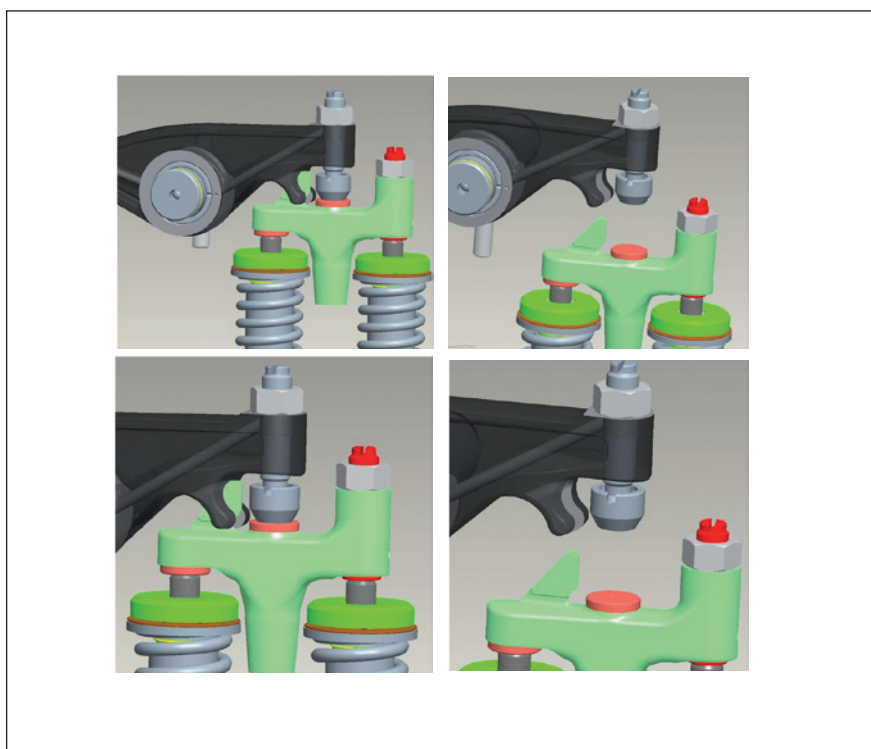
For new engines, the solution to prevent the valve bridge from turning is a so-called “shark fin”, see Fig. 3.

Fig. 3: L16/24: valve arrangement, new serial solution

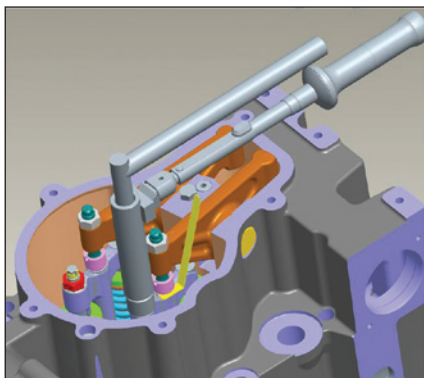
Service experience has revealed that, from time to time, valve clearance adjustment was not done properly or with the required accuracy. This has largely been the case for the L16/24 type engine, but only to a very limited extent for the L27/38, and very seldom for the L21/31 engine.

Fig. 4: Tool for correct tightening torque (L16/24, L21/31 and L27/38)

For this reason, we simplified the adjustment procedure and safeguarded a correct tightening torque by means of a new special tool, see Fig. 4.

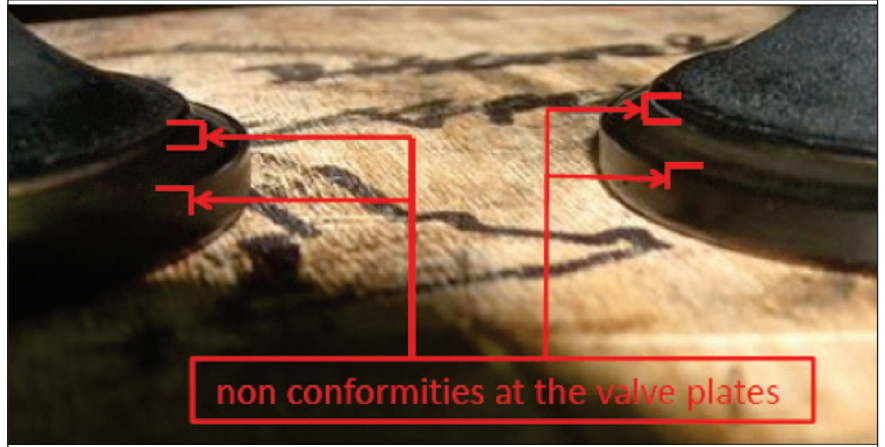
We have experienced heavy wear on the inlet valve seat for engines running on low-sulphur diesel, see Fig. 5.

Fig. 5: Wear on valve seat (L21/31 and L27/38)

This kind of wear has never been seen on HFO-running engines or on most common diesels. To overcome the problem, we are currently testing a new armouring of the valve seats.

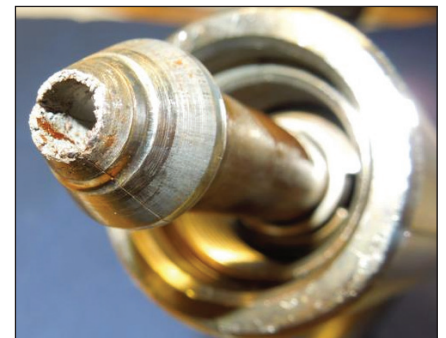
Ever stricter requirements on exhaust gas emissions imply that more marine engines and power plant engines operate on gas oil. Operationally, this can have a negative influence on the fuel injection equipment. Marine gas oil (MGO) has a lower vapour pressure than HFO, and the system pressure is also lower. This may lead to cavitation, and cavitation on the plunger leads to lower capacity of the fuel pumps, with a lower power output as a possible consequence. Cavitation of plugs and valves in the pump may result in larger particles blocking the nozzle holes. Erosion of the delivery and constant-pressure valves can result in loss of residual pressure in the high-pressure system. This may result in cavitation of the high-pressure pipes and nozzle parts, see Fig. 6.

Fig. 6: Cavitation of high-pressure pipe (L21/31 and L27/38)

Actions taken to minimise cavitation:

- supply system pressure increased
- circulation flow increased
- temperature kept as low as possible.

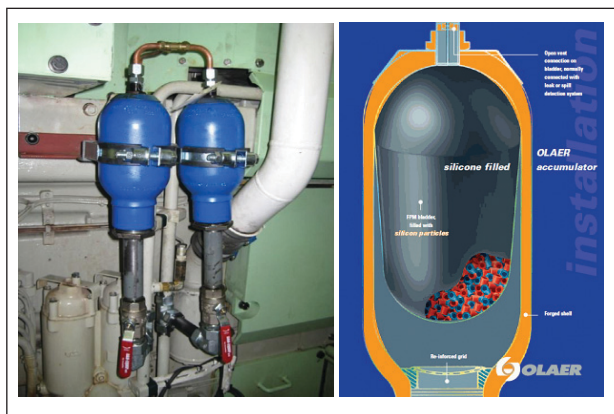
MGO operation may also lead to pressure fluctuations in the low-pressure fuel system. At the end of each injection, the high pressure is released to the suction chamber in the fuel pump. On HFO, the viscosity of the fuel absorbs most of the pressure peak, whereas on MDO/MGO, the pressure peak is transmitted to the fuel piping.

caused damage on pressure transducers and other components in the system.

Fig. 7: Gas dampers being tested in service (L21/31 and L27/38)

- installation of gas dampers (Fig. 7)
- matching of fuel pump inlet and outlet nozzles.

We are testing the gas damper on several plants, see Fig. 7. Service experience looks promising, but we need more running hours to close the topic. Matching on different nozzles is still on-going.

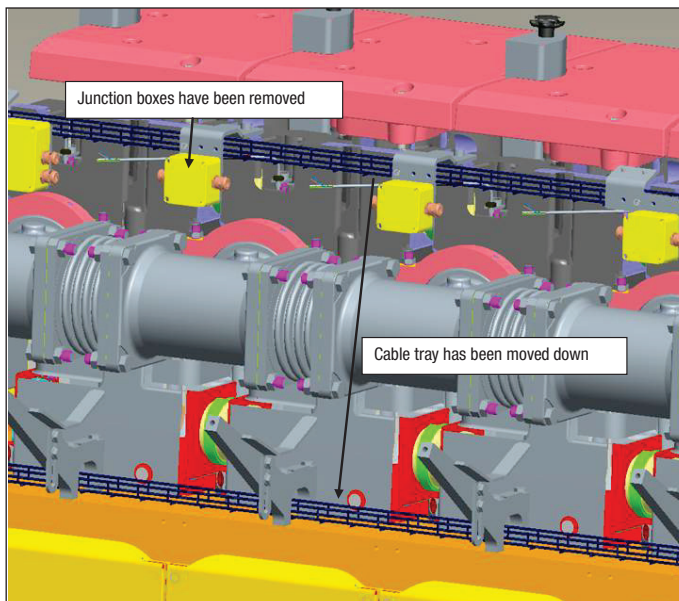
On the L21/31 engines, licensees and operators have often reported a failing temperature signal. The problem was claimed to MAN Diesel & Turbo, and an investigation of the root cause was initiated.

1. Sensors were not sufficiently reliable from the manufacturer
2. Junction box connections suffered from loose wires and failures
3. Longer sleeves had not been fitted correctly
4. Teflon cables had not been introduced correctly
5. Insufficient exhaust gas pipe insulation resulted in sensor cable failure.

Fig. 8: Exhaust gas sensors on L21/31

1. Junction boxes removed (see Fig. 8)
2. Sensors with full cable length applied
3. Washer applied on engines in service, and long sleeves applied on new engines
4. Service Letter with photo documentation of the exchange procedure issued
5. New assembly drawings and parts lists introduced (new cable route, no

junction box and full cable length on sensors).

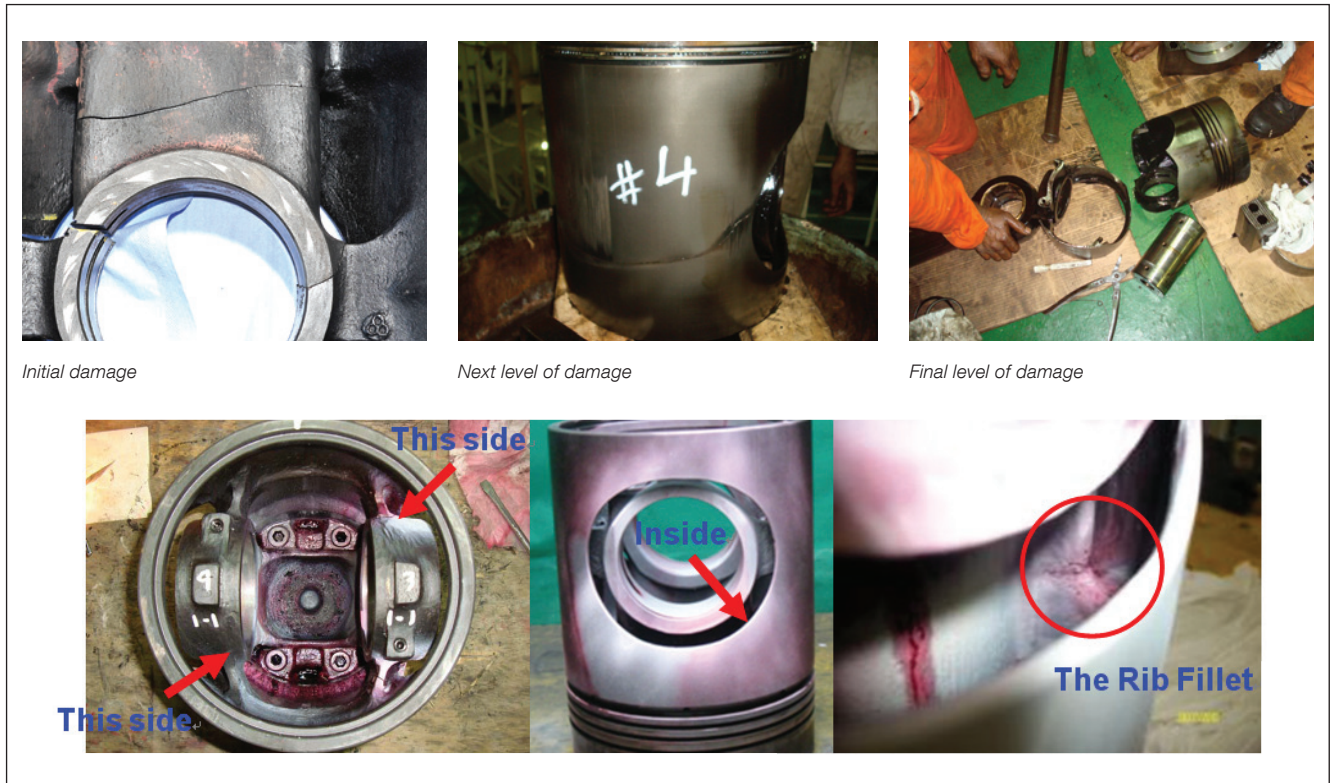
Fig. 9: Cracked pistons on L23/30

In mid-2010, we received a report from a vessel claiming cracks in the L23/30 pistons. After further inspections, cracks were found in all pistons on all three genset engines on board. During the second half of 2010, the same type of failure was reported to MAN Diesel & Turbo (MDT) from more than ten different vessels and ship operators. In some cases, fatigue cracks caused total piston failure with consequential damage to the engine. The cracks were found in pistons that had been in service from 20,000, but also up to 50,000 hours. The pistons were sent for material examination, which revealed that the pistons always had a primary initial crack, and one or two typical consequential cracks. Primary cracks start from the inner connecting bar towards the piston bottom.

Consequential cracks run from the lateral piston bolt accommodation in circumferential direction to the piston skirt or through the pin boss. Investigations into the origin of the problem proved that a too small rounding and poor casting quality of the surface roughness had led to an excessively high stress level. All engines affected were equipped with pistons from the same maker. Nearly 21,000 pistons were in service worldwide. According to an agreement between the licensees involved and MDT, service letters were issued from all parties involved. One general service letter from MDT, and one from each licensee to the specific operator with pistons installed from their engine production. The service letters strongly recommended to replace the pistons due to the potential risk of engine damage and

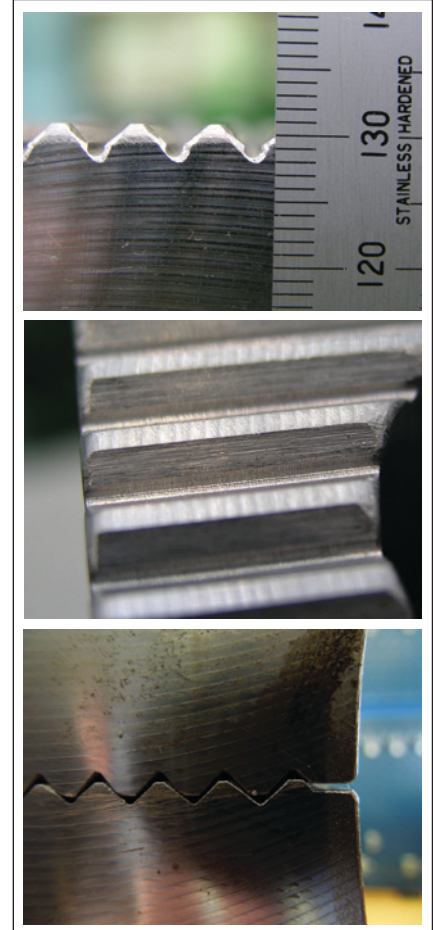
1. If the connecting rod is found with high ovality and/or cracks in the serration the first time the connecting rod is disassembled, then this is related to incorrect machining of the serration by the maker of the connecting rod. The geometry of the serrations on both sides of the big end was measured, and there was not correct correspondence between the upper part and the lower part. The incorrect geometry of the serrations will have a negative influence on the ovality and the occurrence of cracks.

The connecting rods are from engines built by different licensees, but the connecting rods are mainly from one sub-supplier. The serrations are, however, not made by this sub-supplier. Fig. 10 shows an example where the requirement of 80% contact between the mating surfaces between the teeth is not fulfilled.

Fig. 10: Connecting rod serration (L23/30 and L28/32)

We always recommend full measurement and reporting when a connecting rod is disassembled to ensure the correct quality of the connecting rod.

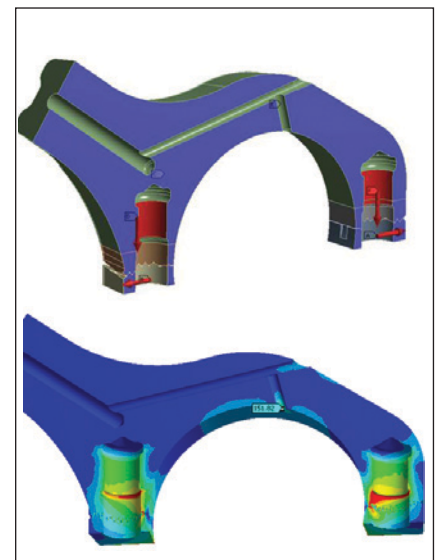
As another important issue related to connecting rods, see Fig. 11, we have seen broken connecting rods causing serious damage to the engine and the risk of personal injury. These failures are due to machining errors of the thread in the connecting rod resulting in a fatigue crack initiated in the bottom of the thread hole.

Fig. 11: L23/30 connecting rod

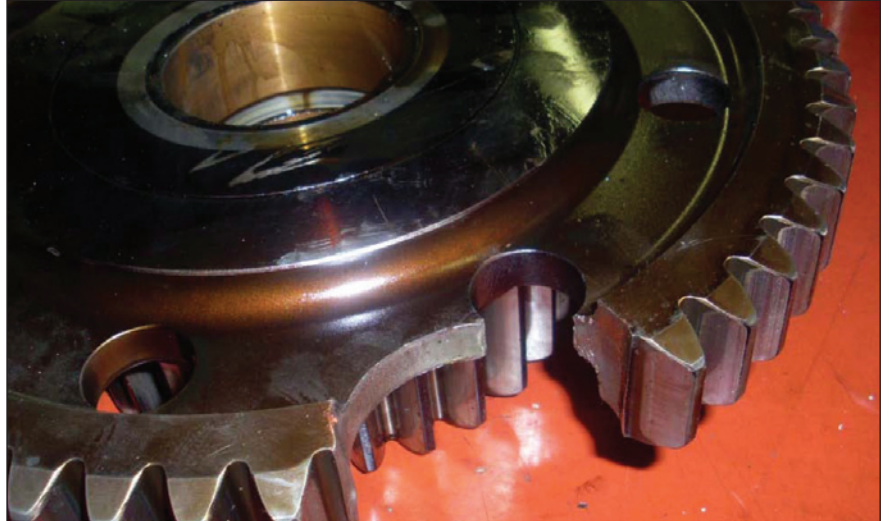
The problem with broken gear wheels is cracks between the teeth of the intermediate wheel driven by the crankshaft. See Fig. 12.

The conclusion is that the crankshaft of a 9-cylinder engine has a small up-and-down movement during rotation, thereby pressing the teeth of the gear wheels so close to each other that they get into full contact. Thus, the stress in the bottom of the teeth becomes high and the resulting fatigue may initiate a crack. Statistics show that only 9-cylinder engines with single bearing alternators are affected.

Fig. 12: Broken gear wheel from L27/38

New two-part gear rings for installation on the crankshaft are in production. The new gear rings will increase the clearance, thereby overcoming the problem. Today, two-bearing alternators are the standard for new 8 and 9L27/38 engines and, thereby, the problem has been eliminated.

A circular letter (CL001-2012) alerting the operator about the issue has been sent out, and new gear wheels will be delivered to the relevant operators.

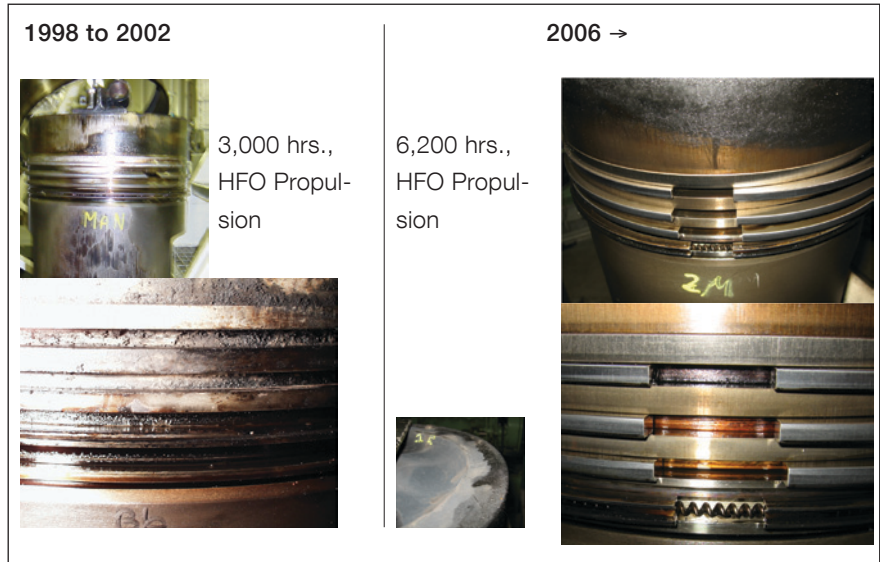
A high liner and ring groove wear on the L27/38 engine was a problem earlier, and various solutions have been tested in the field. As a result, the liner wear is now kept below 10 $\mu\text{m}/1,000$ hours, and the ring groove wear rate can be kept below the target limit, i.e. less than 5 $\mu\text{m}/1,000$ hours. The entire solution package consists of:

Fig. 13: L27/38: improvement on hardware

1. Changed cylinder liner support
2. Changed piston top land clearance
3. Improved scraper ring groove drain
4. Changed compression ring shape and material
5. Cooling jacket with controlled water flow
6. Low-sac fuel nozzle.

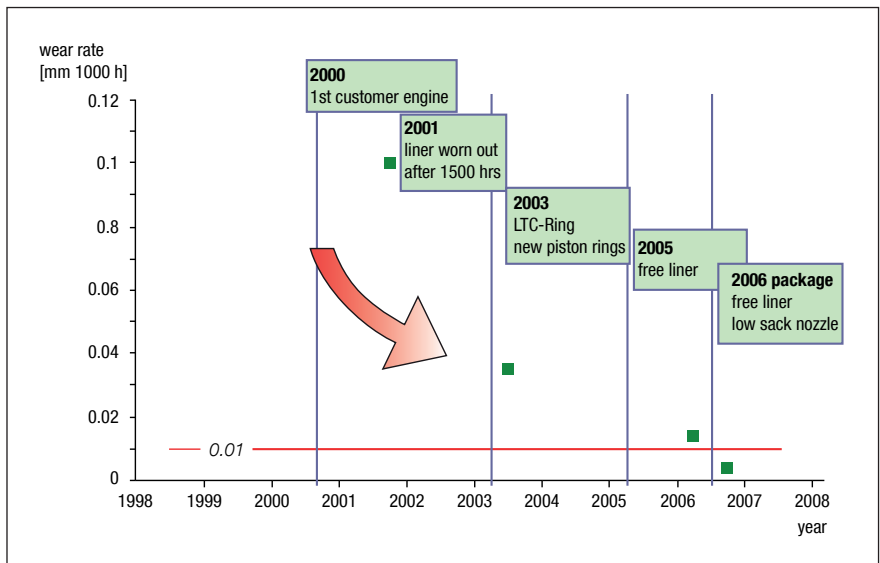
Fig. 14: 27/38 liner wear rates

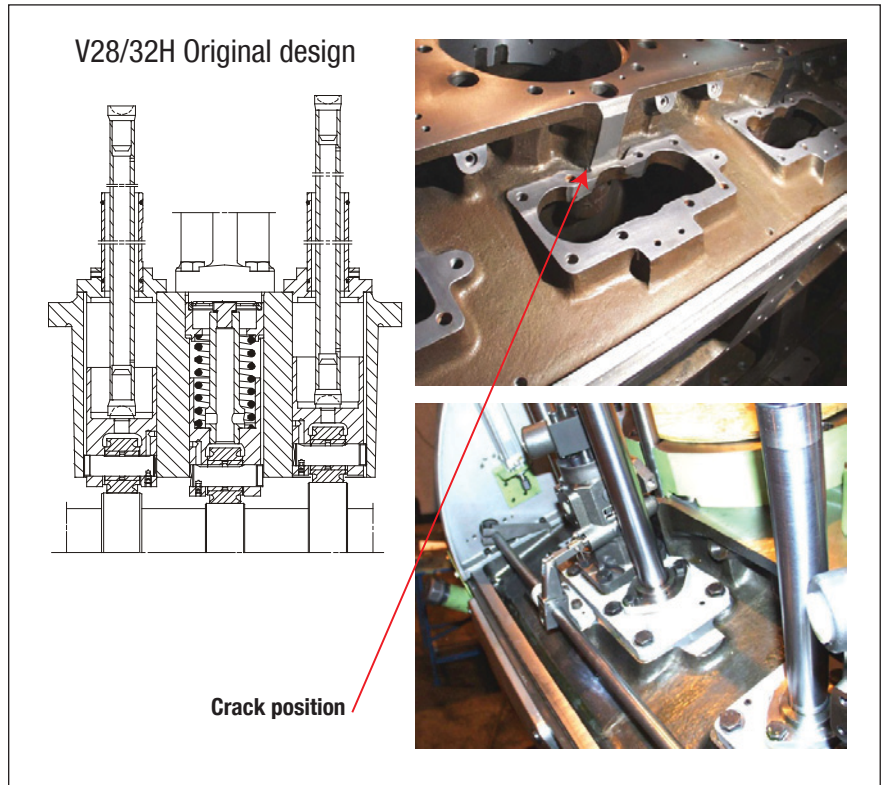
Due to cracks in the engine frame in the area of the roller guide's 12-o'clock stud (see Fig. 15), as well as cost-down considerations, the original roller guide design was simplified and integrated in the engine frame.

weakened by the cut-out for the housing, and cracks developed around the lower cylinder cover stud. Especially the gas engine version was affected.

Fig. 15: Original roller guide design on V28/32H

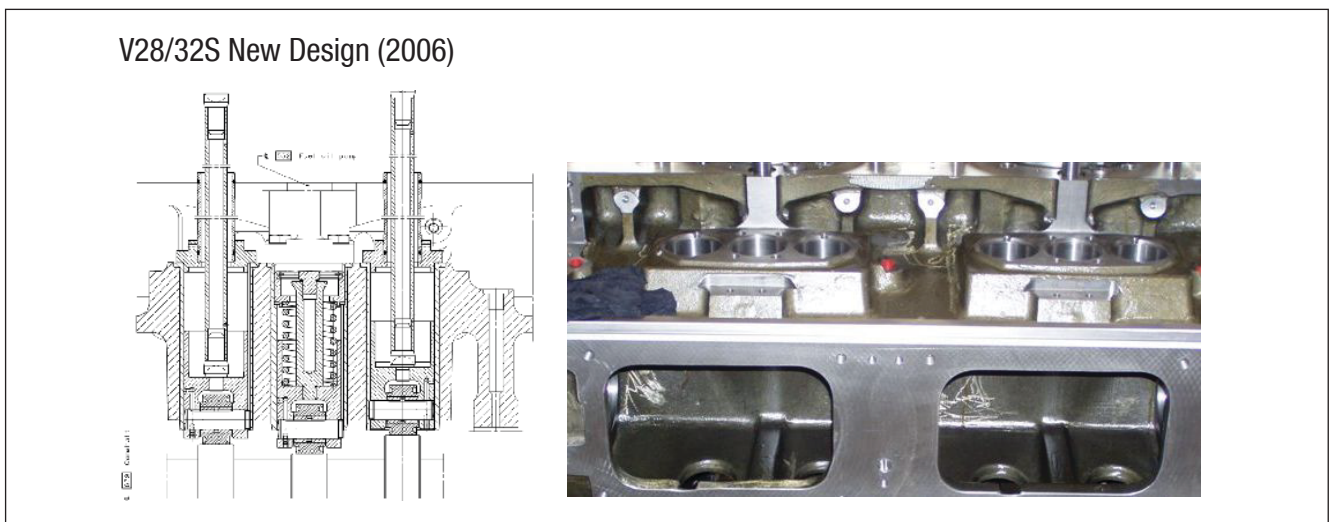
Service experience revealed afterwards that, with an improved design of the roller guide, the wear rates of roller guides and bushings were not as low as

expected and the required lifetime was not achieved.

Fig. 16: V28/32S: present roller guide design

A re-introduction of the guiding bush in combination with enforcement of relevant wall thicknesses was introduced as the new standard and retrofit solution, see Fig. 16.

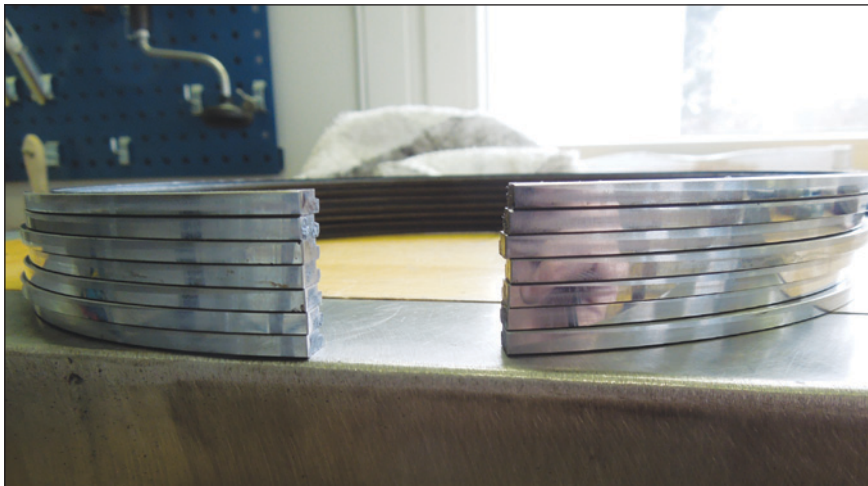
- Cylinder liners, TDC 1st ring: 5 $\mu\text{m}/1,000$ hrs.
- Piston, 1st ring grove: 2 $\mu\text{m}/1,000$ hrs.
- Piston rings: all with intact Cr-layer and no side face corrosion.

Fig. 17 shows the good condition of the piston rings from the 7L23/30H auxiliary engine after 21,199 hrs. in service.

Fig. 17: Piston ring condition after more than 20,000 hrs. in service (7L23/30H)

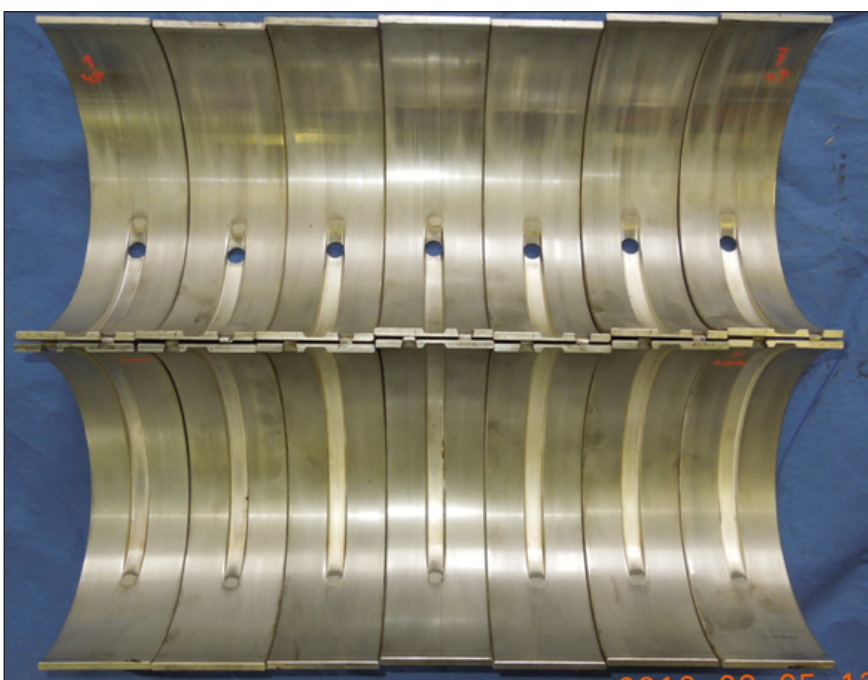
To achieve this prolonged service interval, regular maintenance cleaning of the turbocharger, lube oil, and fuel oil is required. Furthermore, the main overhaul must be carried out according to the instructions and with correct spare parts, and the engine performance must be brought back to “shop test level”. The inspection revealed that the exhaust valves and seat rings seemed to have reached their limit, while bearings, pistons and connecting rods had even more hours left, see Fig. 18.

Fig. 18: Main bearing condition after more than 20,000 hrs. in operation (7L23/30H)

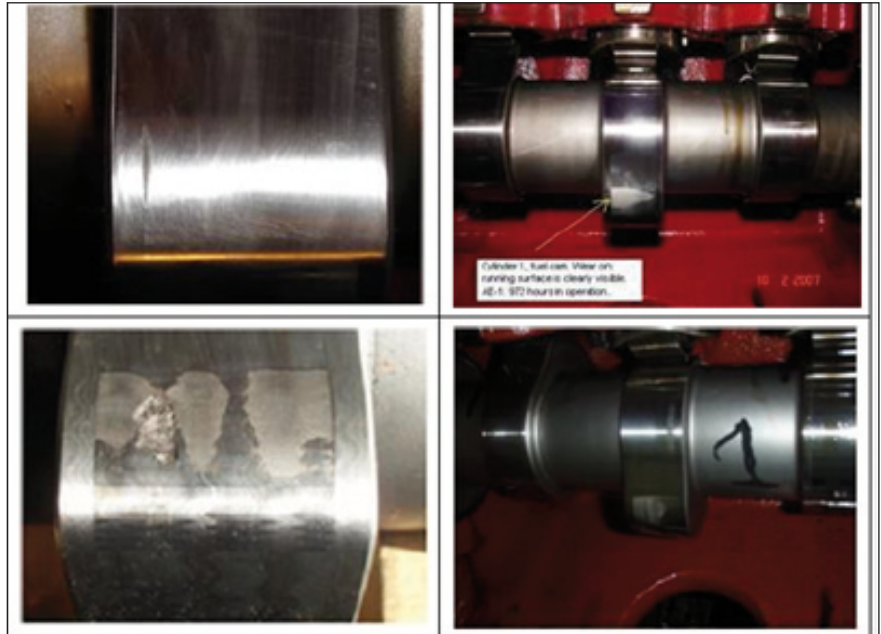
A number of damaged valve cams (ballistic type) were claimed from the operators, and the root cause has been identified to be insufficient material properties and/or an incorrect hardening process, see Fig. 19.

Fig. 19: Camshaft pitting – L28/32 fuel cam with 5,000 operating hours

A solution involving the release of “soft shoulder” cams (see Fig. 20) has been introduced, similar to the ones used on newer engine types, as this design is easier to handle production-wise.

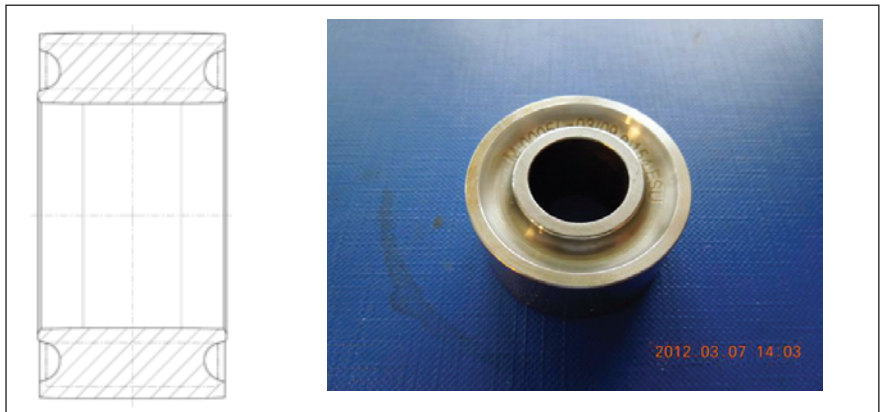
Fig. 20: L28/32 soft shoulder cam design

1. Roller is pre-machined.
2. Roller is hardened to a specified hardness and, more importantly, to a specified hardening depth
3. Roller is grinded to specified dimensions
4. Area to create soft shoulders to be machined away. This machining ensures that hardened material is removed and that the remaining non-hardened material has the wanted flexibility.

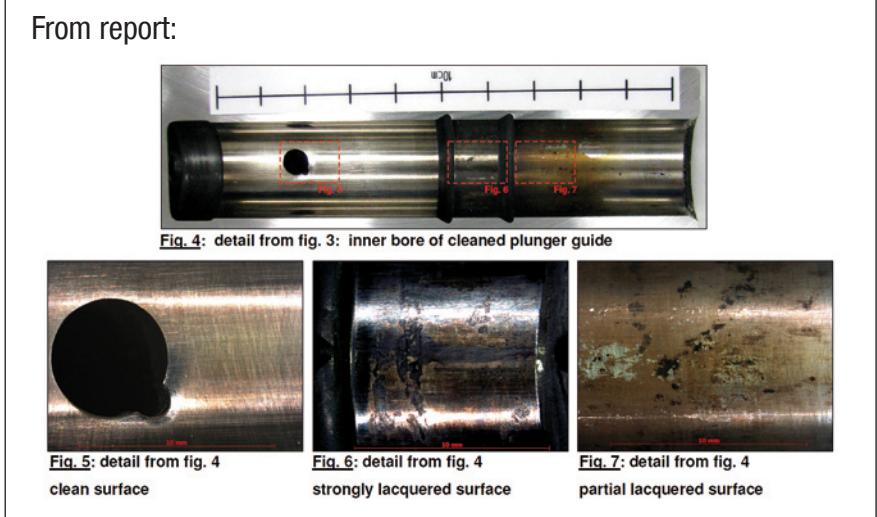
Sticking fuel pumps have always been an annoying problem for engines operating on heavy fuel. Lacquer deposits on the lower part of the plunger reduce the clearance and can lead to sticking of the plunger, especially after standby periods and change to diesel fuel.

High viscosity and low-quality HFO leads to a higher temperature to achieve the correct injection viscosity. The higher temperature increases the tendency to lacquering in the lower drain grooves. Furthermore, when the drain bores are filled/blocked by coke, the leak oil will be trapped there, see Figs. 21 and 22.

Fig. 21: L21/31 pump

In response to the above, investigations are ongoing to eliminate the problem also on engines larger than the L16/24. A similar system for the other small four-stroke engine pumps has been function-tested and will go into field test. Another approach to lower the risk of lacquering is to keep the fuel temperature in the pumps as low as possible within the limits for viscosity and to have a high-circulating fuel flow to maintain a sufficient standby temperature.

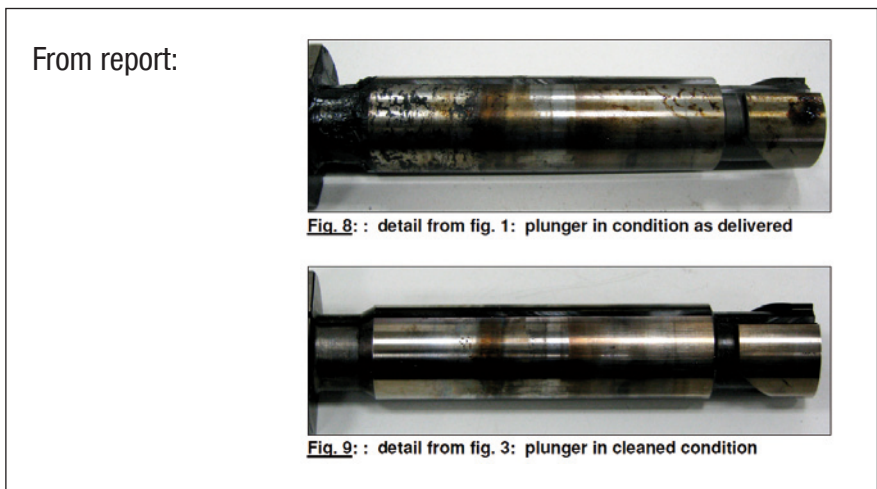
Fig. 22: L21/31 pump plunger

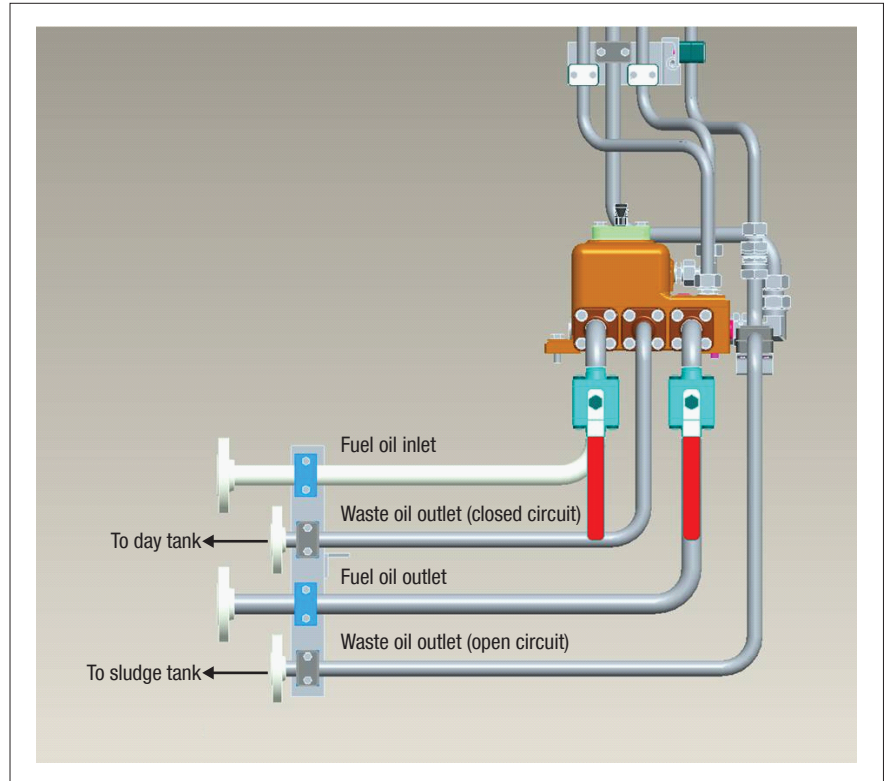
When operating engines on MGO, the leak oil amount increases to nearly 1% of the full load fuel consumption. The increased leak oil flow is caused by the lower viscosity of MGO compared with HFO. The main part of the leak oil comes from the fuel nozzle, and a minor part comes from the fuel pump drain. All this oil can be reused directly. A new system is in the design phase where leak oil from the fuel nozzle and pump will be separated from leaks in the low-pressure system and engine frame top, see Fig. 23.

Fig. 23: L21/31 split drain
