# Breakdown and subsequent drift towards danger of the bulk carrier *ID Integrity*

Coral Sea | 18 to 23 May 2012

**ATSB Transport Safety Report**  
Marine Occurrence Investigation  
294-MO-2012-005  
Final – 22 August 2013

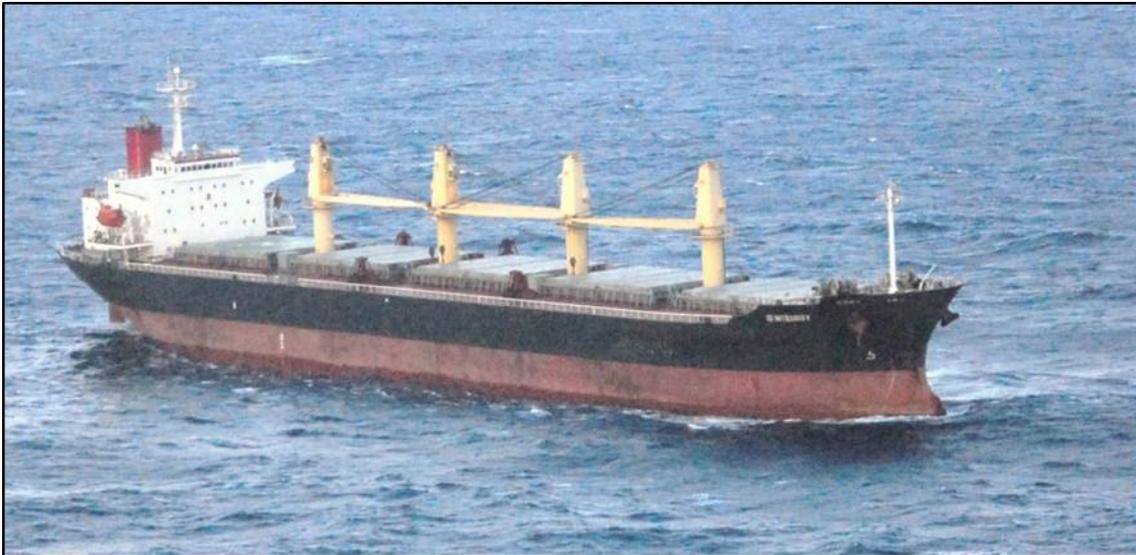
**Figure 1: *ID Integrity* as it drifted across Shark Reef**

At about 1830, *ID Integrity* drifted across the southern end of Shark Reef in waters about 20 m deep, about 4 miles south of the charted 8.1 m depth. *ID Integrity* was now about 60 miles from the eastern edge of the Great Barrier Reef Marine Park and was expected to close on it in less than 24 hours.

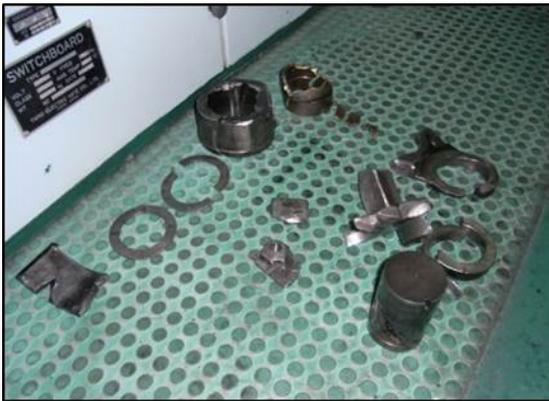
*ID Integrity's* engineers, in consultation with ID Wallem's technical superintendent, continued to search for the cause of the main engine stoppage. While inspecting the engine, the engineers were slowly turning the engine using the turning gear<sup>10</sup> when the turning gear drive motor overloaded and tripped out. The chief engineer concluded that there was a physical obstruction in the engine that was causing an increased resistance to turning, so he decided to inspect the rotating components of the engine, starting with the camshaft. Upon removal of the camshaft cover from number six cylinder, he found pieces of the fuel pump cam, fuel pump roller and reversing mechanism (Figure 4). Closer inspection showed damage to the cam and engine block surfaces (Figures 5, 6 and 7).

**Figure 4: Pieces removed from camshaft space**

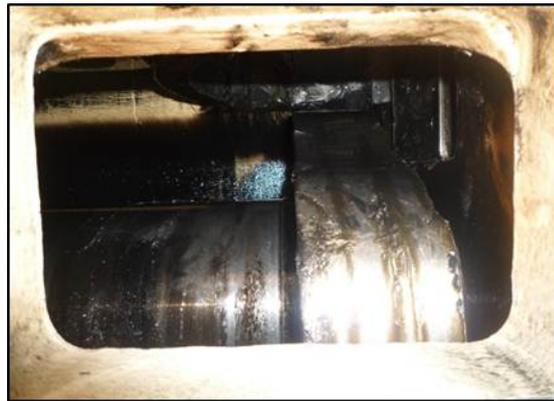
**Figure 5: Fuel pump cam and engine block damage**

The No. 6 fuel roller guide has failed and caused damage [to] the fuel cam for unit<sup>13</sup> 6 which has caused the camshaft to slip 190 degrees in the after most coupling. The resulting mistiming of all cylinders rendered the engine unable to be started.

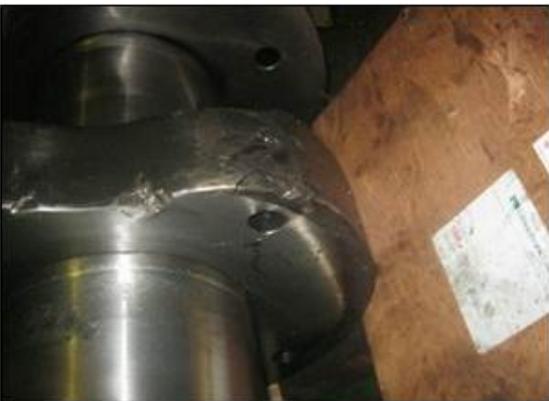
**Figure 6: Fuel pump cam damage**

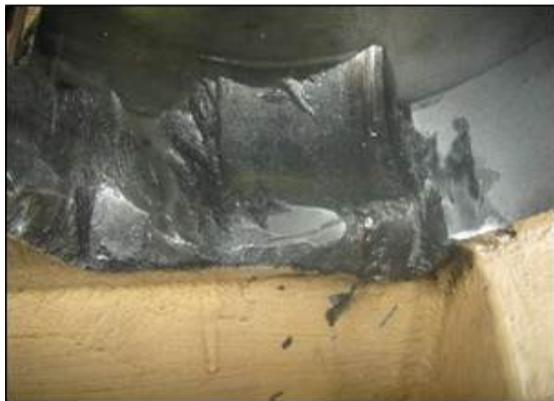
**Figure 7: Damage to roller guide housing**

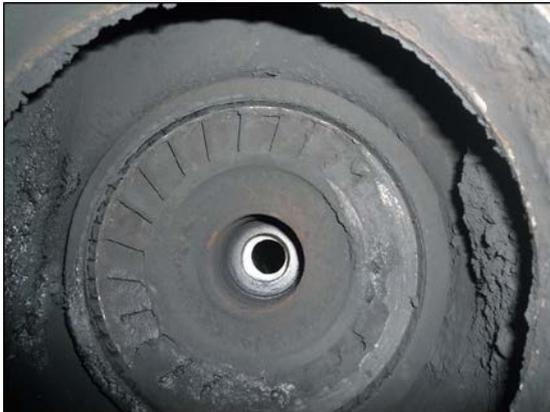
**Figure 10: Number 3 diesel generator turbocharger, May 2012**

During this time, the engineers concentrated their efforts on rectifying the symptom, the fouled turbochargers, rather than identifying and rectifying the actual cause of the turbocharger fouling.

It is likely that, as a result of prolonged periods of operation at reduced load, the cylinder bores and piston ring faces had become glazed. This probably led to poor sealing of piston rings to cylinder liner resulting in carry-over of lubricating oil into the exhaust system (Figure 10). Furthermore, operating the engines on heavy fuel at low loads probably resulted in poor combustion and carry-over of unburnt fuel. It is also possible that oil entered the exhaust system through leaking valve guide seals in the cylinder head. Together, these conditions probably led to the fouling of the turbochargers.

a) Fouled turbocharger nozzle ring

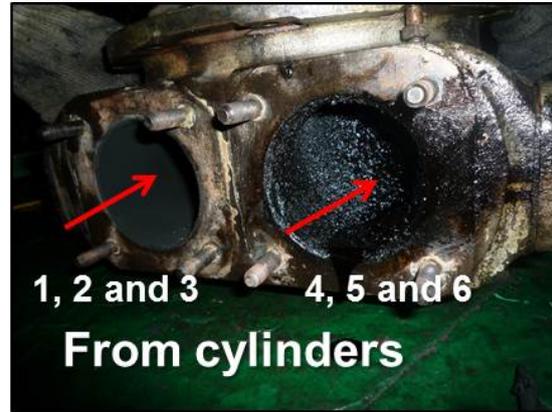
b) Turbocharger exhaust inlet pipes
