# **Service Bulletin**

# **RTA-28**

Technical Information to all the Owners of Sulzer RTA – Type Diesel Engines equipped with DENIS-1 and DENIS-5 ENGINE CONTROL SYSTEMS

# Improvement of the Engine Control System

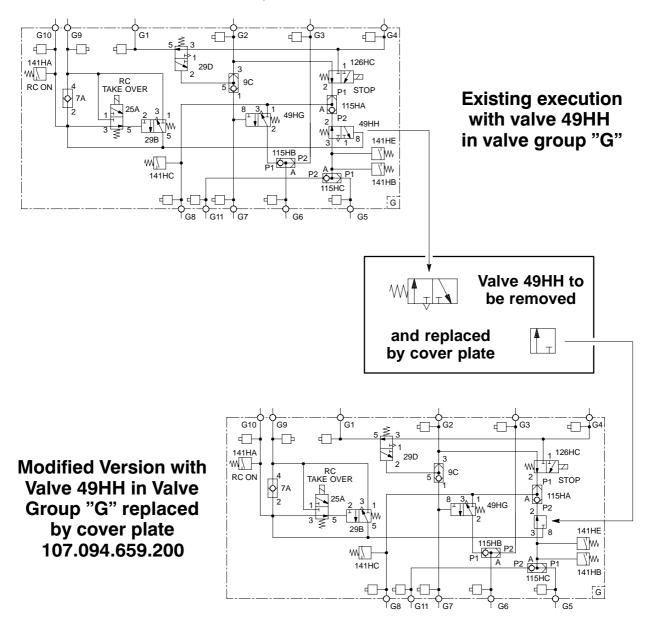
The engine internal fuel interlock for the direction of rotation safeguard is not active if the engine is in "Remote Control" mode (valve 49HH is activated). Under certain circumstances, such as defective control valves in combination with a failure of the crosshead oil pump, an undesired reversing of the engine may result.

On the modified version where the valve 49HH is omitted and the cover plate fitted instead the direction of rotation safeguard and the monitoring of the reversing servomotor end-position remain activated at all times, regardless whether the engine is operated from the bridge, the control room or from the local control stand.

Remove valve 49HH and fit cover plate 107.094.659.200 instead. The cover plate will now blind-off connection No. 8 and will join the connection No. 3 with connection No. 2.

# The cover plate 107.094.659.200 can be ordered from New Sulzer Diesel Ltd.

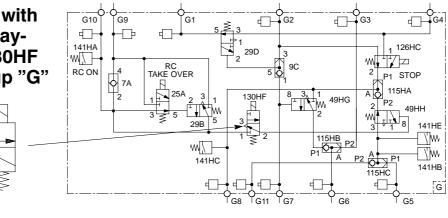
Modified version with additional 3/2-waysolenoid valve 130HF fitted in valve group "G"

The valve 130HF prevents a blackout, which could occur in case of a pressure drop in the main bearing oil system until the stand-by oil pump is automatically put in service. In case the normal bearing oil pressure is not built up again within a few seconds the engine will be stopped by the safety system.

b) For plants with an engine driven generator the solution is to fit an additional solenoid valve 130HF (please refer to the sketch below and the fitting instructions on next page).

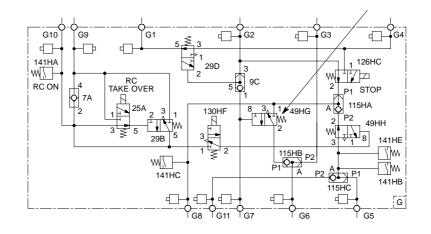
# **1.2.1.** Existing Execution with Valve 49HG in Valve Group "G"

When running the engine from the bridge, from the control room or from the local control stand there is no control air pressure on port No. 8 of valve 49HG and the valve is in the same mode as drawn on the above diagram i.e. there is no connection between port No. 1 and port No. 2. When the engine is stopped and during reversing the fuel is cut-off by the Woodward governor or the electrical actuator (with electronic governor) via the fuel linkage.

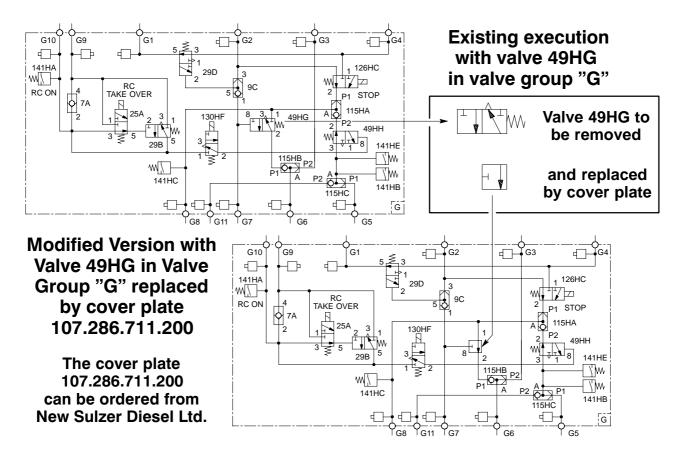
However, it was found that under the latter condition the stop lever 5.07 becomes inoperative and therefore it is necessary to carry out the above modification in order to be sure that the engine can also be stopped at any time with the stop lever.

On engines with electronic speed controls, using electrical actuators to adjust the fuel linkage, valve 49HG **must** be removed and the cover plate 107.286.711.200 must be fitted instead.

The cover plate will now blind-off connection No. 8 and will join the connection No. 1 with connection No. 2 (please refer to the sketch below).
