Service Letter

SL07-483/HRR
August 2007

**Condition-based Piston Overhaul
MC/MC-C and ME/ME-C type engines
Container Vessels, Bulk Carriers and
vessels with similar trade pattern**
Action Code: WHEN CONVENIENT

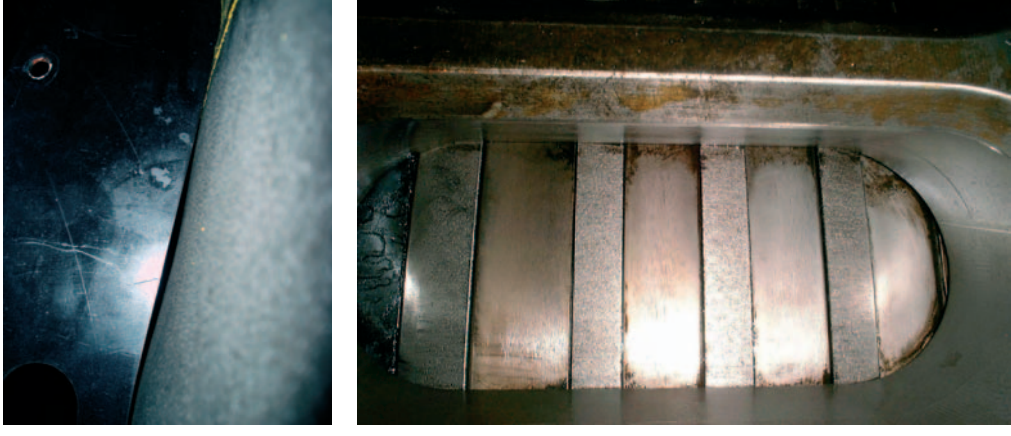
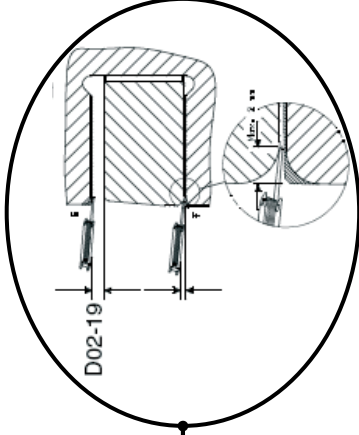
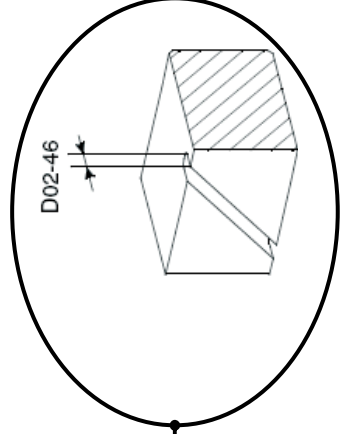
Fig. 1

Most important factors for piston overhauls (see also Fig. 1):

- Piston ring wear (ref. instruction book).
- Max. amount of hot corrosion of piston top allowed on the centre part (where it is normally highest) is 9/12/15 mm on, respectively, 80/90/98-bore engines.
- Ring groove clearance.
Max. recommended clearance is 1.0 mm on the 80 and 90-bore engines, and 1.1 mm on 98-bore engines
- Sticking, broken or collapsed piston rings or leaking pistons.
- Macro-seizures on piston ring running surfaces.

When is piston overhaul necessary?

- Before piston burning reaches the max. allowed
- Before ring groove clearance reaches the max. allowed
- In case of macro-seizures on the rings (scuffing)
- When the wear on the top piston ring has reduced the CL-grooves to the minimum

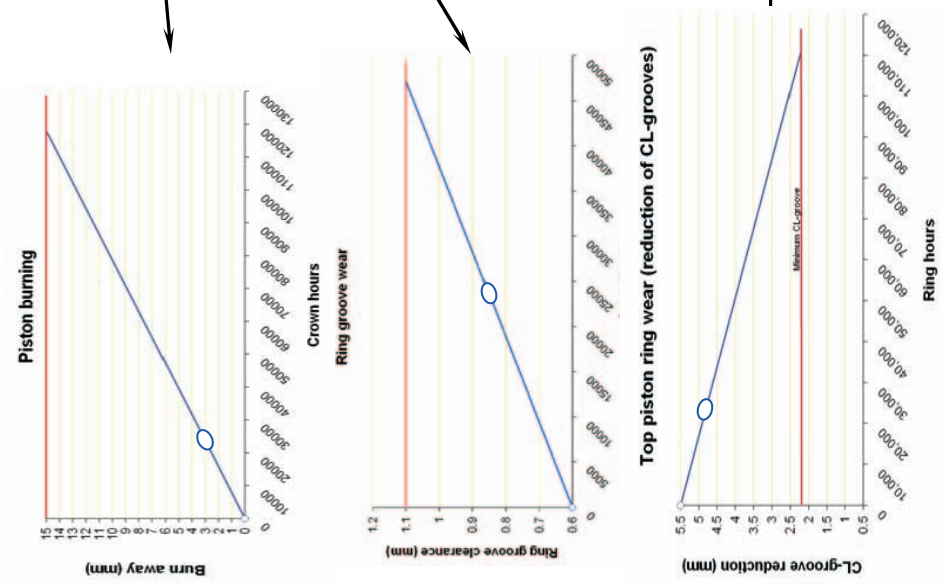
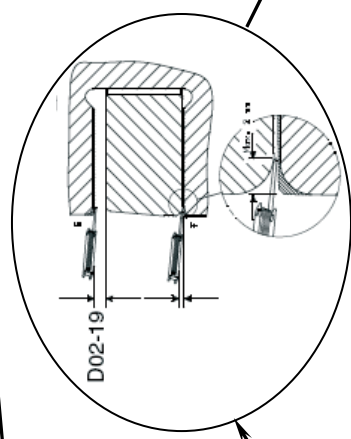
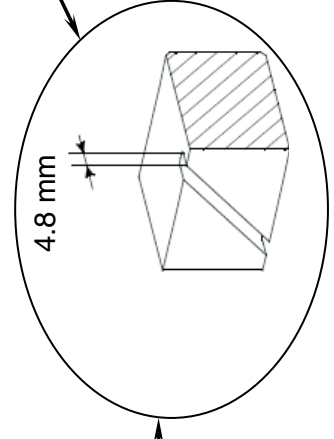
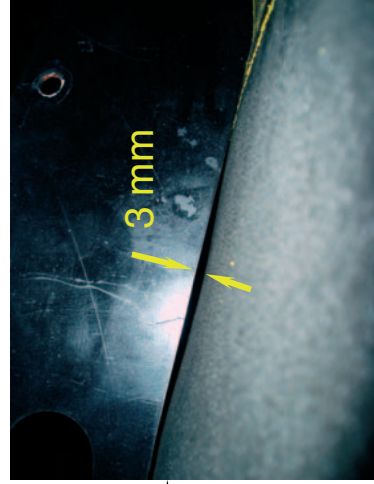
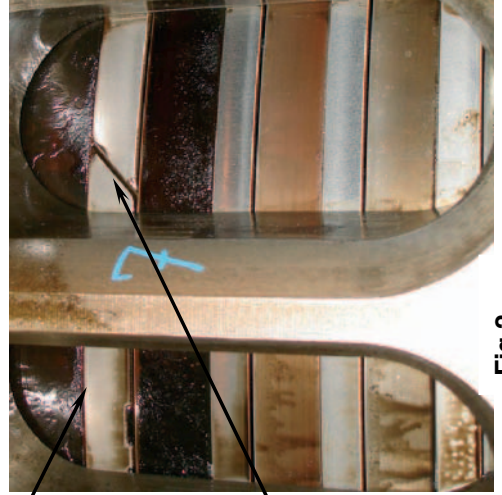
Fig 2

Top piston ring wear, defined by measuring the remaining depth of the CL grooves, ring groove clearances, measured with a feeler gauge, and estimated piston burnings on large-bore engines, measured by means of a template via the scavenge ports, should be recorded. Our standard sheets "Cylinder Condition Report" and "Inspection through Scavenge Ports" can be used, forming the ideal documentation for later review and for making trend curves for future wear forecasts (see the example in Fig. 2).

How to judge, example from a 10K98MC-C with 23,500 running hours without overhaul

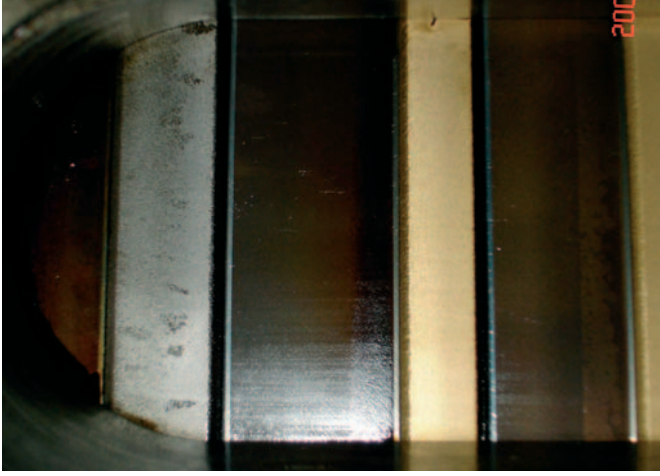
In case of micro-seizures (mz), lubrication should be increased temporarily according to the standard lubrication guidelines. However, it is important to lower the lubrication to normal as soon as the active mz-attack is stopped. It should be noted that old, not active, mz-marks remain visible long time after the attack has stopped, which does not call for increased lubrication. Figs. 4 and 7.

Fig. 4. Unit with micro-seizures on the top ring as a result of metal-to-metal contact. Should be counteracted by temporarily increased lubrication. It is important to lower the lubrication to normal as soon as the active mz-attack is stopped. Note that old, not active, mz-marks remain visible long after the attack has stopped and do not call for increased lubrication.

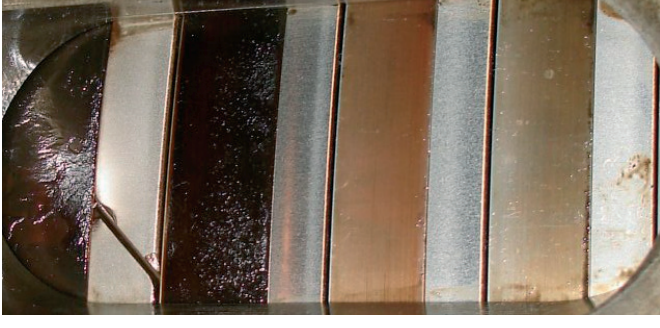
Fig. 5. Unit with 23,500 hours without piston overhaul. Note that most of the rounding is still intact, indicating that only $\frac{1}{4}$ of the wear potential is used. Further, the measurements above from the same unit shows that only $\frac{1}{2}$ of the ring groove wear potential is used, and the rate of burrings on the piston top is insignificant. Consequently, overhaul of that unit is not needed at this stage.

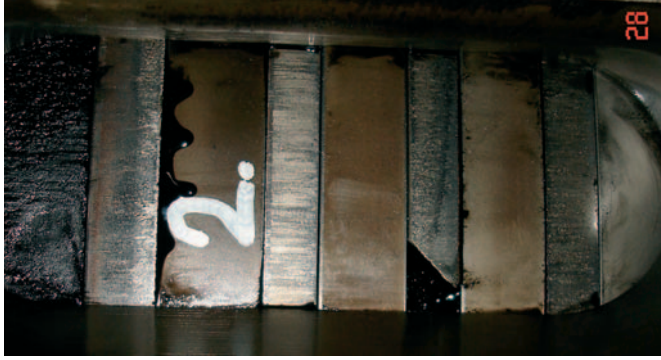
Fig. 6. Totally scuffed unit. Lubrication should be increased to maximum until overhaul is convenient with regard to the schedule of the ship. Due to the friction heat developed, the piston rings get hardened, and the wear rate of the liner increases significantly. However, the hardening protects the rings, which is why operation may be continued safely until next convenient port stay.

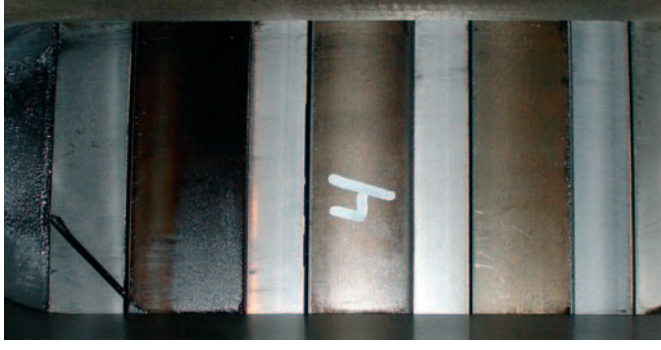
Fig. 8. Unit running very well after 20,021 running hours. Note that the last remains of the alu-coat are still visible on the lower edge, indicating remaining rounding left. This means that the ring wear is less than 2 mm out of possible 3 mm. Consequently, many more hours are left from the point of view of wear.
