SERVICE LETTER

SL97-350/ESC
November 1997

**Subject: Damage of Main Bearings on Rigidly Mounted Auxiliary Engines
caused by External Vibrations from the Hull Structure**

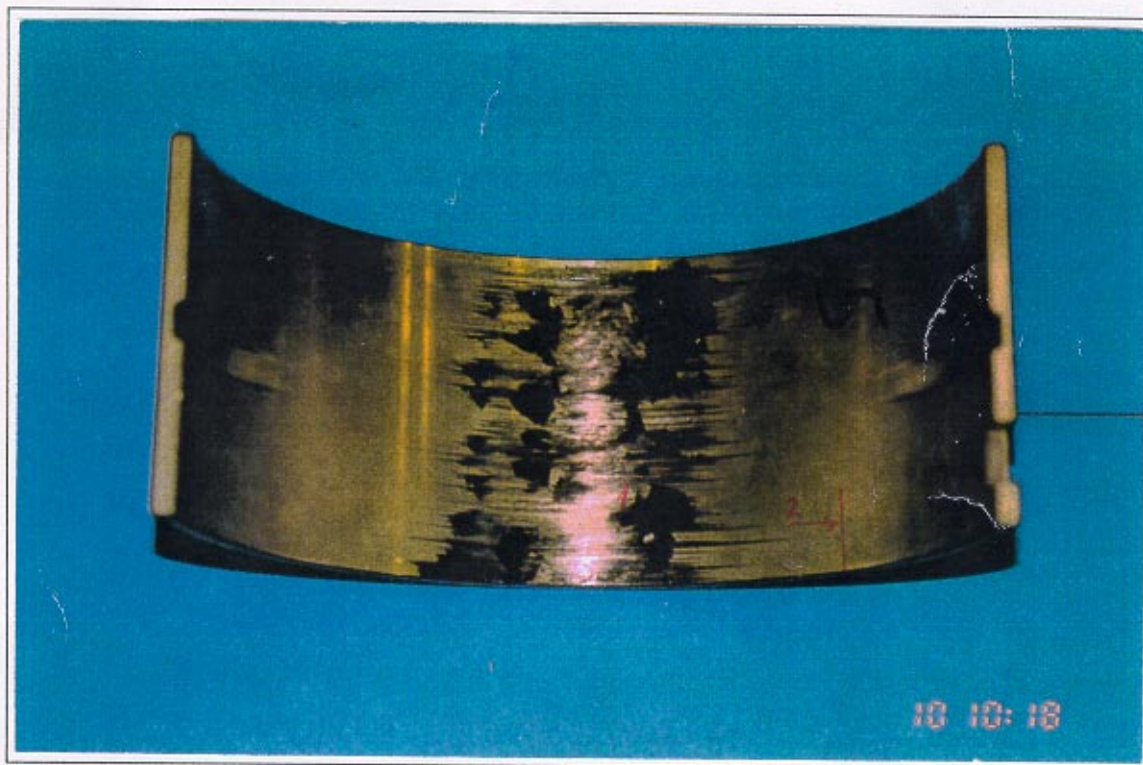
Fig. 1. General view

Lately, the MAN B&W Diesel A/S, Holeby Service Department has seen several examples of main bearings with an abnormality in the form of a black coating on the entire contact surface between bearing and bearing journal, see enclosed Technical Information No 305-S6/610-S5.

Analysis of a damaged main bearing has shown the black coating to be lead oxide caused by static fretting. Measurements have shown the coating to be 6 to 7 times harder than the bearing material.

Such a coating destroys the main bearing surface and results in increased wear of the main bearing journal.

Static fretting occurs during engine standstill, as a consequence of the movement of the main bearings in relation to the crankshaft, caused by external vibrations transmitted to the engine from the hull structure.

We have discovered that the high vibration level is the result of insufficient support of the deck on which the auxiliary engines are mounted. This combined with the fact that the engines are rigidly mounted causes vibrations from the hull to be transmitted to the auxiliary engines.

Finding a solution to this problem requires involvement of a naval architect to make proposals for a change of the deck / platform support.

Continuous operation of the **prelubricating** oil pump during engine standstill may result in certain improvement, although with limited effect.

Alternatively the engines could be mounted resiliently, to which end MAN B&W Diesel A/S, Holeby may be of assistance. However, it is important to bear in mind that the necessary changes will be extensive as all pipe connections etc. must be flexible, and the base frame has to be replaced. Due to the necessity in changing the base frame the foundation has to be modified.

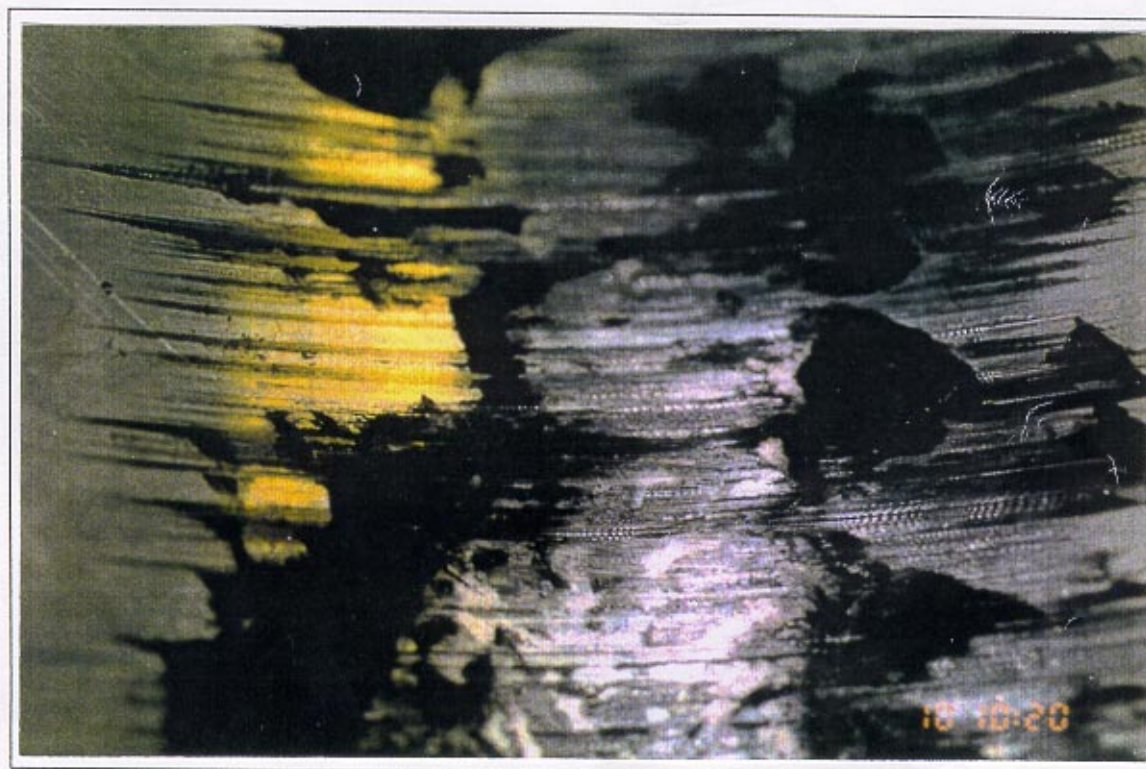
Fig. 2. Blackened and pitted bore
