CLEVITE7[®]
ENGINE BEARINGS

Engine Bearing

failure analysis guide

*A guide to analysis and correction of
premature engine bearing failures*

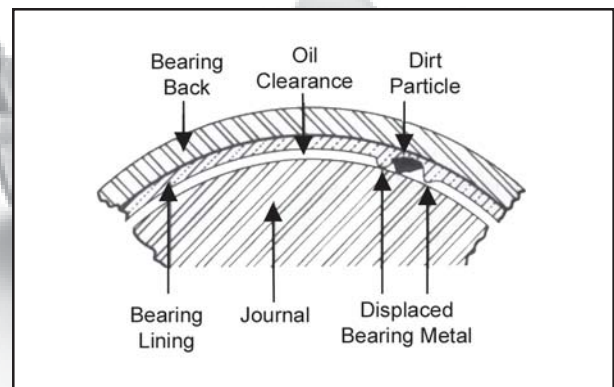
Foreign particles are embedded in the lining of the bearing. Scratch marks may also be visible on the bearing surface.

The high-spot may be large enough to make contact with the journal causing a rubbing action that can lead to the eventual breakdown and rupture of the bearing lining. Foreign particles may embed only partially and the protruding portion may come in contact with the journal and cause a grinding wheel action.

1. Improper cleaning of the engine and parts prior to assembly.
2. Road dirt and sand entering the engine through the air-intake manifold or faulty air filtration.
3. Wear of other engine parts, resulting in small fragments of these parts entering the engine's oil supply.
4. Neglected oil filter and/or air filter replacement.

1. Install new bearings, being careful to follow proper cleaning procedures.
2. Grind journal surfaces if necessary.
3. Recommend that the operator have the oil, air filter, oil filter and crankcase breather-filter replaced as recommended by the manufacturer.

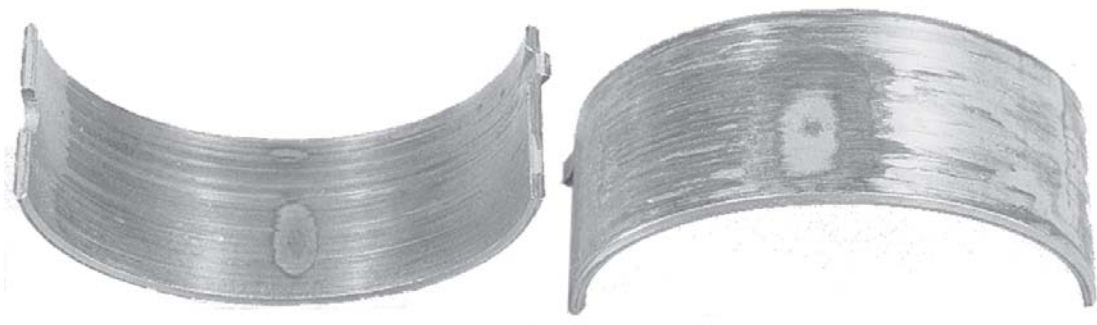
A localized area of wear can be seen on the bearing surface. Also, evidence of foreign particle(s) may be visible on the bearing back or bearing housing directly behind the area of surface wear.

Also, an uneven distribution of the load causes an abnormally high pressure area on the bearing surface, increasing localized wear on this material.

1. Install new bearings following proper cleaning and burr removal procedures for all surfaces.
2. Check journal surfaces and if excessive wear is discovered, regrind.

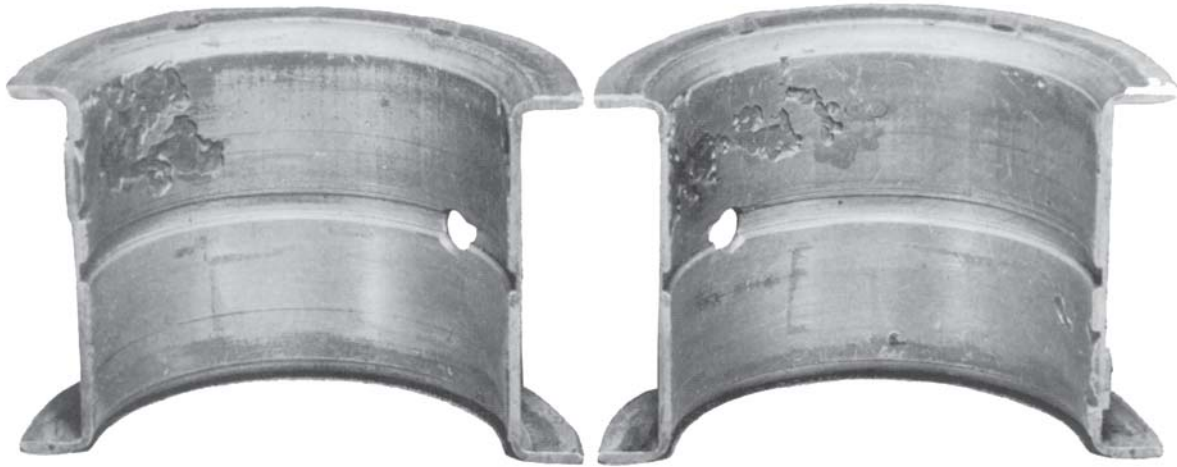
Excessive wear areas can be seen near the parting lines on opposite sides of the upper and lower bearing shells.

The resulting metal-to-metal contact and excessive pressure cause deterioration of the bearing surface and above normal wear areas.

1. Using too large a socket to tighten the bearing cap. In this case, the socket crowds against the cap causing it to shift.
2. Reversing the position of the bearing cap.
3. Inadequate dowel pins between bearing cap and housing (if used), allowing the cap to break away and shift.
4. Improper torquing of cap bolts resulting in a “loose” cap that can shift positions during engine operation.
5. Enlarged cap bolt holes or stretched cap bolts, permitting greater than normal play in the bolt holes.

1. Check journal surfaces for excessive wear and regrind if necessary.
2. Install the new bearing being careful to use the correct size socket to tighten the cap and the correct size dowel pins (if required).
3. Alternate torquing from side to side as to assure proper seating of the cap.
4. Check the bearing cap and make sure it's in its proper position.
5. Use new bolts to assure against overlap within the bolt holes.

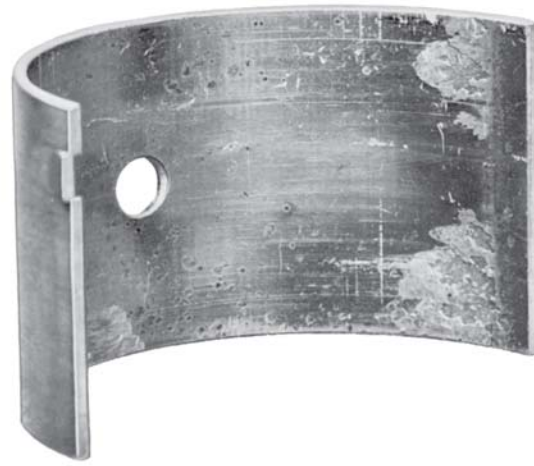
Extreme wear areas visible along the bearing surface adjacent to one or both of the parting line.

When there is too much crush, however, the additional compressive force created by the surplus crush that still remains after the bearing is fully seated causes the bearing to bulge inward at the parting faces. This bearing distortion is called “side pinch.”

1. The bearing caps were filed down in an attempt to reduce oil clearance.
2. The bearing caps were assembled too tightly due to excessive torquing.
3. Not enough shims were utilized (if shims were specified).

1. Rework the bearing housing of the engine block if it has been filed down.
2. Replace the connecting rod if its bearing cap has been filed down.
3. Check journal surfaces and regrind if necessary.
4. Install the new bearing and follow proper installation procedures by never filing down bearing caps and using the recommended torque wrench setting.
5. Correct the shim thickness (if applicable).
6. Check for out-of-roundness of the inside diameter of the assembled bearing by means of an out-of-roundness gauge, inside micrometer, calipers or prussian blue to assure that any out-of-roundness is within safe limits. The maximum assembled bearing I.D. should always be across the split line.

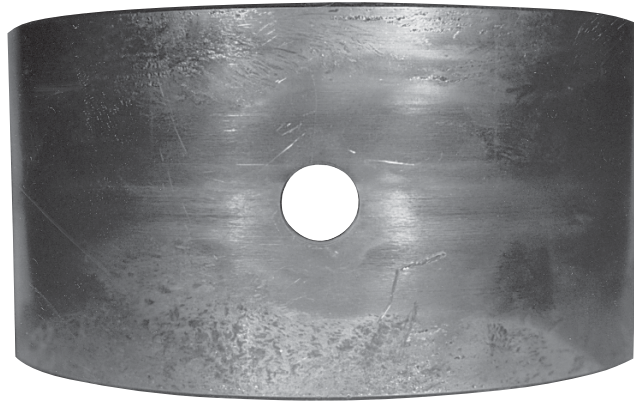
Highly polished areas are visible on the bearing back and/or on the edge of the parting line. Areas of pock marks or build-up due to metal transfer between bearing and housing. This is commonly referred to as “fretting”.

When a bearing with insufficient crush is assembled in an engine, it is loose and therefore free to work back and forth within its housing.

Because of the loss of radial pressure, there is inadequate contact with the bearing housing, thus impeding heat transfer away from the bearing. As a result, the bearing overheats causing deterioration of the bearing surface.

1. Bearing parting faces were filed down in a mistaken attempt to achieve a better fit, thus removing the crush.
2. Bearing caps were held open by dirt or burrs on the contact surface.
3. Insufficient torquing during installation (be certain bolt doesn't bottom in a blind hole).
4. The housing bore was oversize or the bearing cap was stretched, thus minimizing the crush.
5. Too many shims were utilized (if shims are specified).

1. Clean mating surfaces of bearing caps and inspect for nicks and burrs prior to assembly.
2. Check journal surfaces for excessive wear and regrind if necessary.
3. Check the size and condition of the housing bore and recondition if necessary.
4. Correct shim thickness (if applicable).
5. Install new bearings using correct installation procedures (never file bearing parting faces).

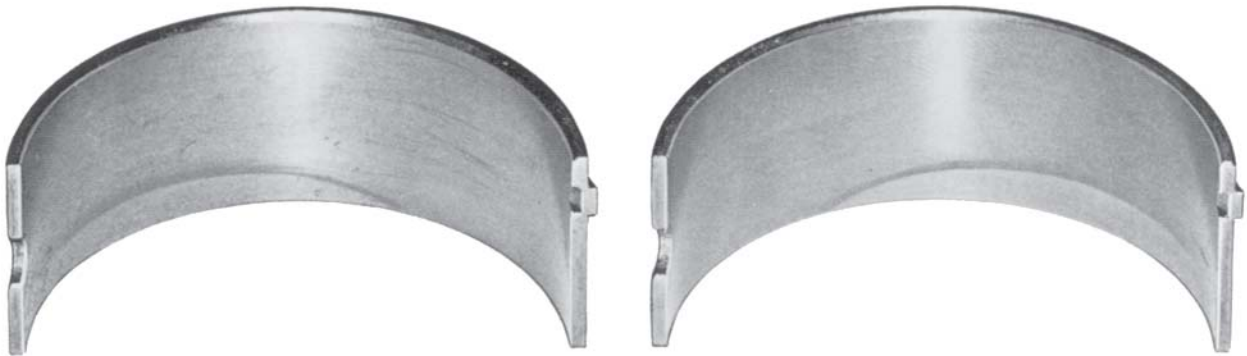
Bent or Twisted Connecting Rod

Excessive wear areas can be seen on opposite ends of the upper and lower connecting rod bearing shells. The wear is localized on one portion of the bearing surface with little or no wear on the remainder.

A bent or twisted connecting rod results in misalignment of the bore, causing the bearing to be cocked so the bearing edge makes metal-to-metal contact with the journal. These metal-to-metal contact areas cause excessive wear on the bearing surface.

1. Extreme operating conditions such as “hot rodding” and “lugging.”
2. Improper reconditioning. See inside front cover.
3. Dropping or abusing the connecting rod prior to assembly.

1. Inspect connecting rod and recondition or replace if bent or twisted.
2. Check journal surfaces for excessive wear and regrind if necessary.
3. Install bearing.
4. Avoid dropping or abusing the connecting rod prior to assembly.
5. Use proper installation techniques.
6. Check related upper cylinder parts and replace if necessary.

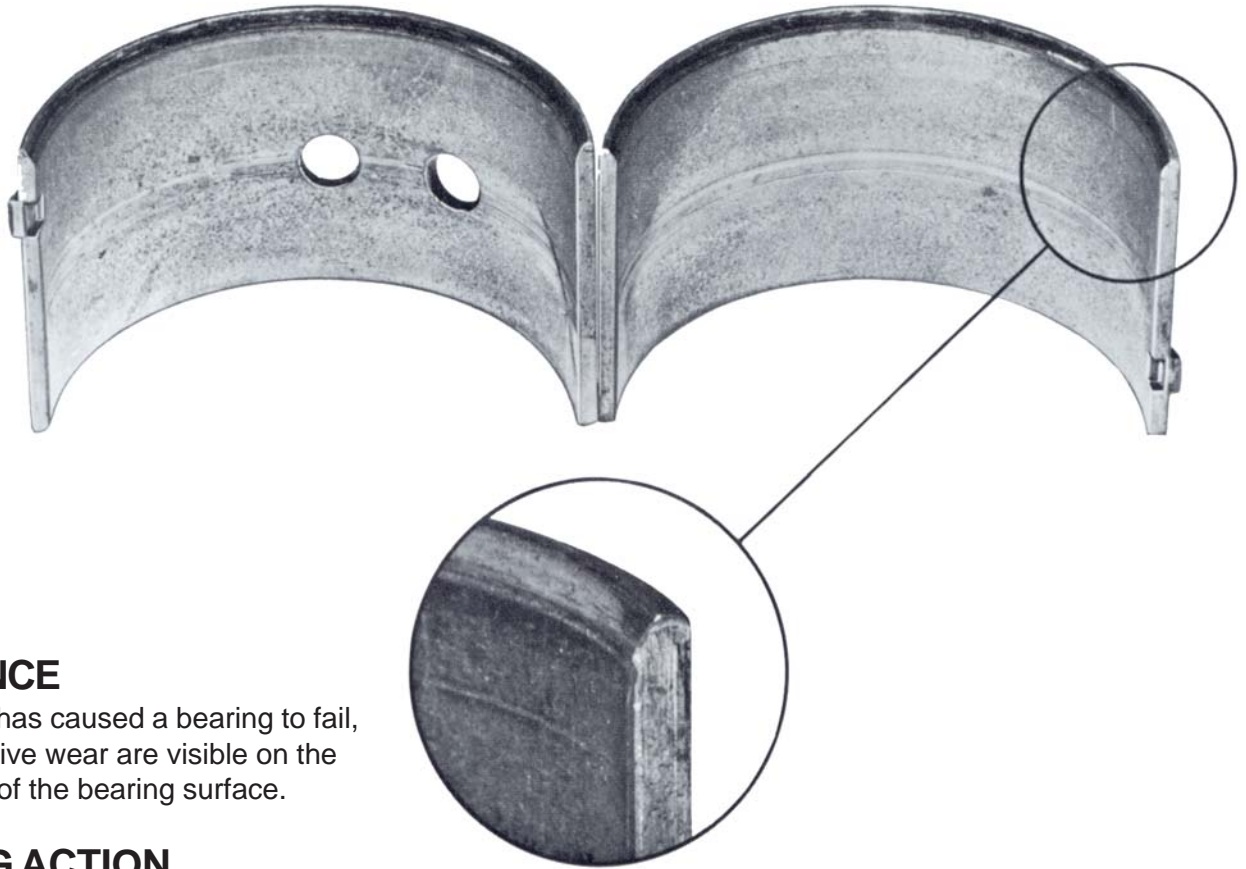
When fillet ride has caused a bearing to fail, areas of excessive wear are visible on the extreme edges of the bearing surface.

This metal-to-metal contact between the bearing and fillet causes excessive wear, leading to premature bearing fatigue.

1. Regrind the crankshaft paying particular attention to allowable fillet radii. **NOTE:** *Be careful not to reduce fillet radius too much, since this can weaken the crankshaft at its most critical point.*
2. Install new bearings with enlarged chamfers that allow proper fillet clearance.

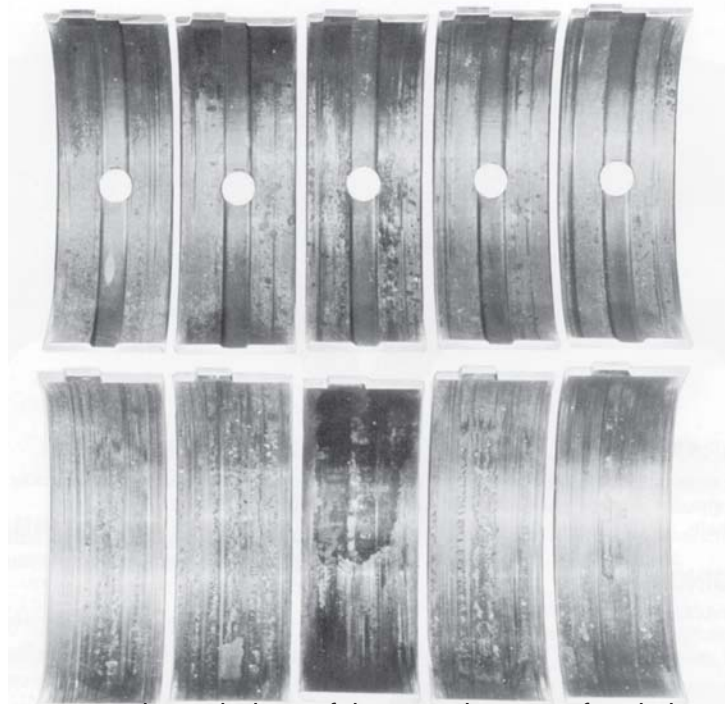
A wear pattern is visible on the upper or lower halves of the complete set of main bearings. The degree of wear varies from bearing to bearing depending upon the nature of the distortion. The center bearing usually shows the greatest wear.

A distorted crankcase imposes excessive loads on the bearings, with the point of greatest load being at the point of greatest distortion. These excessive bearing loads cause excessive bearing wear. Also, oil clearance is reduced and metal-to-metal contact is possible at the point of greatest distortion.

Alternating periods of engine heating and cooling during operation is a prime cause of crankcase distortion. As the engine heats the crankcase expands, and as it cools, the crankcase contracts. This repetitive expanding and contracting causes the crankcase to distort over time in some situations.

- Extreme operating conditions (for example “overheating” and “lugging”)
- Improper torquing procedure for cylinder head bolts, particularly with overhead valve V-8 engines

1. Determine if distortion exists by use of Prussian blue or visual methods.
2. Align bore the housing (if applicable).
3. Install new bearings.

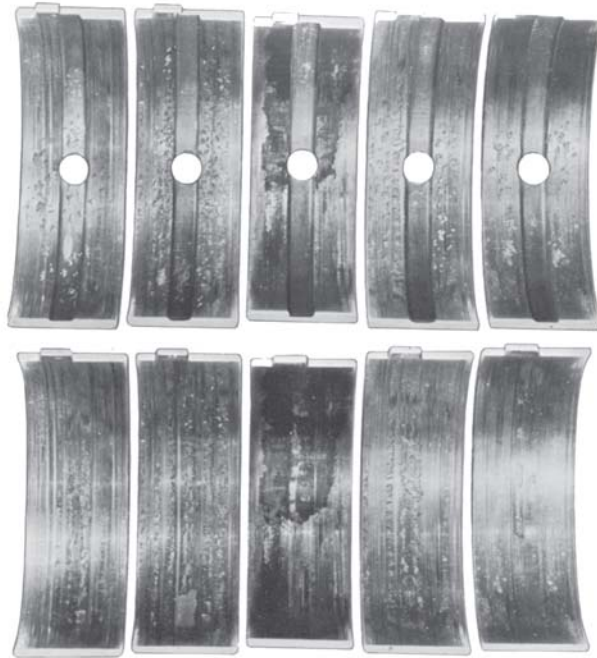
A wear pattern is visible on the upper and lower halves of the complete set of main bearings. The degree of wear varies from bearing to bearing depending upon the nature of the distortion. The center bearing usually shows the greatest wear.

A distorted crankshaft subjects the main bearings to excessive loads, with the greatest load being at the point of greatest distortion. The result is excessive bearing wear. Also, the oil clearance spaces between journals and bearings are reduced, making it possible for metal-to-metal contact to occur at the point of greatest distortion.

A crankshaft is usually distorted due to extreme operating conditions, such as “over-speeding” and “lugging”. It may also be caused by improper handling prior to installation.

1. Determine if distortion exists by means of prussian blue or visual methods.
2. Install a new or reconditioned crankshaft.
3. Install new bearings.

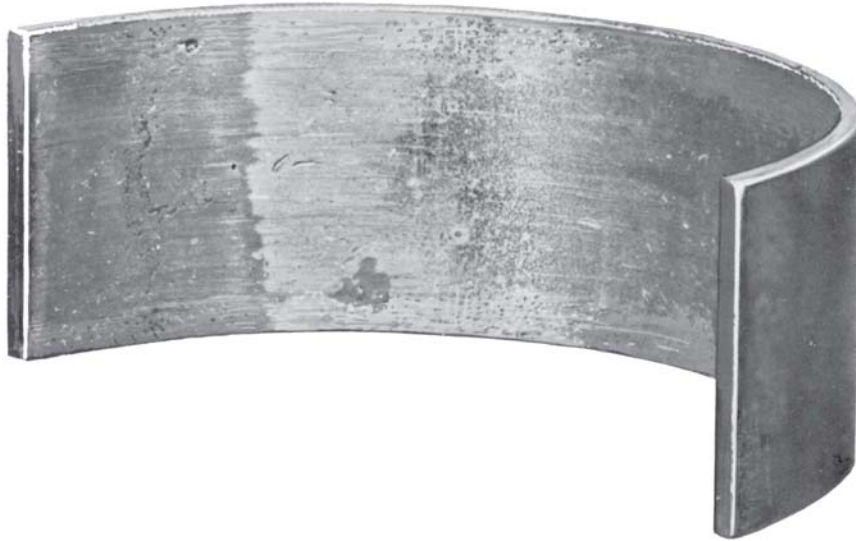
Localized excessive wear areas are visible near the parting line on both top and bottom shells.

Oil clearance near the parting line is decreased to such an extent that metal-to-metal contact between bearing and journal takes place, resulting in areas of above-normal wear.

Also, improper seating between the bearing back and the housing bore may be present which hinders proper heat transfer causing localized heating of the bearing surface and thus reducing fatigue endurance.

Alternating loading and flexing of the connecting rod can cause the bearing housing to become elongated. And because replacement bearing shells, when installed, tend to conform to the shape of the bearing housing, this can result in an out-of-round bearing surface.

1. Check the roundness of bearing housings before installing the new bearings. If they are found to be out-of-round, recondition the bearing housings (or replace connecting rod).
2. Check the journal surfaces for excessive wear and regrind if necessary.
3. Install new bearings.

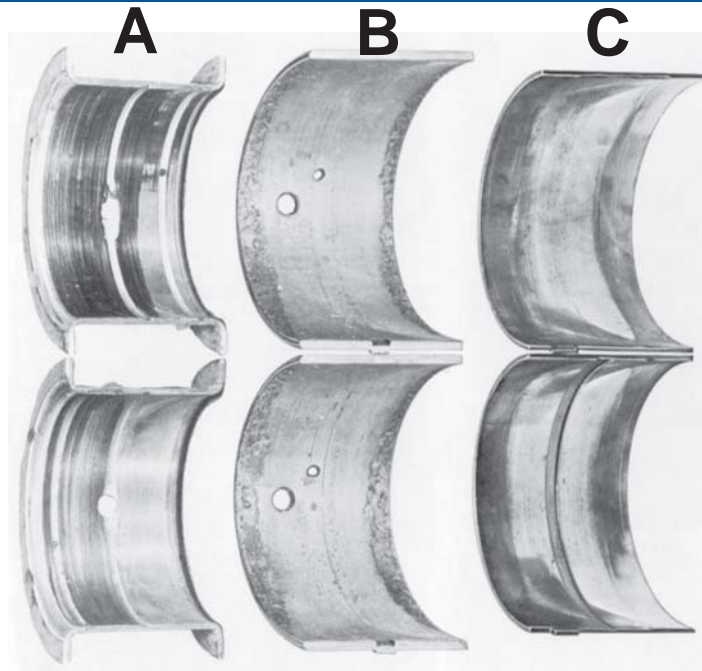
In general, if a bearing has failed because of an out-of-shape journal, an uneven wear pattern is visible on the bearing surface. Specifically, however, these wear areas can be in any one of three patterns: Photo A above shows the wear pattern caused by a **tapered** journal. Photo B shows the wear pattern caused by an **hour-glass** shaped journal. Photo C shows the pattern of a **barrel** shaped journal.

An out-of-shape journal imposes an uneven distribution of the load on the bearing surface, increasing heat generated and thus accelerating bearing wear. An out-of-shape journal also affects the bearing's oil clearance, making it insufficient in some areas and excessive in others, thereby upsetting the proper functioning of the lubrication system.

1. Uneven wear of the journal during operation (misaligned rod).
2. Improper machining of the journal at some previous time.

If the journal is **hour-glass** or **barrel** shaped, this is usually the result of improper machining or polishing.

Regrinding the crankshaft can best remedy out-of-shape journal problems. Then install new bearings in accordance with proper installation procedures.

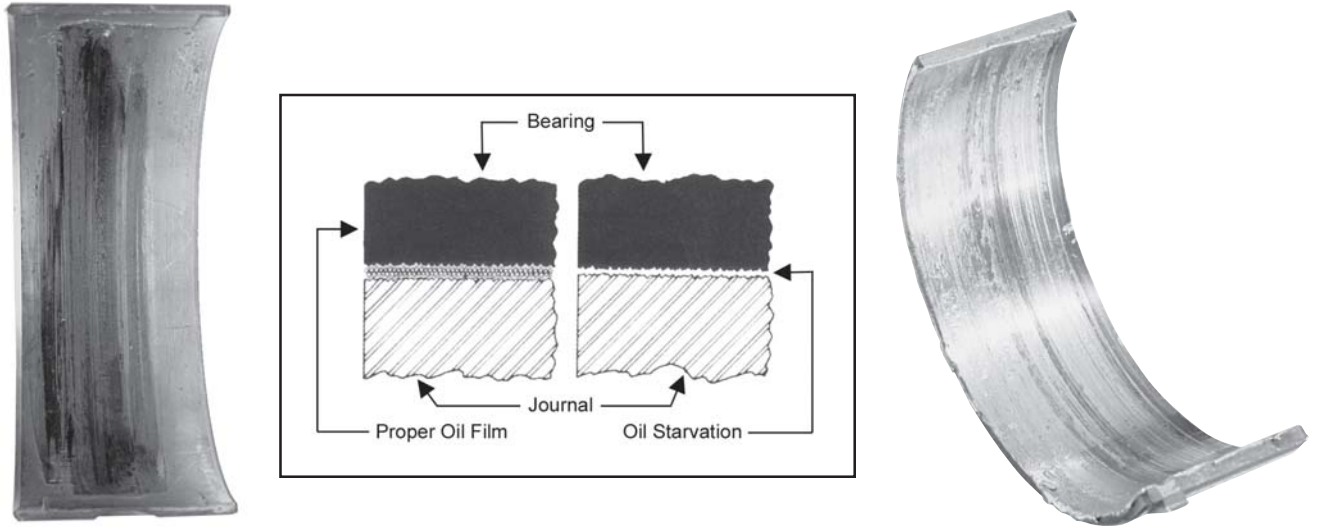
When a bearing has failed due to oil starvation, its surface is usually very shiny. In addition, there may be excessive wear of the bearing surface due to the wiping action of the journal. In the most severe cases the bearing surface will be smeared or scratched and torn. The bearing will begin to turn dark blue to black in color.

The absence of a sufficient oil film between the bearing and the journal permits metal-to-metal contact. The resulting wiping action causes premature bearing fatigue.

1. Insufficient oil clearance – usually the result of utilizing a replacement bearing that has too great a wall thickness. In some cases, the journal may be oversize.
2. Broken or plugged oil passages, prohibiting proper oil flow.
3. A blocked oil suction screen or oil filter.
4. A malfunctioning oil pump or pressure relief valve.
5. Misassembling main bearings metering off an oil hole.
6. Lubrication system not primed before start up.

1. Double-check all measurements taken during the bearing selection procedure to catch any errors in calculation. (During assembly check oil clearance with Plastigage[®].)
2. Check to be sure that the replacement bearing you are about to install is the correct one for the application.
3. Check the journals for damage and regrind if necessary.
4. Check engine for possible blockage of oil passages, oil suction screen and oil filter.
5. Check the operation of the oil pump and pressure relief valve.
6. Be sure that the oil holes are properly indexed when installing the replacement bearings.
7. Advise the operator about the results of engine lugging.
8. Always prime the lubrication system before the engine is started the first time.

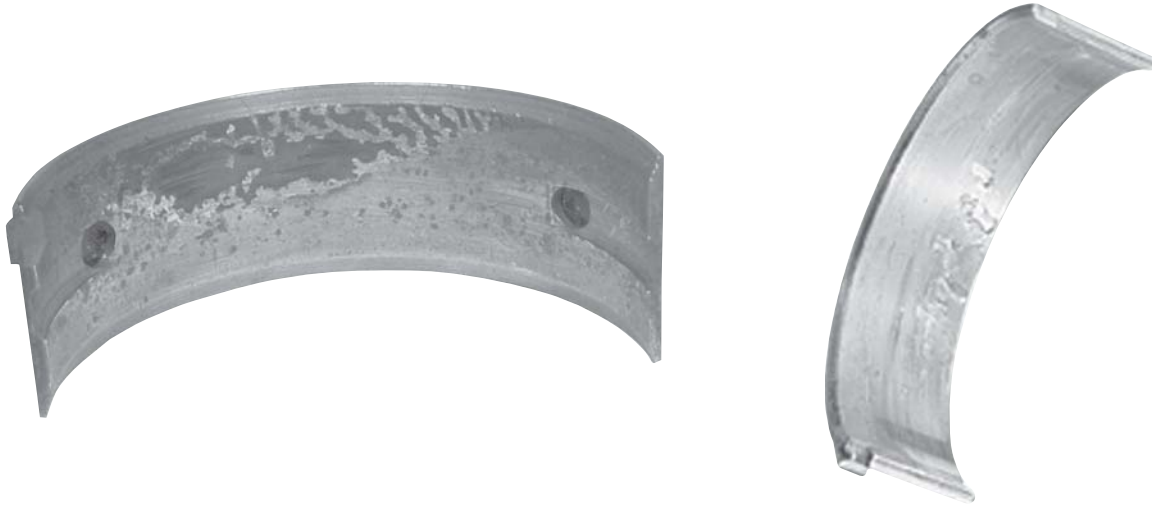
Bearing surface cracked, small irregular areas of surface material missing from the bearing lining.

Heavy pulsating loads imposed upon the bearing by reciprocating motion within the engine cause the bearing surface to crack due to metal fatigue.

Fatigue cracks widen and deepen perpendicular to the bond line. Close to the bond line, fatigue cracks turn and run parallel to the bond line, eventually joining and causing pieces of the surface to flake out.

1. Overloading (lugging, detonation, or overfueling).
2. Uneven loading (see sections on misalignment).
3. Bearing material of inadequate fatigue strength for application.
4. Bearing failure due to surface fatigue can be the result of the normal life span of the bearing being exceeded.

1. If the service life for the old bearing was adequate, replace with the same type of bearing to obtain a similar service life.
2. If the service life of the old bearing was too short, replace with a heavier duty bearing to obtain a longer life.
3. Replace all other bearings (main connecting rod and camshaft) as their remaining service life may be short.
4. Recommend that the operator avoid "hot rodding" and "lugging" as these tend to shorten bearing life.
5. Check for misassembly. Use proper installation techniques.

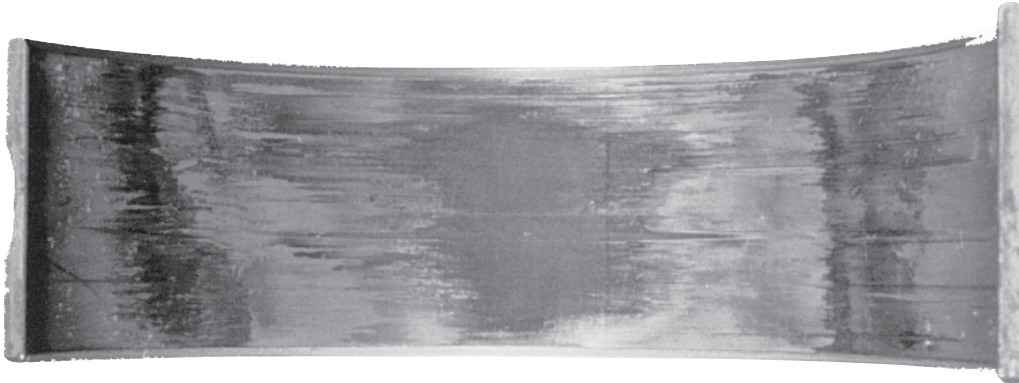
Bearing surface darkened, spongy, etched by chemical attack.

This is usually the result of contamination of the oil from either the fuel system or internal engine leaks. This condition is further pronounced when there is poor routine maintenance.

1. Identify and correct source of contamination.
2. Install new bearings using correct installation procedures.
3. Use a better quality fuel, if possible.
4. Oil should be changed at recommended intervals using the proper grade and rating. In some applications oil analysis may be needed to determine the optimum oil change intervals.

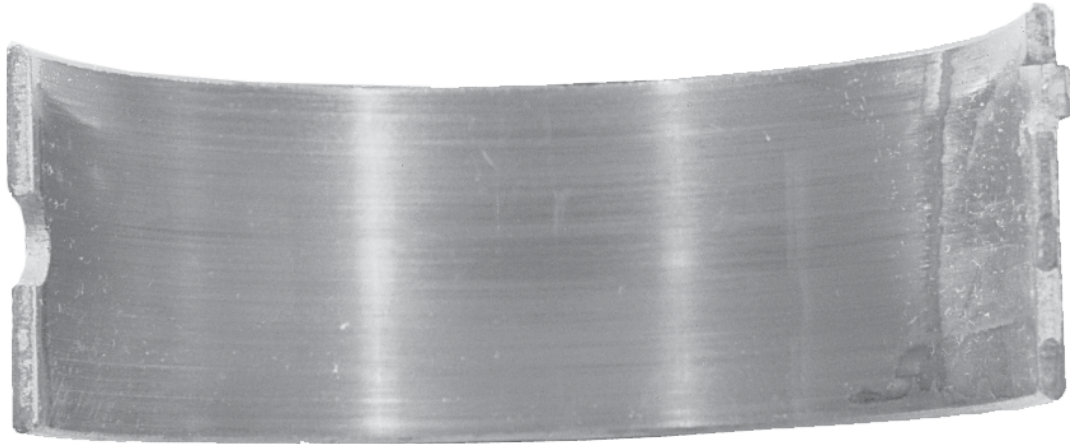
Wall thickness reduced from original dimension. Bearing surface worn and polished but not smeared, torn or scored. No evidence of heat, no embedded foreign particles.

Grinding and polishing the crankshaft journals produce burrs that are so small that we can't see or feel them. Not only is it important that the surface finish meet recommended average Ra or better, but it is also important to always grind opposite to rotation and polish in the direction of rotation. Otherwise it is possible for these microscopic burrs to disrupt the oil film and abrade away the bearing surface.

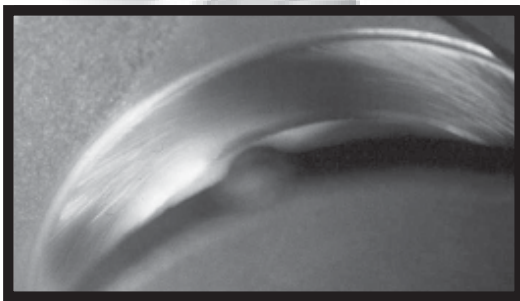
AVOID - SWIRL PATTERN

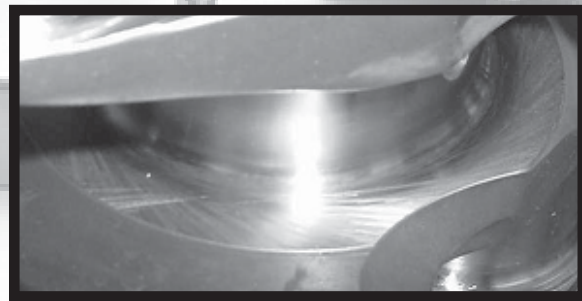
AVOID - CROSSHATCH PATTERN
