INTERNATIONAL COUNCIL ON COMBUSTION ENGINES

Field experience with the MWH ReliaValve with Sentry Rotator: a 2-Stroke exhaust valve with demonstrated time between overhauls (TBO) of over 5 years.

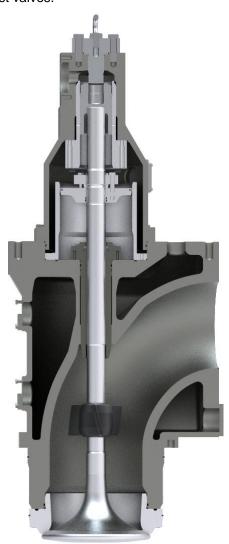
Figure 1: Typical 2-stroke engine exhaust valve
