Service Experience

The present paper gives an update on how the latest generation of MC and MC-C low speed engines, i.e. those having entered service after 1997, are performing. The major development steps are shown in Fig.1, which includes the engines of the recent new breed of large container vessels that have attracted special attention in the marine market, and therefore the large bore main engines of our range in these vessels will be dealt with in this paper.

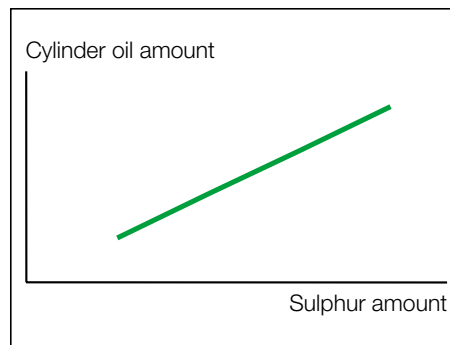
Fig. 4: Cylinder oil amount proportional to sulphur amount entering the cylinders (basic principle of Alpha ACC)

The principle of the Alpha ACC is shown in Fig. 4. The cylinder oil amount is controlled so that it is proportional to the amount of sulphur entering the cylinder with the fuel (the "Sulphur throughput").

The implementation of the above two criteria will lead to an optimal cylinder oil dosage, proportional to the amount of sulphur entering the cylinders, but with a low minimum setting to ensure lubrication.

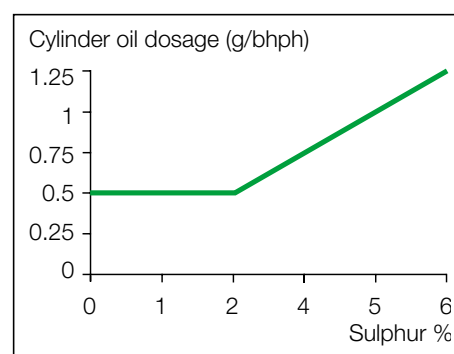
Fig. 5: Cylinder oil dosage proportional to sulphur percentage in the fuel

Fig. 5 shows control of cylinder oil dosage proportional to the sulphur percentage in the fuel. A minimum dosage of 0.5 g/bhph is indicated, based on experience so far. This minimum value is preliminary and, given the efficient lubrication achievable with the Alpha Lubricator system, we expect to be able to further reduce this minimum value in the future.

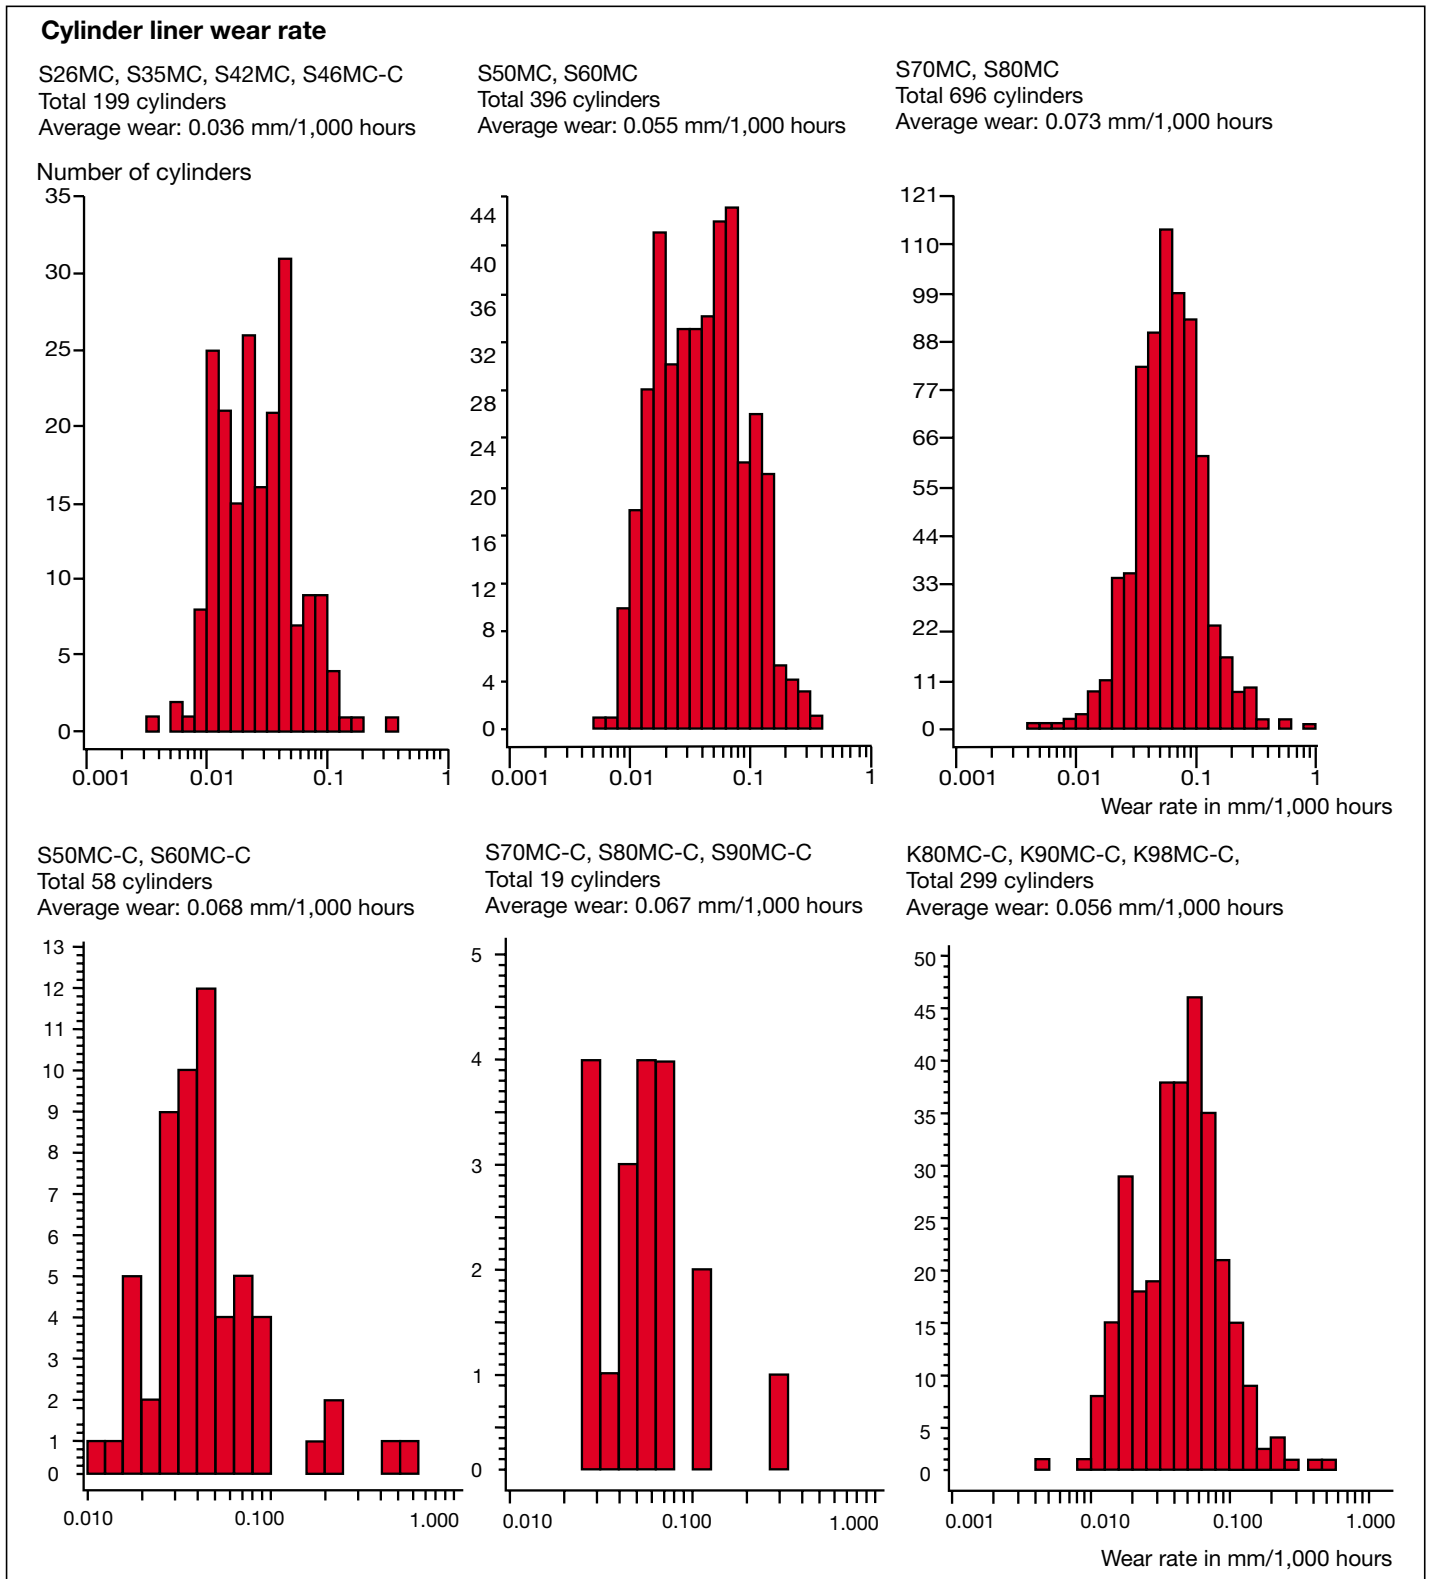
Fig. 7: Extracts from our database regarding cylinder wear rates

Fig. 7 shows extracts from our database regarding cylinder wear rates.

S-MC engines, S-MC-C engines and K-MC-C engines all experienced low and uniform wear rates.

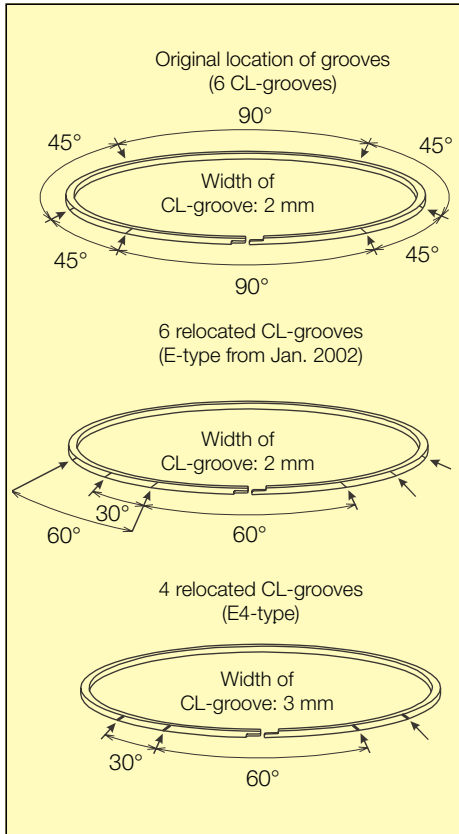
Fig. 8: K98 CPR piston ring development

On the K98 engines, as mentioned above, the cylinder condition has been good, with very low wear rates and low cylinder oil feed rates. However, on these engines the good condition has been temporarily overshadowed by a number of failures of the top piston ring. Though there are strong indications of this being a production-related issue, the top ring design has been upgraded to increase the safety margin against

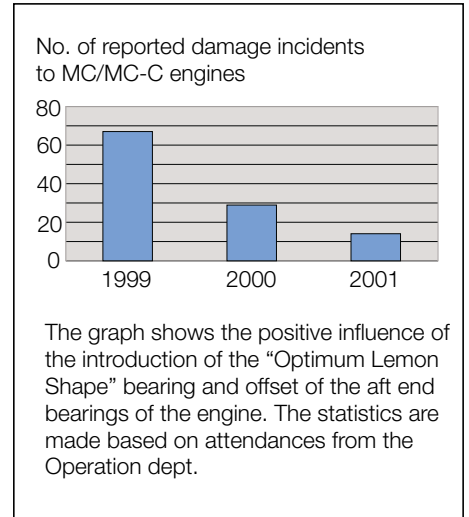
Fig. 10: Bearings – statistics

There has been a significant reduction in the number of main bearing failures, as will appear from Fig. 10. However, it must be acknowledged that main bearing damage sometimes still does occur, e.g. due to poor bonding of the bearing metal.

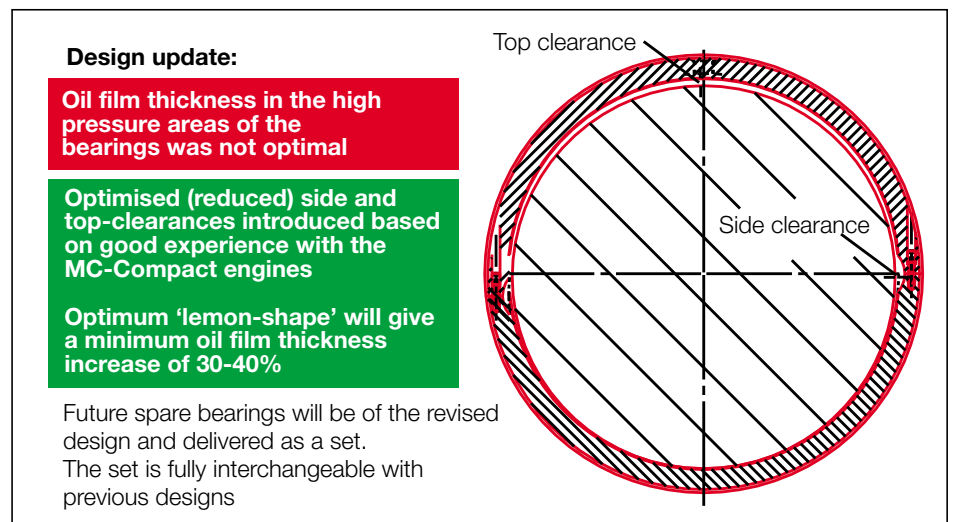
Optimum Lemon Shape (OLS) bearing with flexible edges

Fig. 9: Main bearing, thick shell design

As an evolution of the Mark 5 bearing type, the “Optimum Lemon Shape” type main bearing was introduced, see Fig. 9. This type features optimised (reduced) top and side clearances. Service experience has confirmed the efficiency of this bearing type simply by the significantly reduced number of reported damage incidents.

The flexibility has been achieved by removing the contact between the shell and bedplate at the end portions of the shell. The unsupported width of the shell is equal to the shell thickness. Apart from the flexible edges, the properties of the bearing are similar to those of the Optimum Lemon Shape type. This design provides a larger safety margin in the event of geometrical non-conformities.

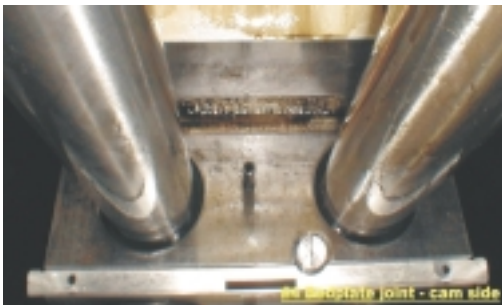
Fig. 11: Thin shell AlSn40 main bearing

7K98MC main bearing No. 4 after 6,000 hours
No remarks – except for minor traces of dirt

Service experience with this configuration has been excellent, see Fig. 11.

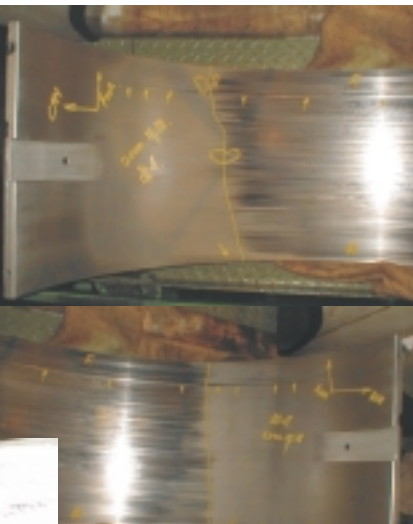
Fig. 12: K98MC-C white metal main bearing

On the large bore engines, the bearings are lined with white metal, see Fig. 12.

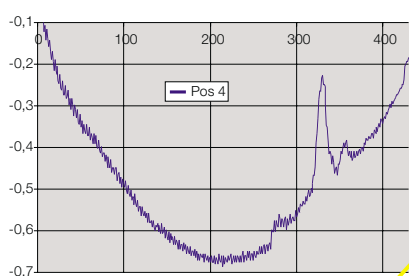
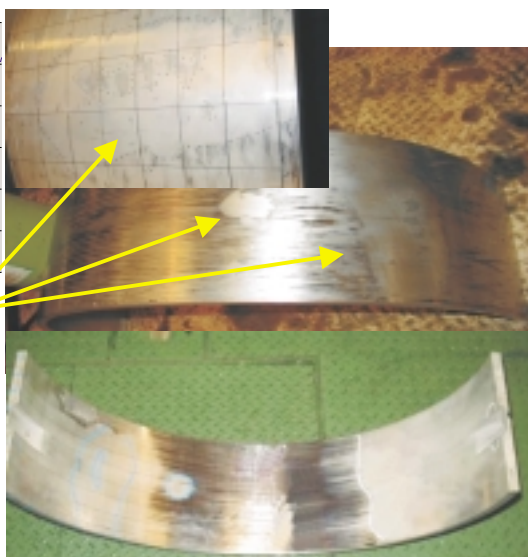
Large rectified area – missing contact between shell and support. Maximum depth of rectified area 0.20 mm

Fig. 13: Weld-rectified bearing support

- Following Q/A inspections, weld rectification of bearing saddles has occasionally been carried out during the production of the engine. In a few cases, these welds have been introduced at a late stage (after final machining). This has provided either high spots on the running surface of the bearing shell or areas with missing contact. Both could disturb the oil film, leading to high local load, and thus fatigue damage, see Fig. 13. Countermeasures introduced have been either adaptation of the running surface of the bearing shell by means of scraping or the introduction of bearings with AlSn40 lining, offering an increased margin against fatigue

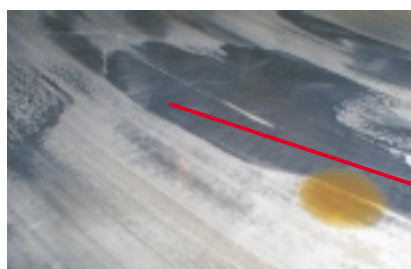
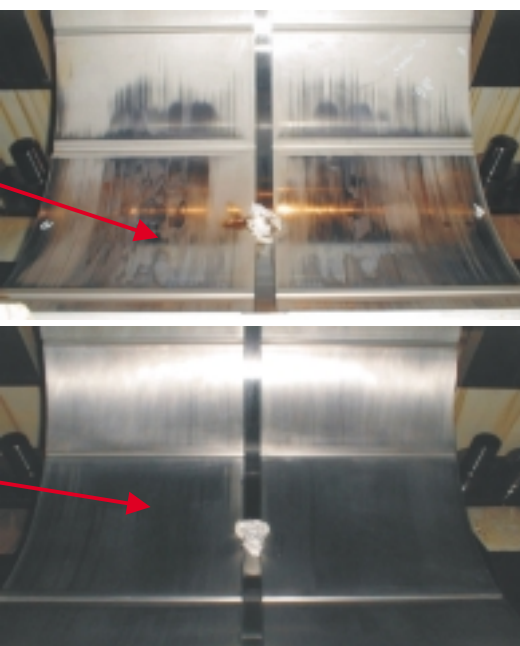
S90MC-C crosshead # 6 (3,500 hours) before dressing up. Note that the lead overlay apparently has a tendency of non-conformity. In this case the problem is only cosmetic

S90MC-C crosshead # 6 (3,500 hours) after dressing up

Fig. 14: S90MC-C crosshead bearing

In general, the crosshead bearings in both MC and MC-C engines perform very satisfactorily, but cases of wiping have been observed. In itself, this wiping is of a cosmetic nature, but it can sometimes cause blockage of the oil-wedges that normally build up the oil film to the “pads” inside the bearing, see Fig. 14. Disturbance of the oil film build-up inside the bearing could result in slight fatigue damage just behind the blocked area of the oil-wedge. If the phenomenon is observed at an early stage during inspections, the problem is solved by removing the wiped lead from the oil-wedge.

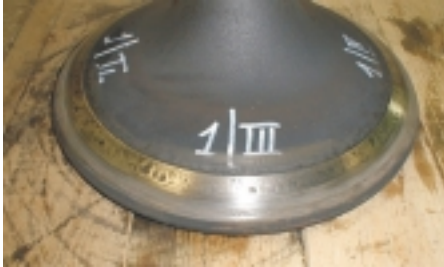
Fig. 15: Nimonic valve normal condition, after 11,500 running hours

Nimonic spindles are well accepted now that the operators have become acquainted with the long-lasting seat performance despite dent marks, see Fig. 15. Nimonic spindles are standard for 50MC and for 60MC/MC-C upwards, and Stellite spindles are standard for smaller engines.

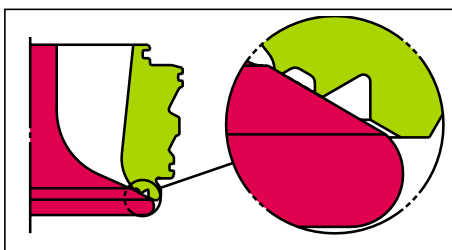
Fig. 16: W-seat, exhaust valve

lifetime was by altering the seat geometry of the bottom piece to the patented W-seat, see Fig. 16. On a few S50MC-C engines with Al50 spindles, the results were remarkably better using the W-seat, which is now standard on all MC/MC-C engines. When using the new type of slide fuel valves as well, the result is even better.

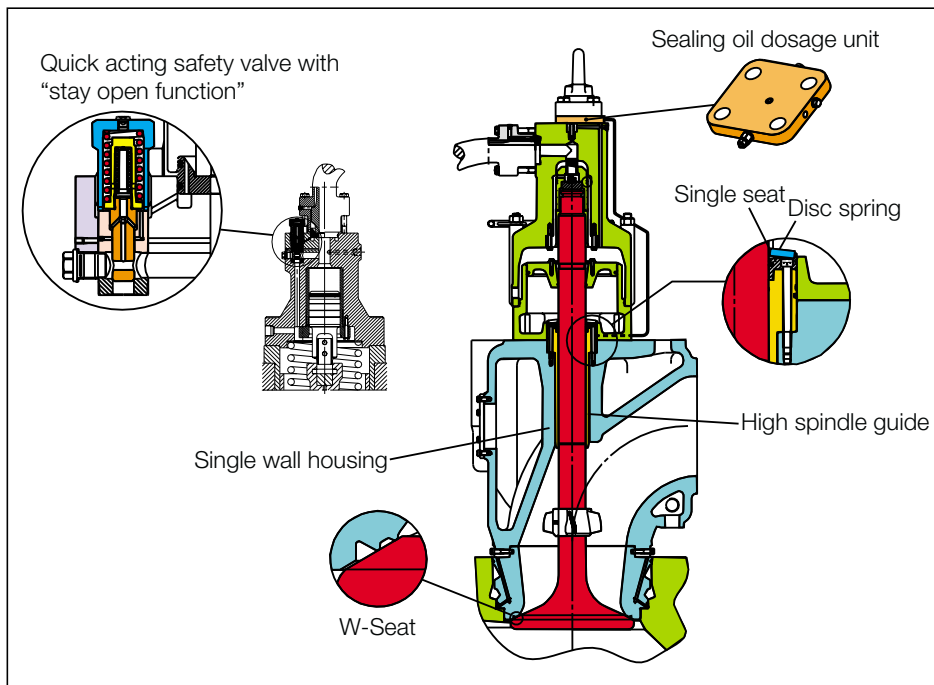
Fig. 17: Exhaust valve, 80-90MC

Unfortunately, a few cases of damaged exhaust valves and camshaft sections have been reported, due to different external factors, including insufficient release action of the safety valve. Consequently, the safety valve has been re-designed. Once activated, it implements a special function to keep it open for about 20 seconds. Furthermore, a disc spring has been introduced in the exhaust valve on top of the spindle guide to avoid damage to the air piston in the event of 'over-shoot'/extended lift of the valve spindle. This has eliminated the problem. Fig. 17 shows the various design details mentioned.

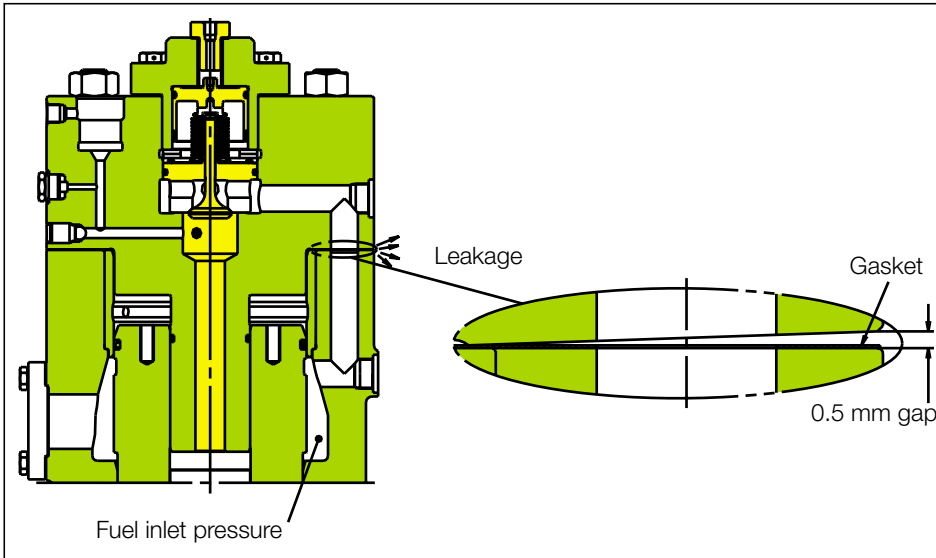
Fig. 18: Fuel pump top cover leakage

On K98MC/MC-C and S90MC-C, leakage has been seen between fuel pump housing and top cover. One problem was related to production tolerances, as a gap of up to 0.5 mm was found between the pump housing and the top cover, see Fig. 18. However, leakage has been experienced even in cases where the machining was correct. Therefore, a new type of gasket has been introduced. The primary sealing is

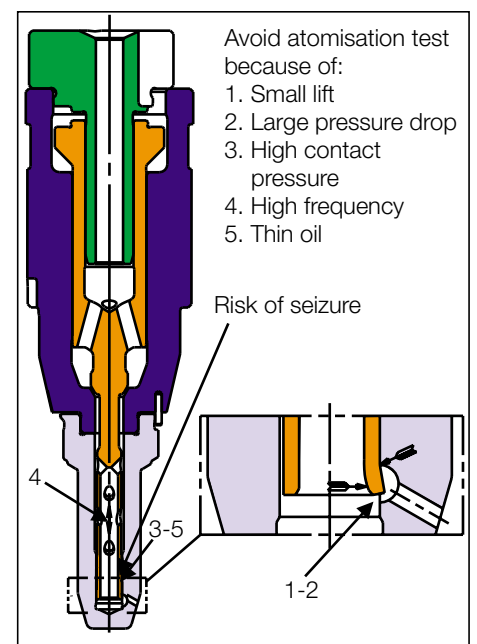
Fig. 20: Slide valve pressure testing

probably because of the difference, in some cases been misinterpreted by the operators. Slide fuel valves must be disassembled and cleaned before pressure testing, and an atomisation test must not be performed on slide fuel valves. The cleaning is necessary because the cold and sticky heavy fuel oil, in combination with the very small clearance between the cut-off shaft

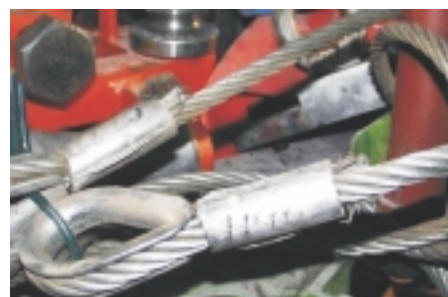
Fig. 21: Wire ends with strands of wire sticking out

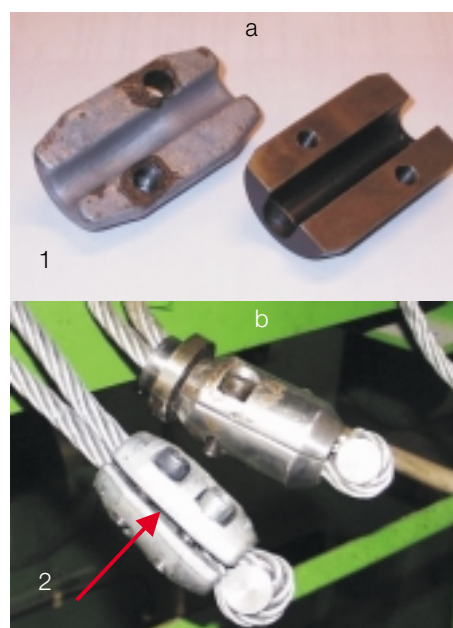
Fig. 22: Wire-locks

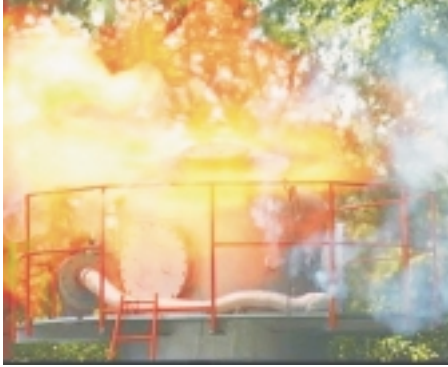
Fig. 23: Testing of a non-functioning crankcase relief valve

In the past, reliance was placed on specifying safety equipment that had been type approved by the classification societies. However, type approval is not sufficient as it only comprises the checking of the opening pressure of the relief valve.

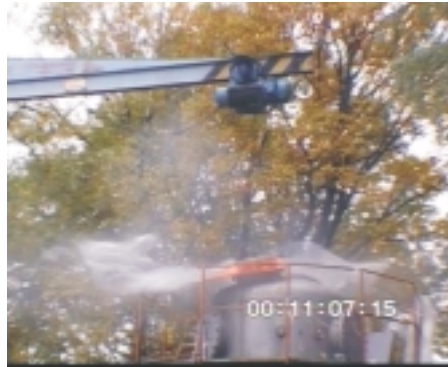
Fig. 24: Testing of an approved type of crankcase relief valve

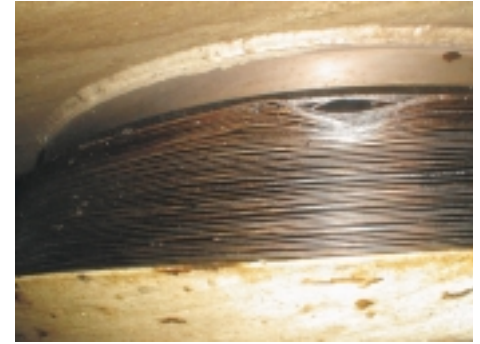
Fig. 25: Deformation of flame arrester

If the oil mist meets a hot spot, it can be ignited. Therefore, it is important to keep the insulation around the exhaust pipes in good condition. Of course, the largest risk of igniting the oil mist would be if the flame arrester on the relief valve does not function properly.
