Service Experience

Two-stroke Engines

MAN Diesel & Turbo

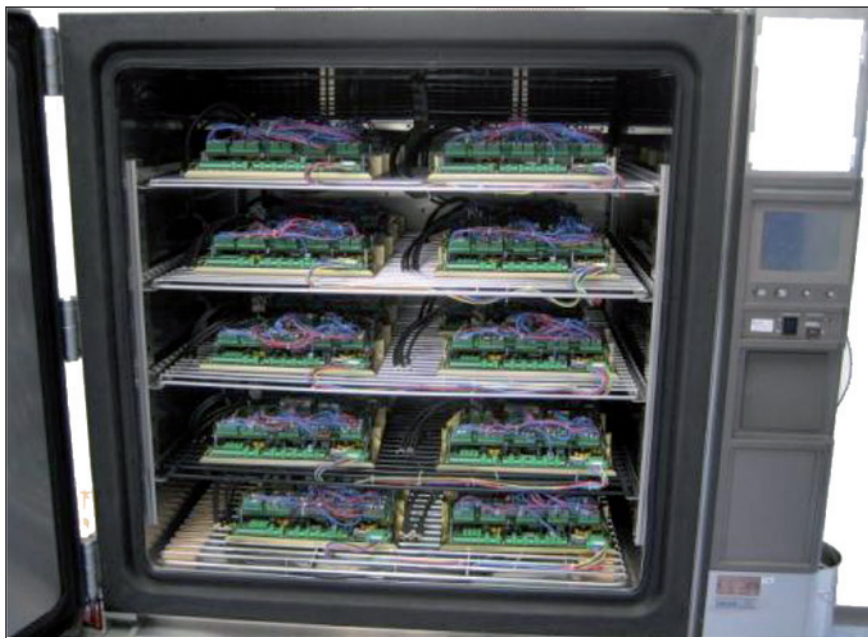
Fig. 1: Burn-in test of MPCs

various temperatures. In this way, also weak MPC's are sorted out. This test will typically run over a 14-hour period, see Fig. 1.

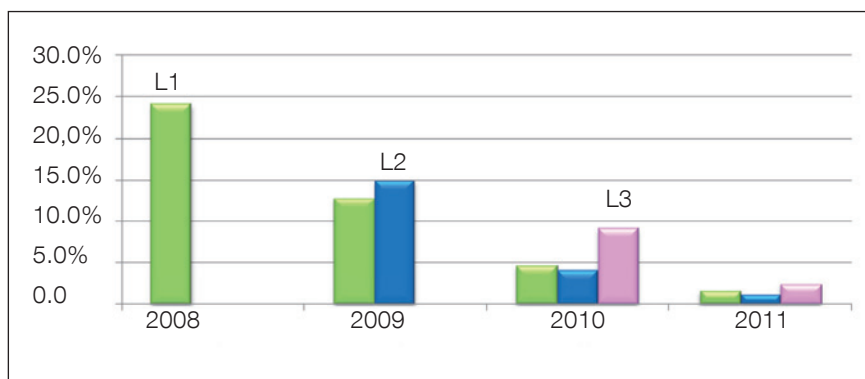
Fig. 2: Return rates of MPCs from our EMS provider

As mentioned above, the MPC is one of the components for which too high return rates have been reported. Reports from one Asian electronics manufacturing services (EMS) provider indicate that these return rates are now under control, see Fig. 2. L1, L2 and L3 are three different engine builders.

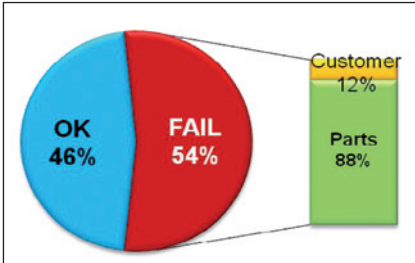
Fig. 3: Analysis of returned parts

The same EMS provider has analysed the returned MPCs and found that nearly half of them had no failures, see Fig. 3. Also, we have often received back electronic and electro-hydraulic parts that had no failures when checked in our laboratory. The reason for this is often a poor possibility of doing qualified troubleshooting when a failure has been experienced on board a vessel with an ME engine. The initial versions of the ECS software did not give the crew on board many possibilities for locating the failing electronic or electro-hydraulic part. In many cases, this has resulted in the return of parts which had no failures.

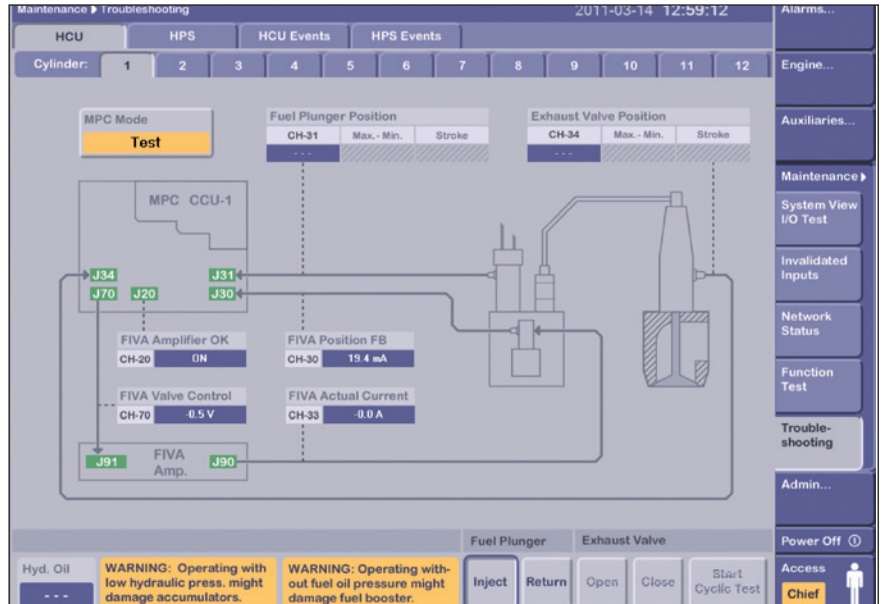
Fig. 4: HCU troubleshooting screen

Examples of troubleshooting screens and data-logger screens are seen in Figs. 4 and 5. Fig. 4 shows the troubleshooting screen for the hydraulic cylinder unit (HCU), and Fig. 5 shows the data-logger screen for the HCU, the so-called “HCU Events”. The data-logger continuously records predetermined signals related to each HCU at high frequency (2 kHz), and storage is triggered by an event, typically an alarm. Data from just before the event and from just after the event can then be analysed on board, exported to Excel and further analysed on board or ashore.

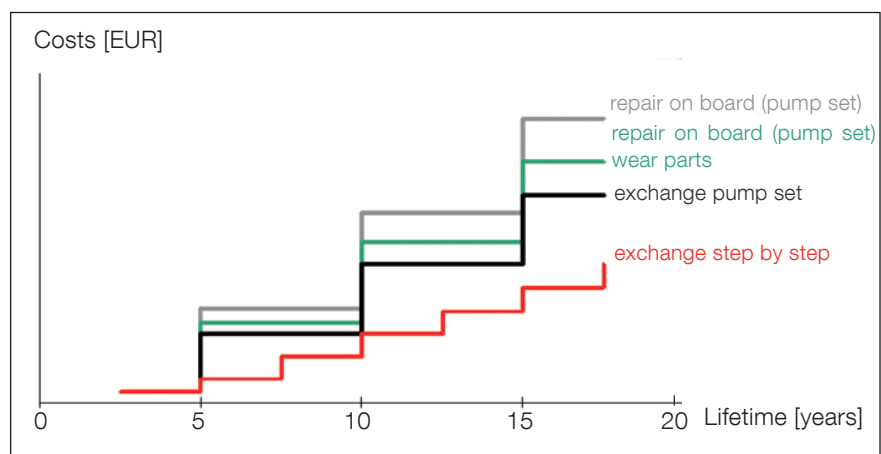
Fig. 6: Alternative overhaul strategies for main hydraulic pumps for ME engines

Recent experience with the main hydraulic pumps indicates that more than 32,000 hours between major overhaul can be obtained. This will require inspection on board to evaluate the wear condition of one of the pumps and then set up a sequential overhaul of the pumps one by one. Fig. 6 shows the

original overhaul regime (black) compared with the latest “step-by-step” approach (red).

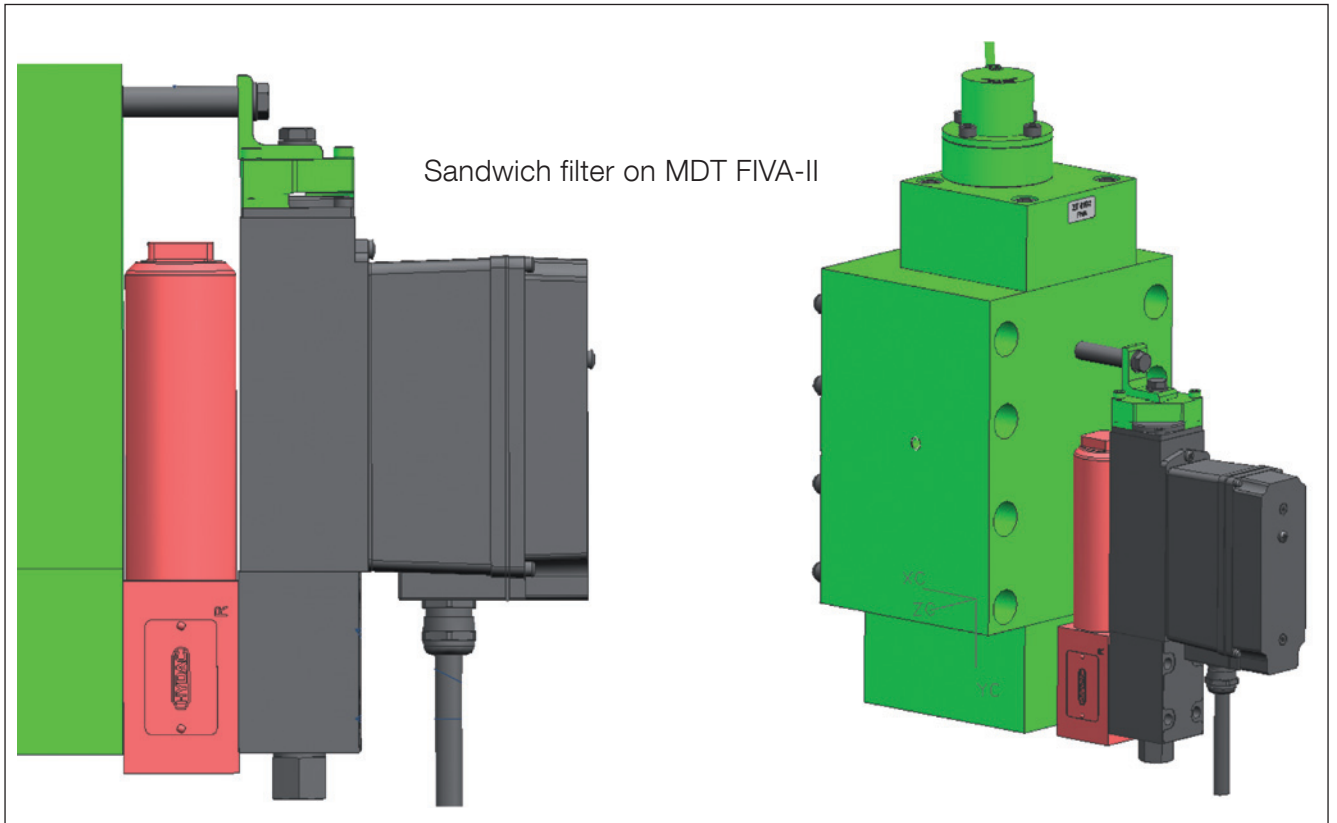
Fig. 7: MDT FIVA valve with sandwich filter mounted

Another central part of the ME system is the fuel injection valve actuation (FIVA). For the FIVA valve, we also state 32,000 hours between overhauls. In order to reach this interval, we need to protect the pilot valve from dirt in the hydraulic oil during commissioning. We are presently testing so-called sandwich filters installed during commissioning at the engine builder and at the

shipyard. These filters will be dismantled before vessel delivery. In this way, we will be able to obtain 32,000 hours between exchange of the pilot valve. The pilot valve can be exchanged on board by the ship's crew. Fig. 7 shows the FIVA valve with a sandwich filter installed. The main valve is green, the sandwich filter is red and the pilot valve is dark grey.

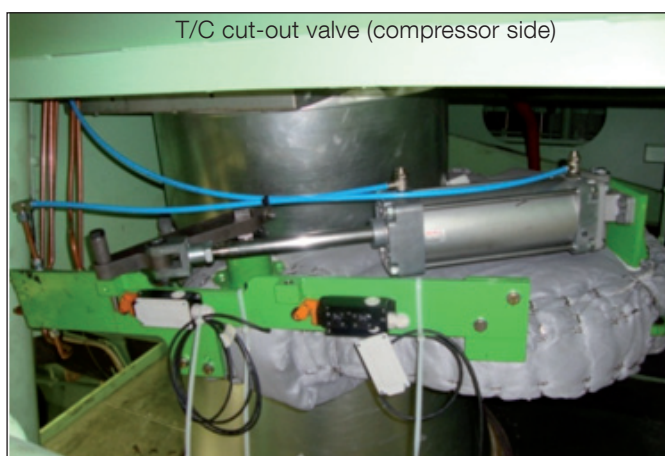
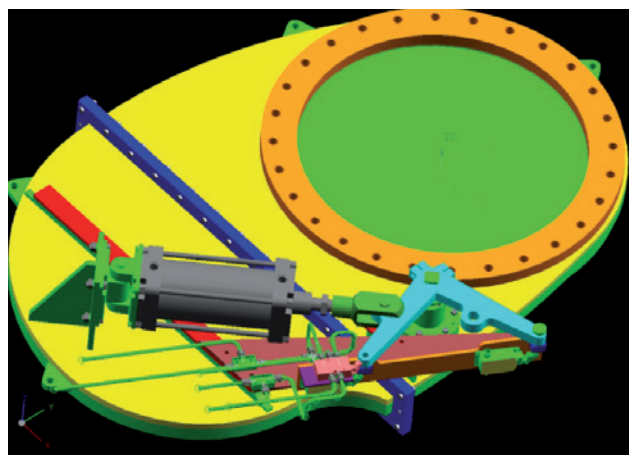
Fig. 8: Swing gate valve for flexible T/C cut-out

For engines in service, the flexible turbocharger cut-out system with control of the so-called swing gate valves has become a retrofit solution often applied on engines with two, three or four turbochargers. Fig. 8 illustrates this design, in principle and in reality, on the compressor side of a K98ME engine. Fig. 9 indicates how the T/C cut-out mode is implemented with a separate view on the MOP.

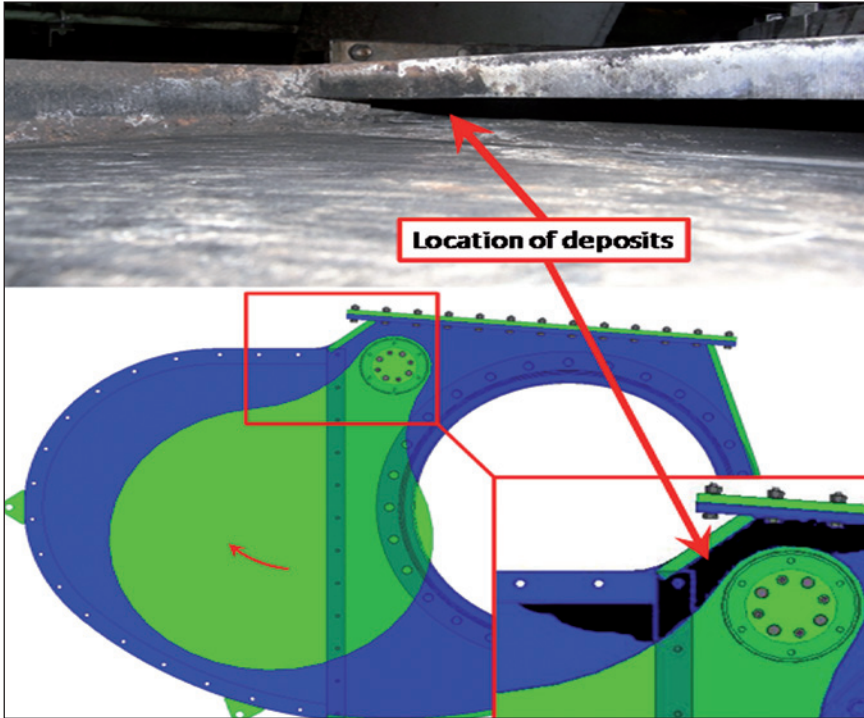
Fig. 10: Carbon deposits on the swing gate valve on the turbine side

For the swing gate valve on the turbine side, accumulation of combustion deposits has been seen as shown in Fig. 10. Cleaning instructions have therefore been included in the service manual to ensure the correct functioning of the valve.

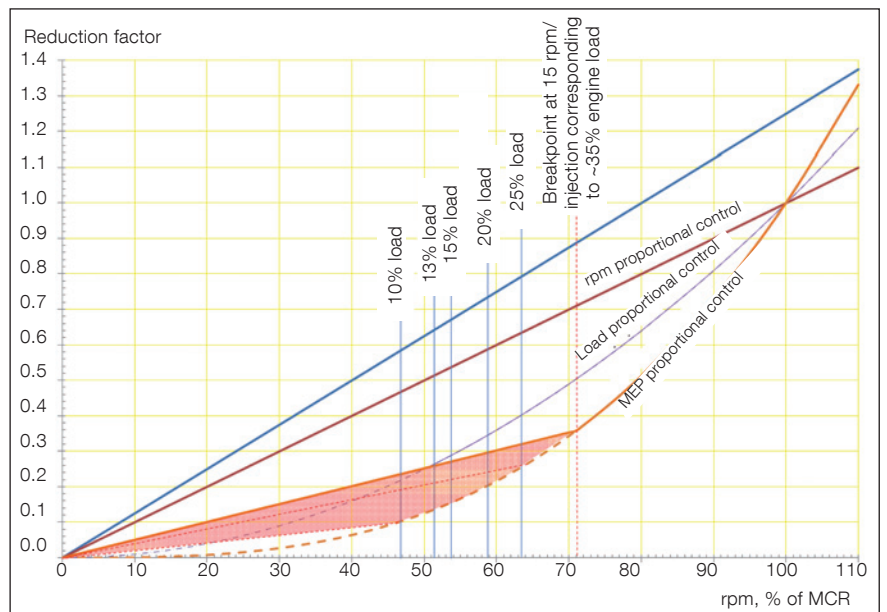
Fig. 11: Cylinder oil feed rate reduction with breakpoint at various loads

tested this on several engines with very good results, running load-proportional lubrication reduction of the cylinder oil feed rate all the way down to 10% load. In this way, it is possible to save half the cylinder oil at loads in the range of 10-15%. This is illustrated in Fig. 11.

For ME engines, this changed adjustment can be accomplished simply by making parameter changes in the ME ECS software. For mechanical engines with Alpha Lubricators, rebuilding of the lubricators is required.

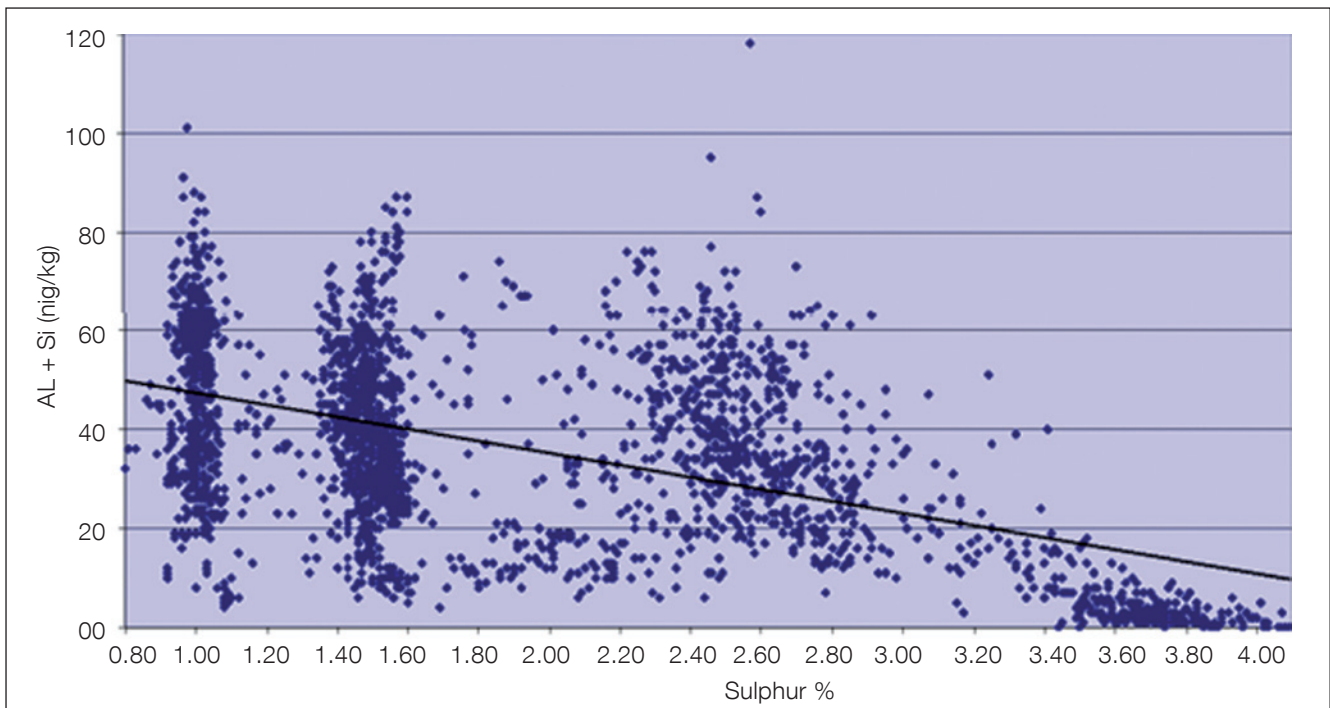
Fig. 12: Cat fines in bunker fuel (source: DNVPS)

For low-sulphur HFOs, the most important issue is the increased number of catalytic fines seen in average when bunkering HFOs with a low sulphur content, see Fig. 12. This fact will put even more focus on optimal fuel treatment on board vessels with efficient use of the purifiers installed.

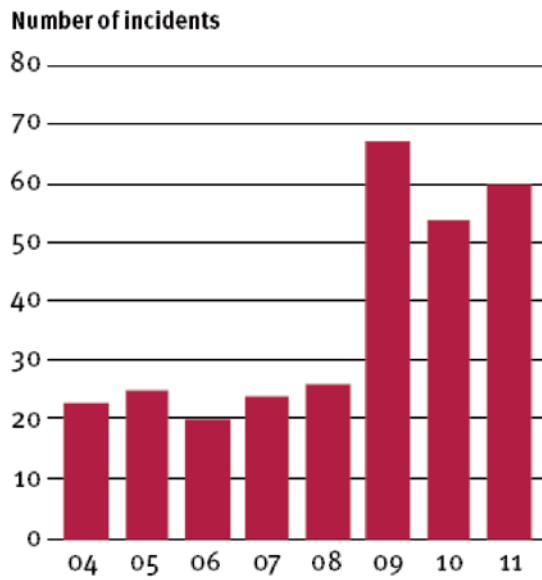
Fig. 13: Loss of propulsion incidents – California Ports. In 2009, a cap on fuel sulphur content was introduced in California waters

LOSS OF PROPULSION INCIDENTS January 2004 to August 2011

It should be mentioned that not one single incident of fuel switching LOP has been recorded with our ME engines whereas other types of electronically controlled engines are represented.

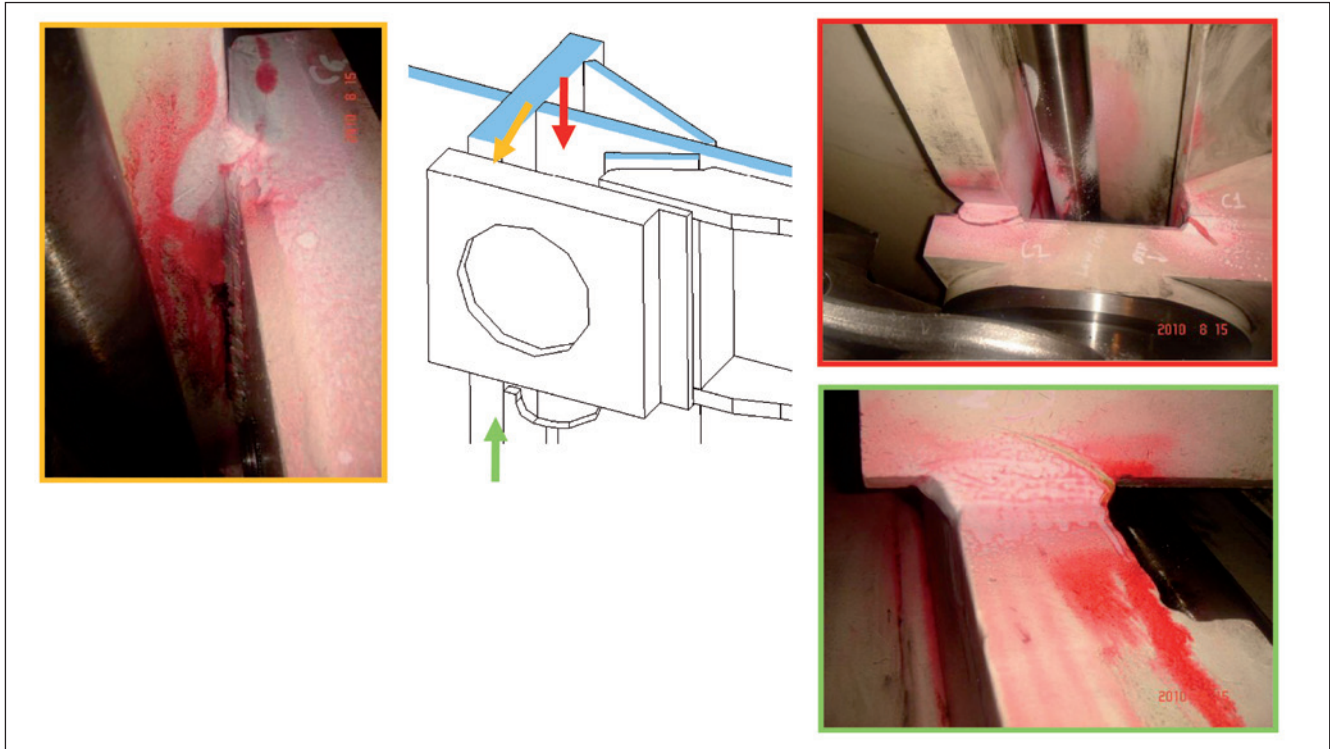
Fig.14: Example of crack in bracket carrying a second order moment compensator

The biggest single guarantee case ever in relation to MAN B&W two-stroke engines is the second order moment compensator bracket crack case. Fig. 14 shows a typical crack. When this case was discovered for 60/70ME-C/MC-C engines in late summer 2010, we immediately communicated this to all licensees involved. We also took immediate initiative to perform a design review, and based on this review, we subsequently updated the design with an action code covering all engines not yet delivered. In cooperation with all licensees involved, and with the assistance of especially PrimeServ-Korea, we managed to avoid putting further vessels in service without the updated design. The previous and updated designs are shown in Fig. 15.

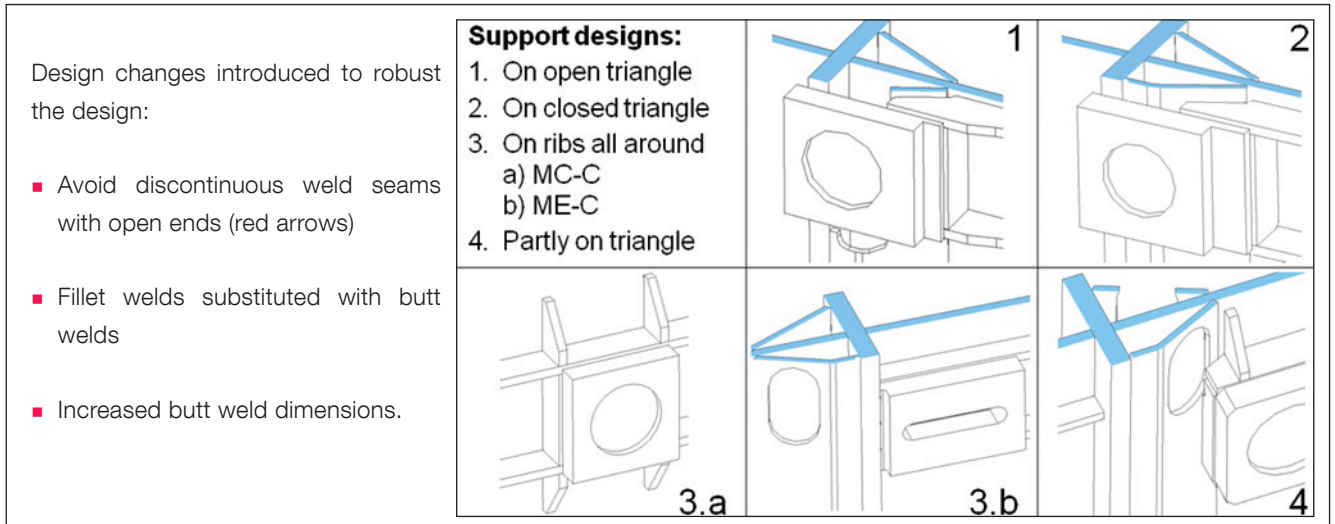
Fig. 16: Design variants in service

At the end of 2011, we were ready to slightly modify our plan of action for the update of engines in service. In another Circular Letter, the designs were categorised in four variants, see Fig. 16.

Based on feedback from service, we now concentrated preventive rectification on variant No. 1, support on open triangle. The 2011 Circular Letter also specified an inspection scheme for the first 18,000 hours of operation. There is no need for rectification (also for design variant No. 1) after 18,000 hours of operation without crack formation. We also specify inspections during the first 18,000 hours after a welding rectification in order to ensure that the rectification has been successful.

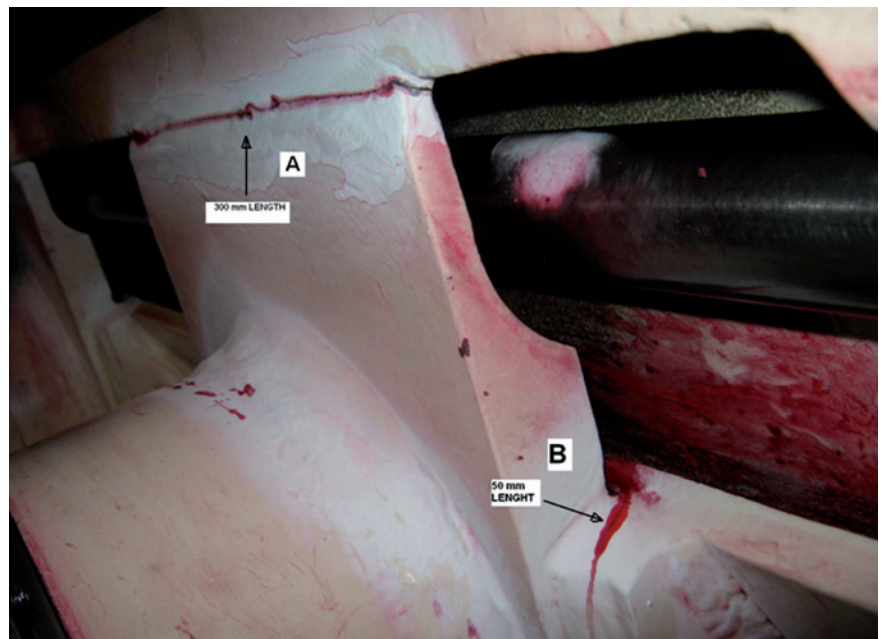
Fig. 17: S50MC-C: crack in second order moment compensator bracket

At the beginning of 2012, we discovered cracks in the second order moment compensator bracket on an S50MC-C engine type. Fig. 17 shows an example of these. The designs of the S50MC-C and S46MC-C engines had already been updated in June 2011 based on experience gained in the meantime with 60 and 70-cm bore

Therefore, a new design update note (DUN) with a harder action code has been released, specifying modification instructions for all S46/50MC-C/ME-C under production. At the time of writing,

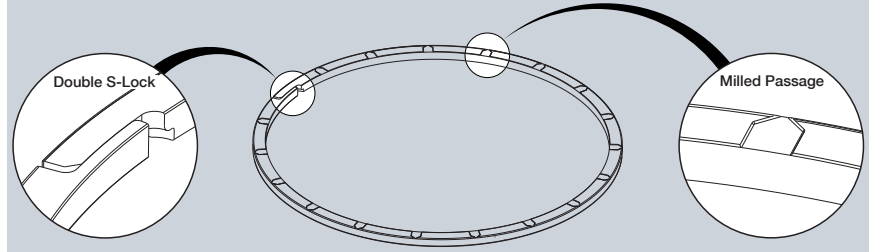
Fig. 19: Port-on-plane (POP) top piston ring design

The port-on-plane (POP) top piston ring, Fig. 19, will have the opposite characteristics. As the top ring wears, the relief ports will increase the leakage area and, thereby, the pressure drop across the top ring will decrease. This will reduce the contact pressure between the top piston ring and the cylinder liner, and also reduce piston ring wear. The POP top piston ring has a stabilising influence on piston ring wear. This is opposite to the conventional CPR ring, which is basically unstable. For small bore engines, this is an important difference giving the new POP piston ring pack a longer lifetime.

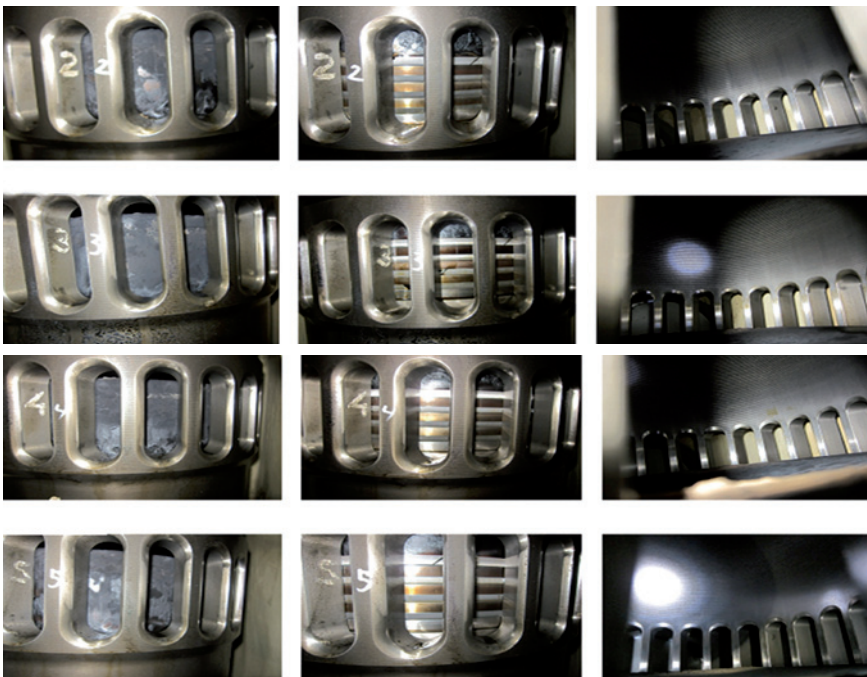
Fig. 20: Scavenge port inspection of prototype 6S40ME-B at 10,000 hours

The introduction of the POP ring pack is based on the service experience gained on the 6S40ME-B prototype engine. At first glance, the cylinder condition looks very satisfactory after 10,000 hours of operation, see Fig. 20. Also, the cylinder liner wear is very satisfactory, see Fig. 21. All liners inspected have wear rates below 0.05 mm per 1,000 hours.

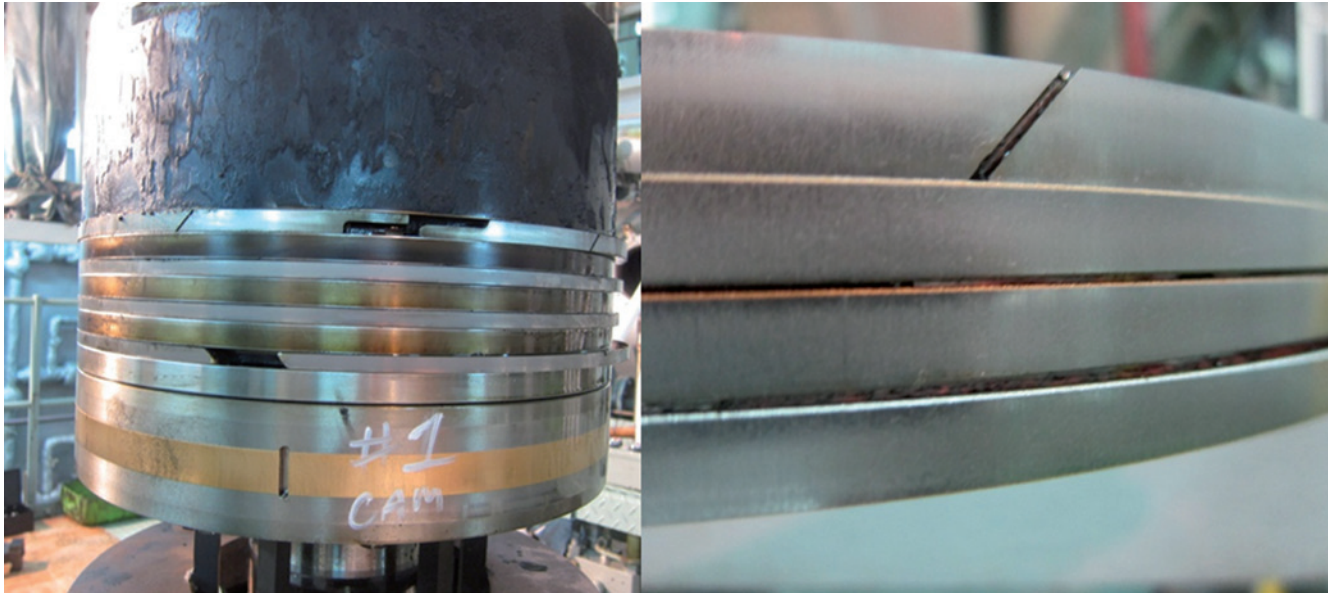
Fig. 22: Piston rings indicating rather high wear rates, 6S40ME-B

However, when looking more closely on the wear condition of the top piston ring, it can be seen that unit No. 1 is very near the wear limit due to the CL-groove depth reduction, see Fig. 22.

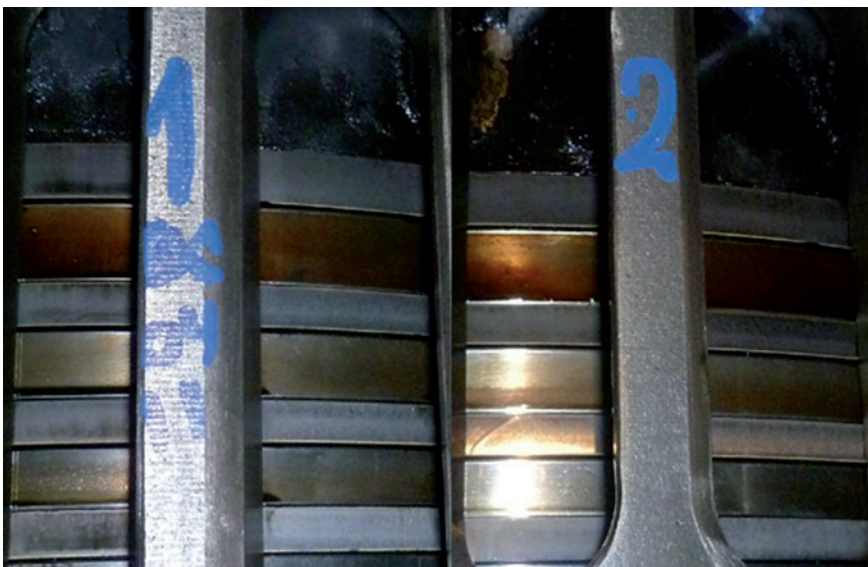
Fig. 23: 6S46MC-C unit with POP ring pack

6S46MC-C engine. After 6,735 hours, the width of the port opening had increased by 1.1 mm, corresponding to a top piston ring wear of 0.55 mm, see Fig. 23. With a wear potential of 2.7 mm, wear-out is estimated to happen after approx. 33,000 hours. Due to the self-stabilising nature of the POP ring, as described above, the estimated lifetime of 33,000 hours is conservative. We can expect even more running hours before wear-out occurs.

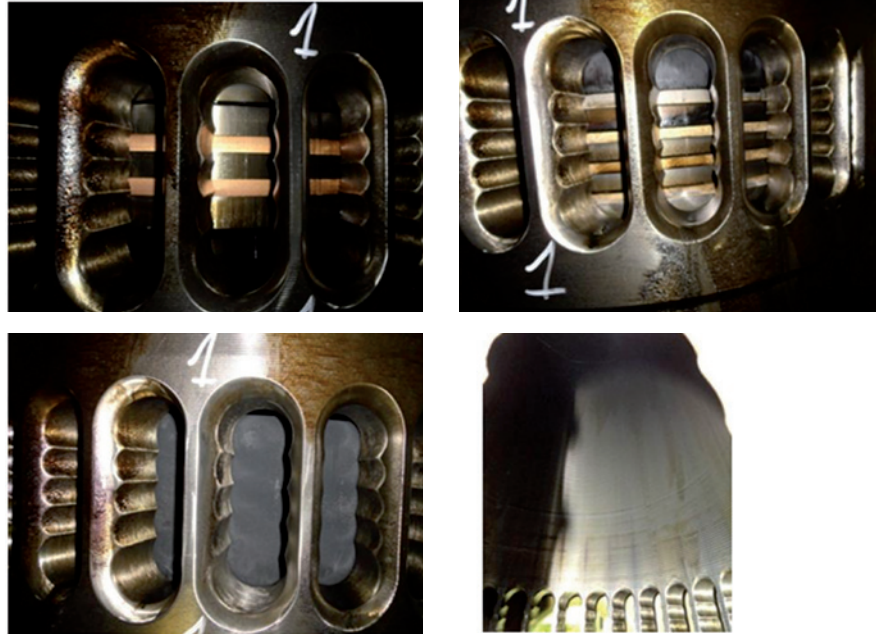
Fig. 24: S90ME-C8 in container vessel application. Scavenge port inspection after 1,800 hours revealed excellent condition

Traditionally, the S90 engine type has been very successful as prime mover for VLCCs. The cylinder condition for this engine type has been very stable, with long times between piston overhauls at very low cylinder oil feed rates. Now, this engine type has entered service as prime mover for large container vessels with a rather different load profile and many more harbour visits. Therefore, we are following early cylinder condition feedbacks in this relation. A scavenge port inspection after a little more than 1,800 hours showed excellent condition, see Fig. 24.

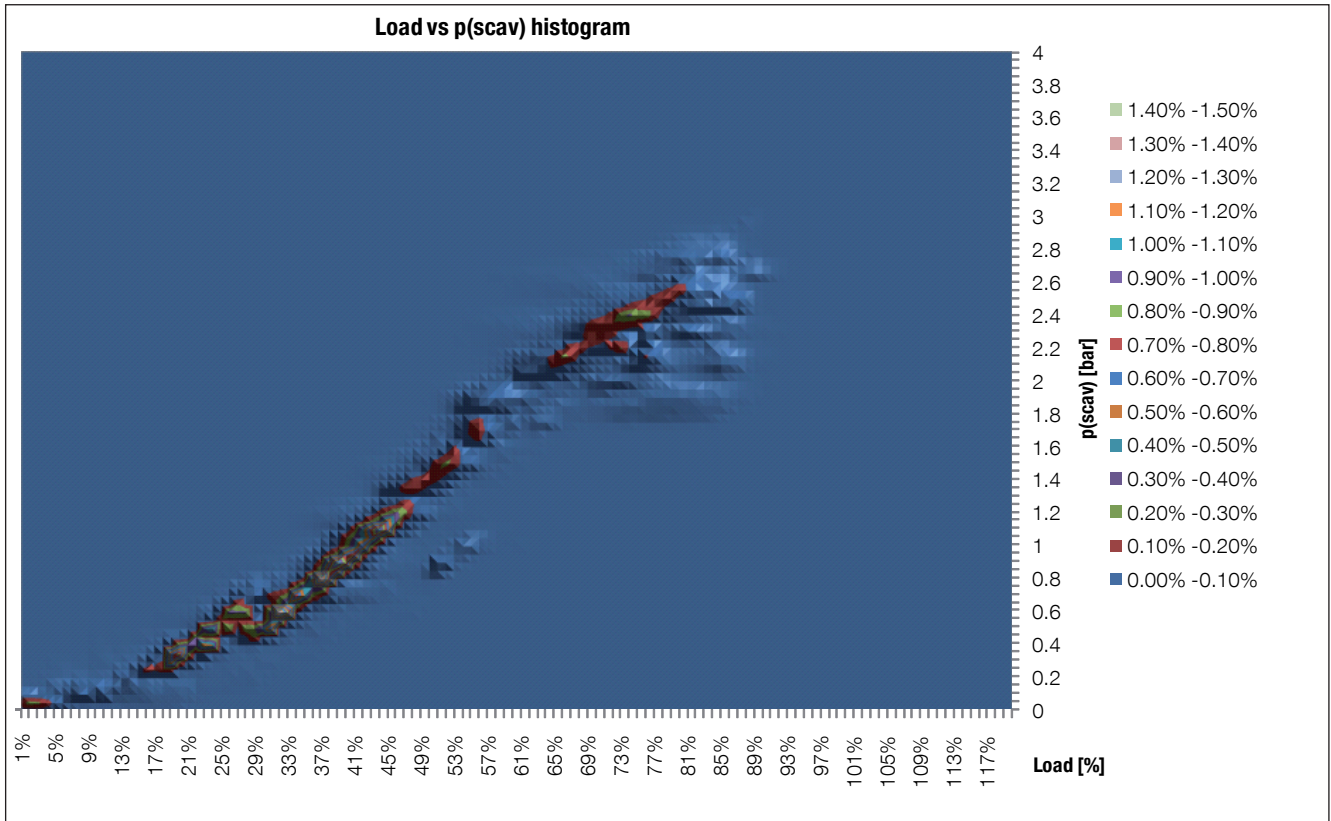
Fig. 25: CoCoS-EDS data, scavange air pressure in one period on S80ME-C9

On the first series of the S80ME-C Mk 9 type engine, we have experienced initial cylinder condition problems due to the large variation in scavenge air pressure in the whole load range of the engine.

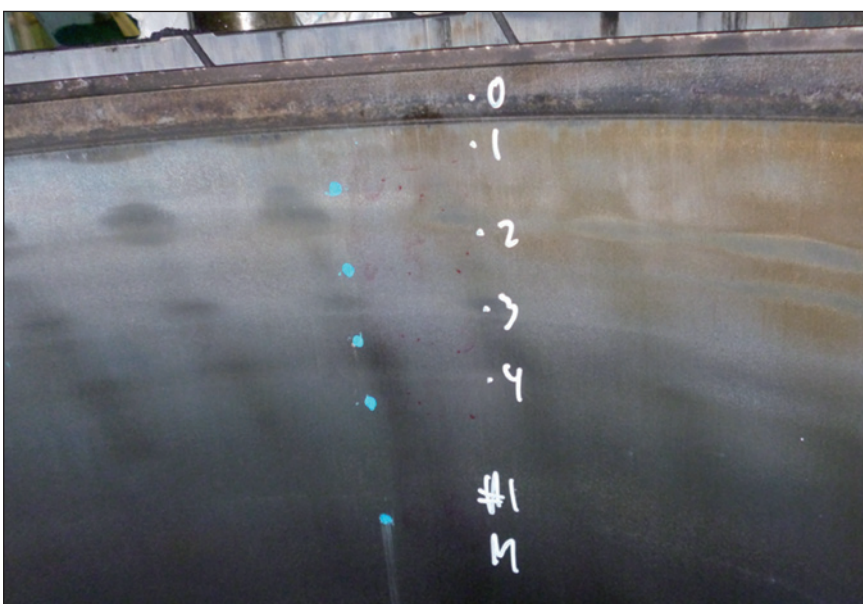
Fig. 26: Cold corrosion in the top of the cylinder liner

In this period, the cylinder liners suffered from cold corrosion due to the rather low liner temperature and excessive acid condensation on the liner sur-

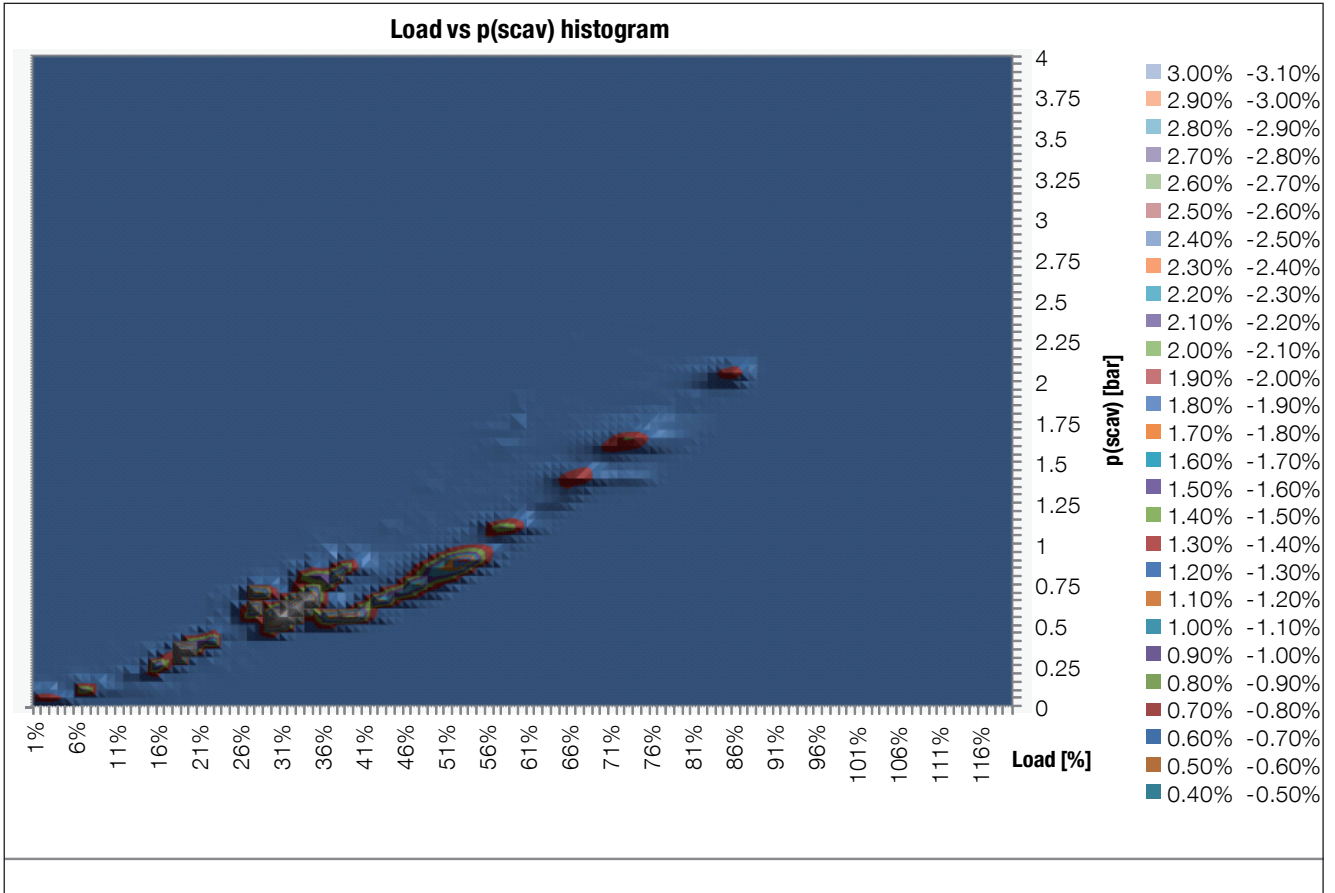
Fig. 27: CoCoS-EDS data, scavenge air pressure in another period

In a later period (4th quarter of 2011), CoCoS EDS data showed much lower scavenge air pressures, between 0.6 bar to 1.5 bar in the load range from 40% to 70%, see Fig. 27.

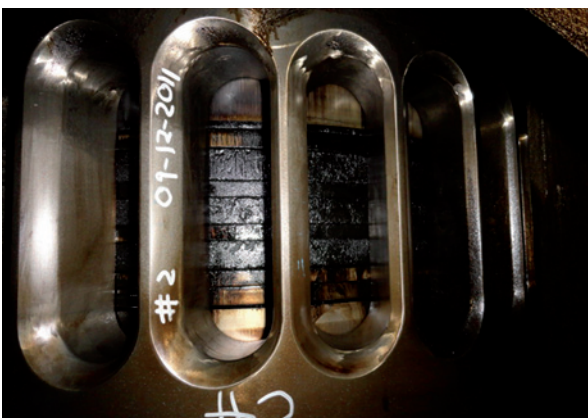
Fig. 28: S80ME-C9: Collapsed/broken piston rings

In the later period, the engine suffered from collapsed and broken piston rings, see Fig. 28. The reason for this was a high usage of WHR, rather low compression pressure and still maximum pressure according to the model curves. This resulted in a very high pressure rise and high load on the piston ring pack, especially the top piston rings.

To avoid this, improved control via the ME-ESC system is necessary to protect the engine against this situation and stabilise the cylinder condition.

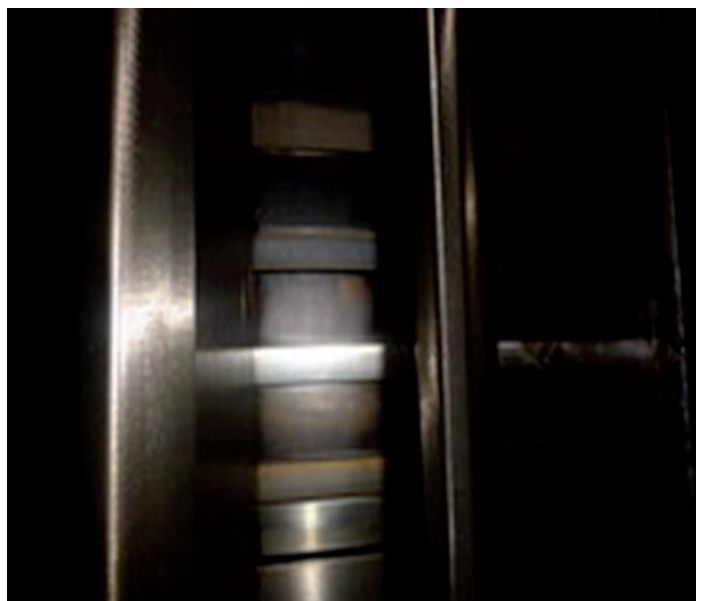
Fig. 29: S80ME-C9: Good cylinder condition

Tests in this respect are currently in progress. Initial results, see Fig. 29, indicate that our countermeasures work well.

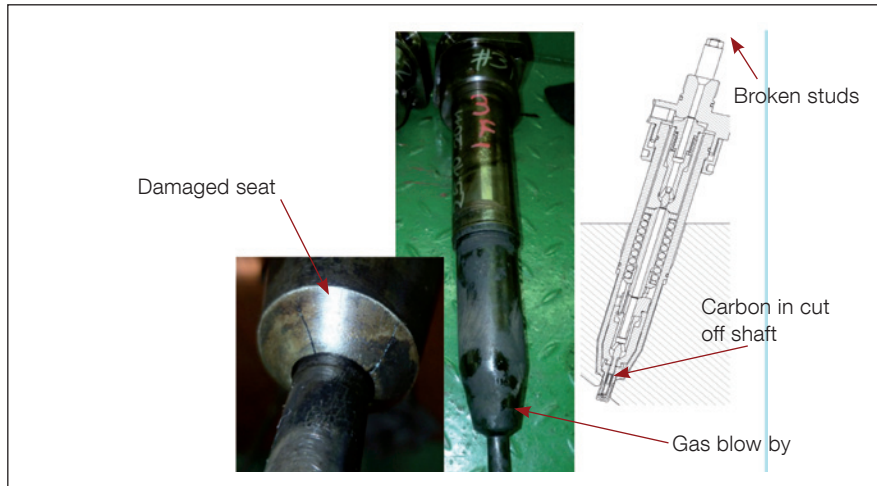
Fig. 30: Damaged parts of fuel valve

At the end of 2011, we received a number of reports of fuel injector malfunction on the first S50ME-C engines with the 300-bar hydraulic system. The incidents occurred after less than 1,000 hours of operation and, in a few cases, the jumping fuel injectors led to broken fuel valve studs and gas leakage between the fuel injector and cylinder cover. The damaged parts, i.e. broken studs, carbon deposits in the cut-off shaft, damaged valve seat and gas blow-by, are shown in Fig. 30.

- Fuel oil pressure disappears too fast from the fuel injector (before the cut-off shaft can close) →
- Combustion gas enters fuel valve →
- Closing speed of cut-off shaft increases →
- Hard impact between cut-off shaft and spindle guide →
- Plastic deformation of seat between fuel valve and cylinder cover →
- Correct pre-tension of fuel valve studs is lost →
- Cylinder gas acts on the O-ring diameter of fuel valve →
- Valve starts jumping and, in some cases, the valve stud breaks.

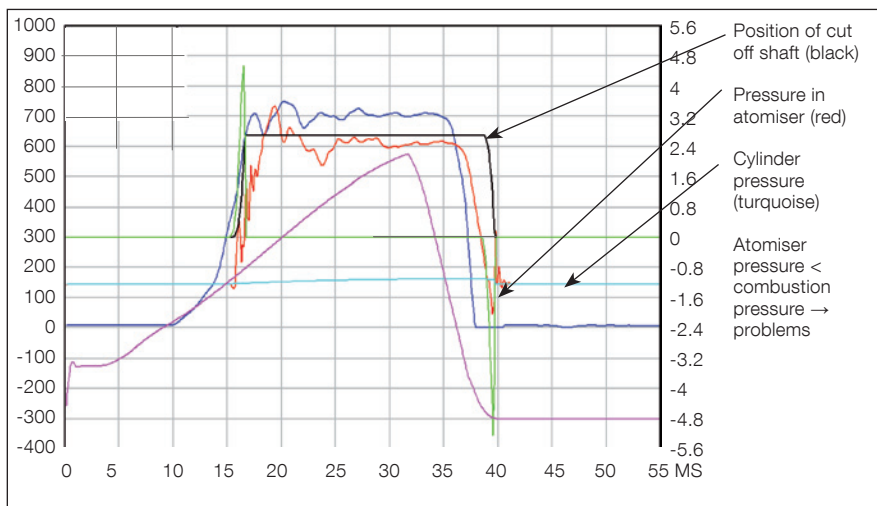
Fig. 31: Initial closing parameters

This sequence of events is supported by pressure measurements in the fuel valve itself. The initial closing parameters for the fuel valve pressure, see Fig. 31, drop faster than the cylinder pressure, thereby, enabling combustion gases to enter the fuel valve.

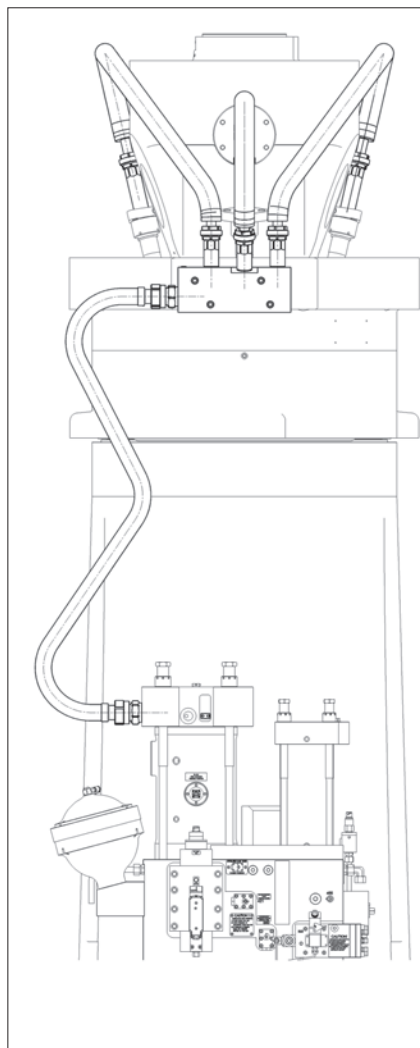
Fig. 33: High-pressure fuel pipe design on S80ME-C9

The S80ME-C9 high-pressure fuel pipe design comprises one hose-type pipe from the fuel booster to a distributor block and short double-bended fuel pipes from the distributor block to the three fuel valves. Fig. 33 gives an outline of the design.

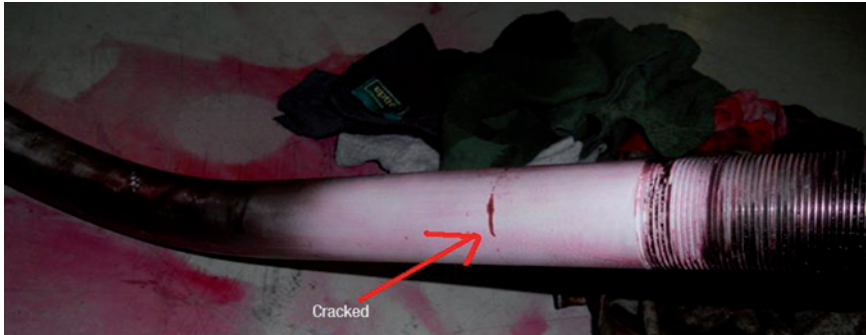
Fig. 34: Cracked central high-pressure fuel pipe of the hose type

We have experienced some cases of cracks in the central hose-type high-pressure fuel pipe from the fuel booster to the distributor block, see Fig. 34. An

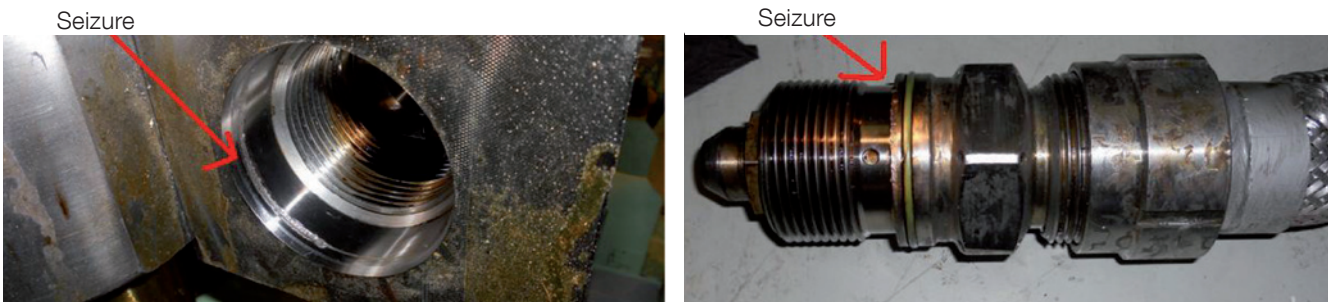
Fig. 35: Seizures on distributor block and pipe union

inspection of the parts on pipes with cracks revealed seizures on both the pipe union and on the bore in the distributor block, see Fig. 35.

When creating the seizures, a torque is required and this torque will reduce the clamping force and risk of fretting and wear, and thereby the risk of crack formation is increased.

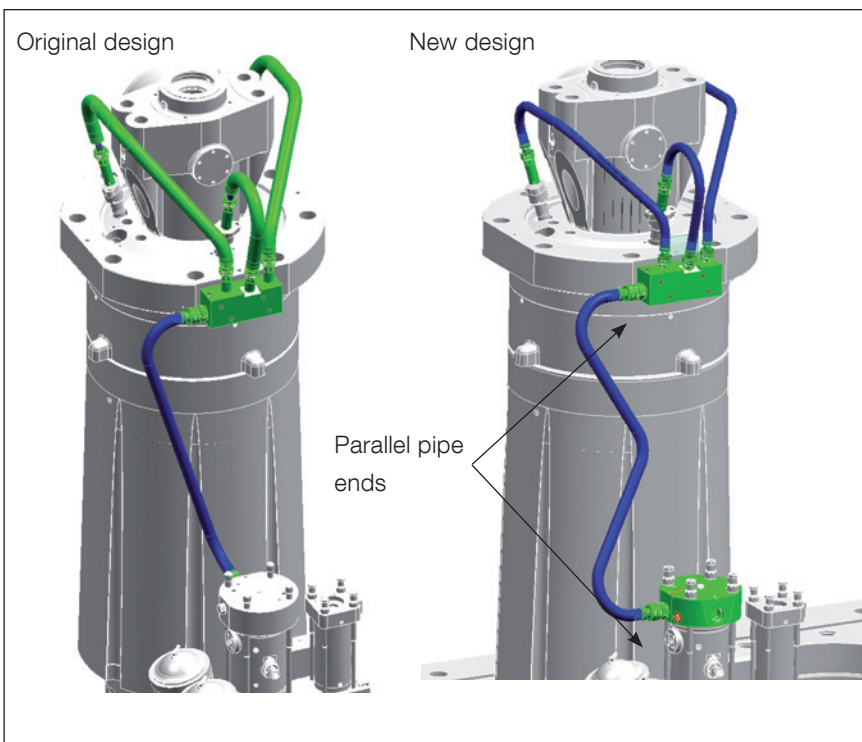
Fig. 36: Original and new pipe designs

Therefore, we have re-designed this high-pressure pipe introducing a more flexible pipe with parallel pipe ends. Fig. 36 shows the original pipe design and the new so-called sigma-pipe. The sigma-pipe will be introduced on all S80ME-C9 engines including those already in service.

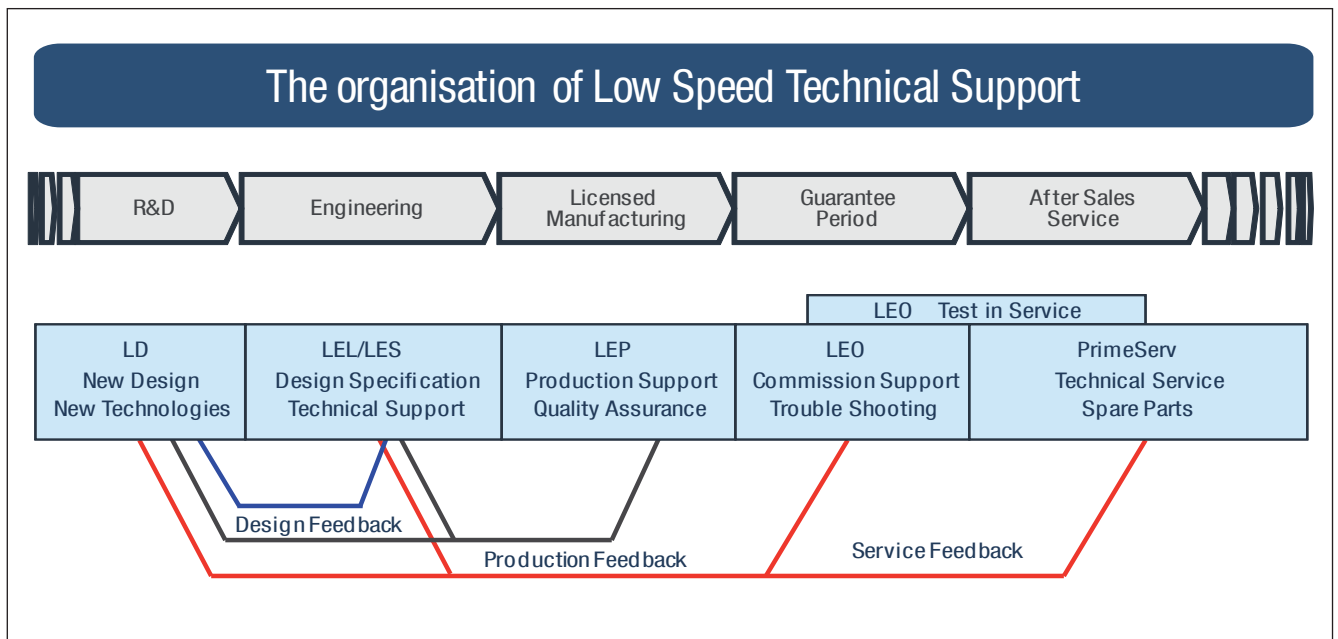
Fig. 37: MAN B&W two-stroke feedback cycle

When the commissioning phase starts, with shop test of the engine, the Operation department assists, and feedback from the commissioning phase (shop test, quay trial and sea trial) is given to the R&D and Design departments. This feedback typically continues throughout the guarantee period, and often also somewhat longer depending on the agreements with the shipowner in question.
