Service Experience

Two-stroke Engines

MAN Diesel & Turbo

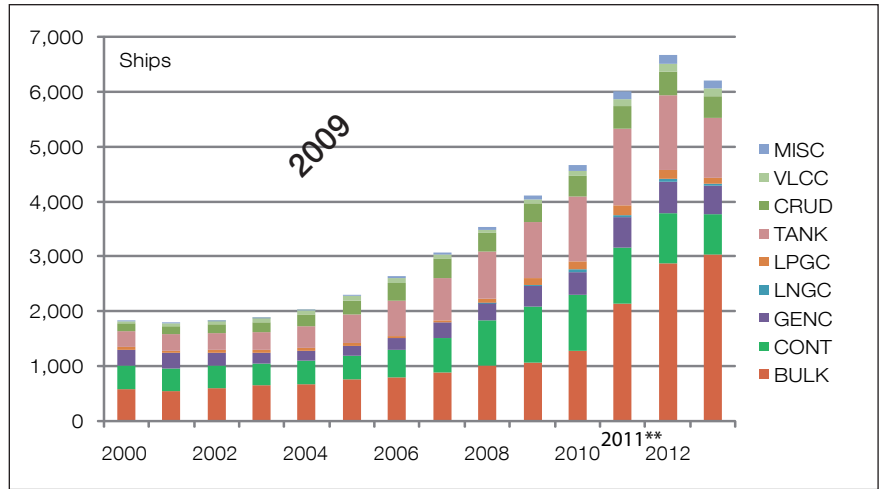
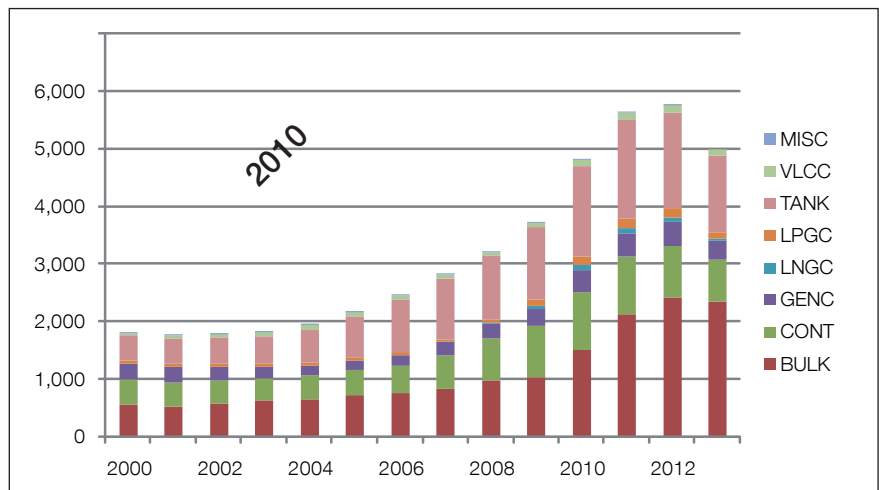
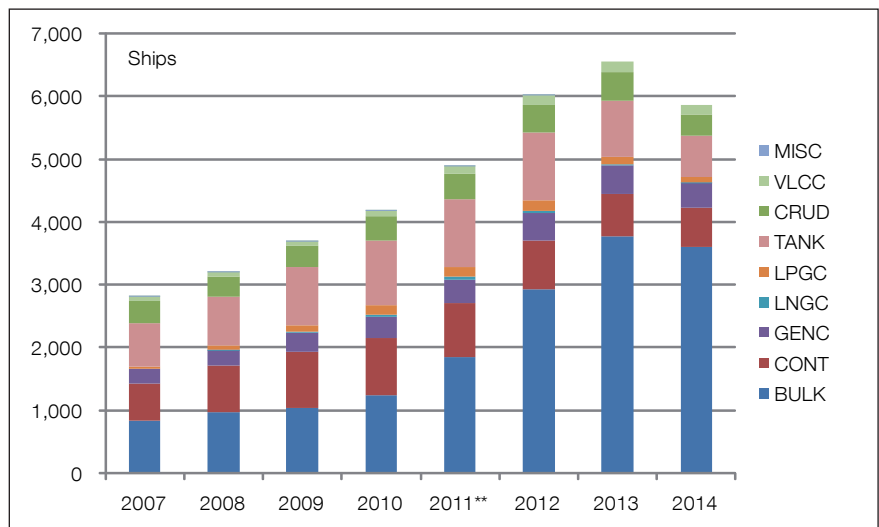
Fig. 38: Number of ships powered by MAN B&W two-stroke engines in the age group 0 to 3 years

Fig. 38 shows the development of a number of vessels powered by MAN B&W two-stroke engines in the age group from 0 to 3 years. A strongly increasing population can be seen during the last years, and we can look forward to a further increase in the years to come. This gives us an outstanding possibility of receiving efficient feedback and further optimise the MAN B&W two-stroke concept.
