MAN Diesel A/S • Denmark

Service Letter

SL07-488/PMN November 2007

# Work Inside Cylinder Liners

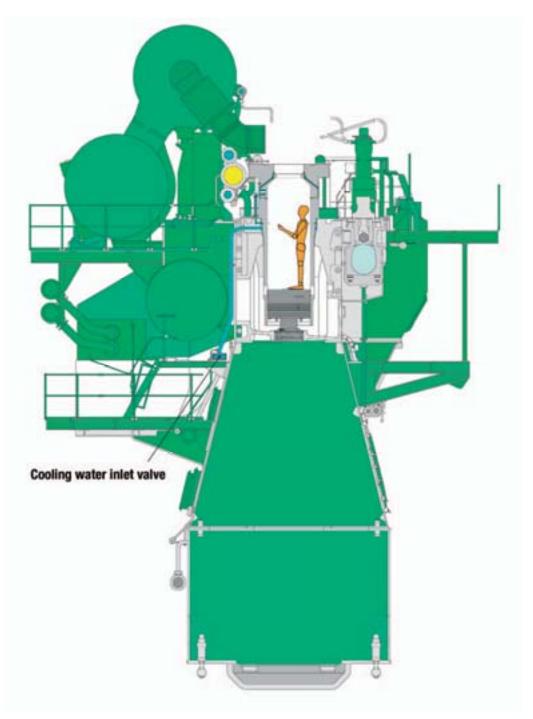
Encl. 1 for SL07-488/PMN

During modification work inside the cylinder liner on a K90MC engine, only the exhaust valve had been removed to allow access into the cylinder liner. One fitter was inside the liner when cooling water was admitted by accident, see Encl. 1.

The cooling water entered the combustion chamber from the bores in the cylinder cover, where cooling water passes from the cylinder cover to the exhaust valve. Further to normal precautious practices and safety procedures, we therefore stress the following:

# Person working inside a cylinder liner with cylinder cover mounted

For any work, inspection or cleaning inside a cylinder liner, the cylinder cover **must** always be removed before entering. A cylinder liner should never be entered by only removing the exhaust valve and gain access by either standing on the piston and turning, or by climbing down a ladder through the bore in the cylinder cover.

A safety assistant **must**, at all times, be present outside the cylinder liner and be in constant contact with the person working inside the cylinder liner.

A ladder **must** be present in order for the person inside the liner to be able to escape even in the event of a power failure.
