CLEVITE7[®]
ENGINE BEARINGS

Engine Bearing

failure analysis guide

*A guide to analysis and correction of
premature engine bearing failures*

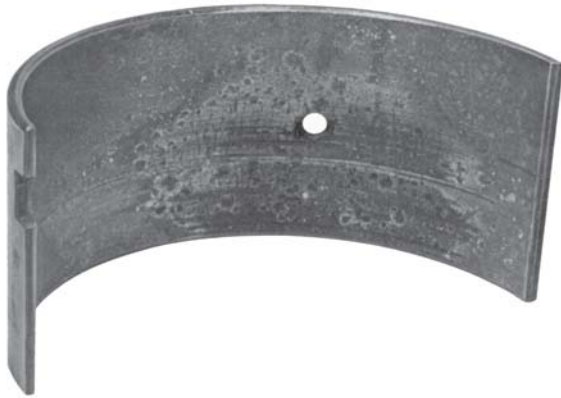
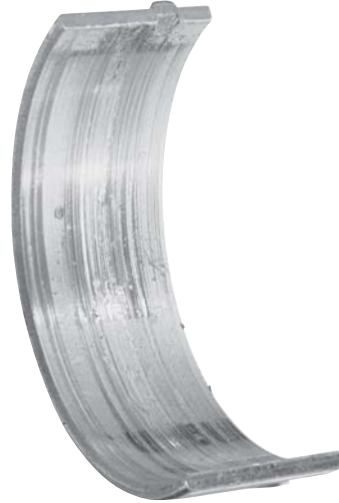
Foreign particles are embedded in the lining of the bearing. Scratch marks may also be visible on the bearing surface.

The high-spot may be large enough to make contact with the journal causing a rubbing action that can lead to the eventual breakdown and rupture of the bearing lining. Foreign particles may embed only partially and the protruding portion may come in contact with the journal and cause a grinding wheel action.

1. Improper cleaning of the engine and parts prior to assembly.
2. Road dirt and sand entering the engine through the air-intake manifold or faulty air filtration.
3. Wear of other engine parts, resulting in small fragments of these parts entering the engine's oil supply.
4. Neglected oil filter and/or air filter replacement.

1. Install new bearings, being careful to follow proper cleaning procedures.
2. Grind journal surfaces if necessary.
3. Recommend that the operator have the oil, air filter, oil filter and crankcase breather-filter replaced as recommended by the manufacturer.

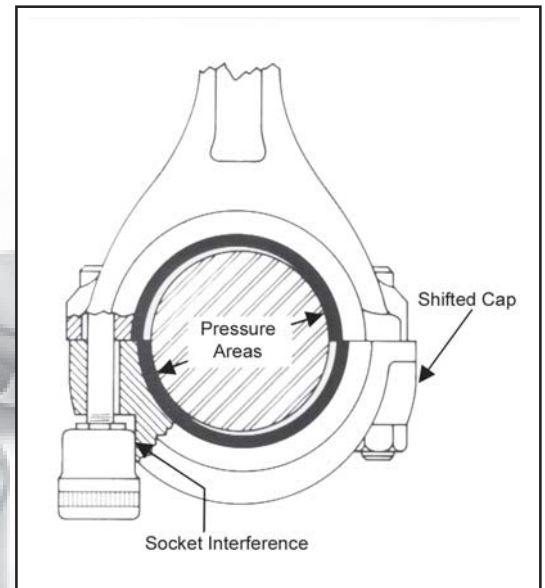
Extreme wear areas visible along the bearing surface adjacent to one or both of the parting line.

When there is too much crush, however, the additional compressive force created by the surplus crush that still remains after the bearing is fully seated causes the bearing to bulge inward at the parting faces. This bearing distortion is called “side pinch.”

1. Rework the bearing housing of the engine block if it has been filed down.
2. Replace the connecting rod if its bearing cap has been filed down.
3. Check journal surfaces and regrind if necessary.
4. Install the new bearing and follow proper installation procedures by never filing down bearing caps and using the recommended torque wrench setting.
5. Correct the shim thickness (if applicable).
6. Check for out-of-roundness of the inside diameter of the assembled bearing by means of an out-of-roundness gauge, inside micrometer, calipers or prussian blue to assure that any out-of-roundness is within safe limits. The maximum assembled bearing I.D. should always be across the split line.

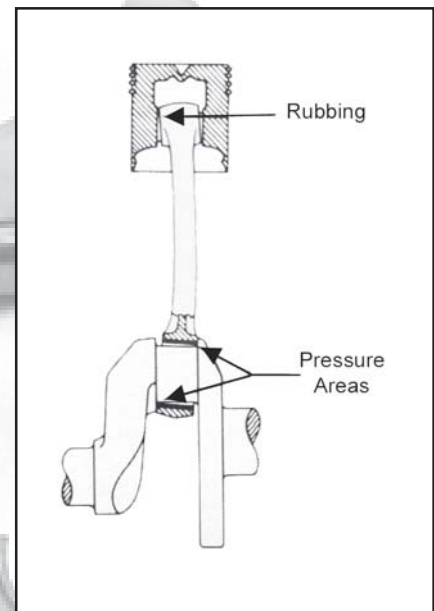
When fillet ride has caused a bearing to fail, areas of excessive wear are visible on the extreme edges of the bearing surface.

This metal-to-metal contact between the bearing and fillet causes excessive wear, leading to premature bearing fatigue.

1. Regrind the crankshaft paying particular attention to allowable fillet radii. **NOTE:** *Be careful not to reduce fillet radius too much, since this can weaken the crankshaft at its most critical point.*
2. Install new bearings with enlarged chamfers that allow proper fillet clearance.

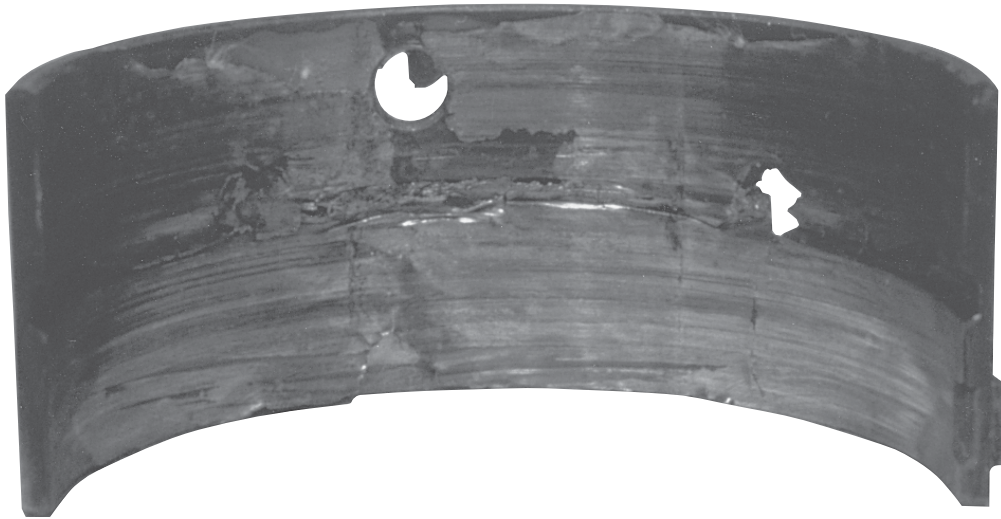
Bearing surface wiped and torn, blackened from heat, with patches of lining material torn cleanly from steel backing.

1. If the service life for the old bearing was adequate, replace with the same type of bearing to obtain a similar service life.
2. If the service life of the old bearing was too short, replace with a heavier duty bearing to obtain a longer life.
3. Replace all other bearings (main connecting rod and camshaft) as their remaining service life may be short.
4. Recommend that the operator avoid "hot rodding" and "lugging" as these tend to shorten bearing life.
5. Check for misassembly. Use proper installation techniques.

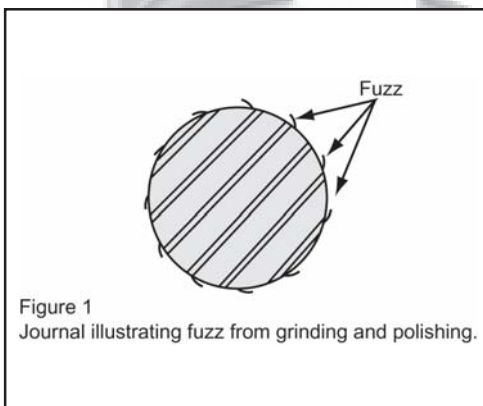
Figure 1
Journal illustrating fuzz from grinding and polishing.

Metal removal tends to raise burrs. This is true of nearly all metal removal processes. Different processes create different types of burrs. Grinding and polishing produces burrs that are so small that we can't see or feel them but they are there and can damage bearings if the shaft surface is not generated in the proper way. Rather than "burrs," let's call what results from grinding and polishing "microscopic fuzz." This better describes what is left by these processes. This microscopic fuzz has a grain or lay to it like the hair on a dog's back. Figure 1 is an illustration depicting the lay of this fuzz on a journal. (Note: All figures
