MAN B&W Diesel

Key Components, Tegholmen Works

MC fuel pump

Fuel Pump Top Cover Fractures

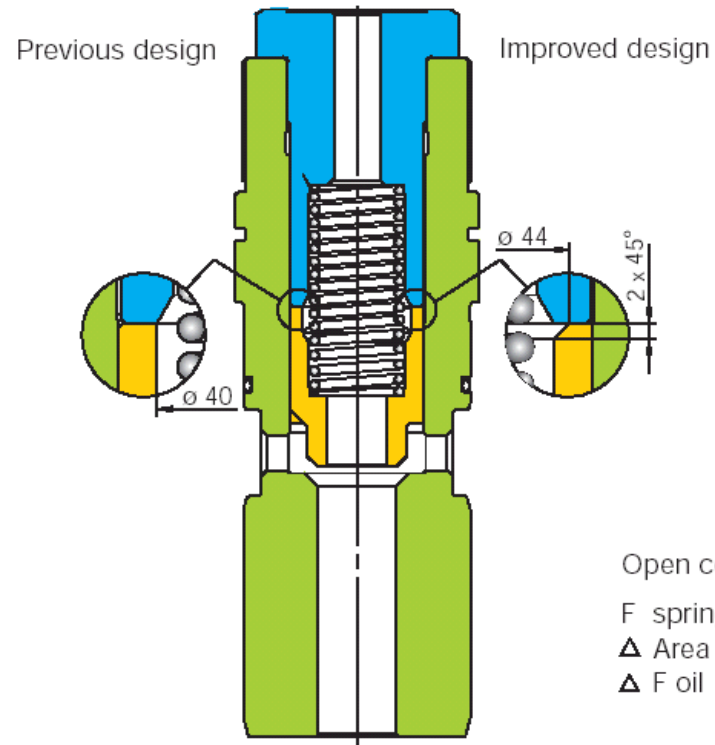
MBD-C Produced Valves

Due to cracked bellows, the design has been changed.

Always ensure to use the latest design.

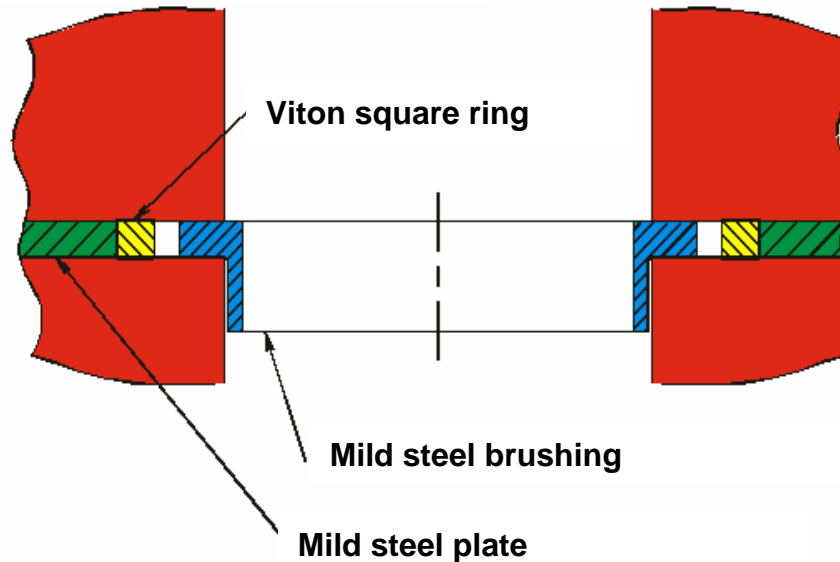
S90-K98MC/MC-C

The previous fibre packing has been modified and is fully interchangeable with the above mentioned unit.

Afterwards only Viton square ring has to be changed.

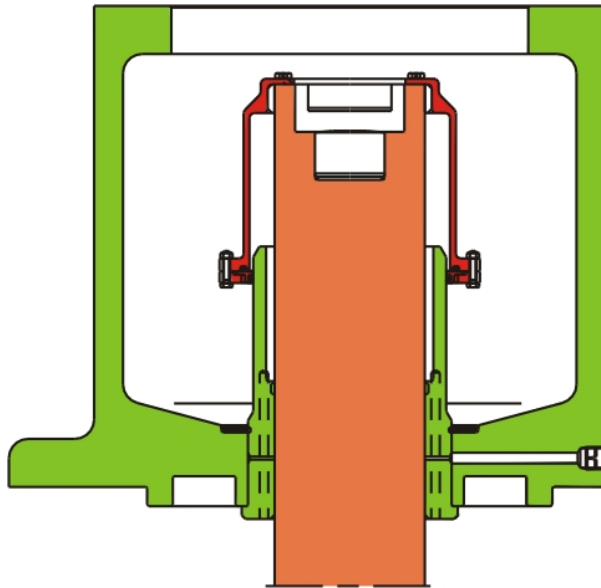
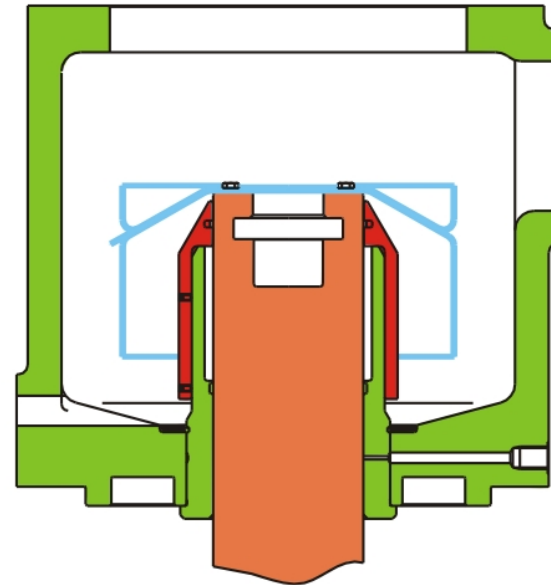
'Umbrella' roller guide for fuel pump (K98MC-C and K98MC engines)

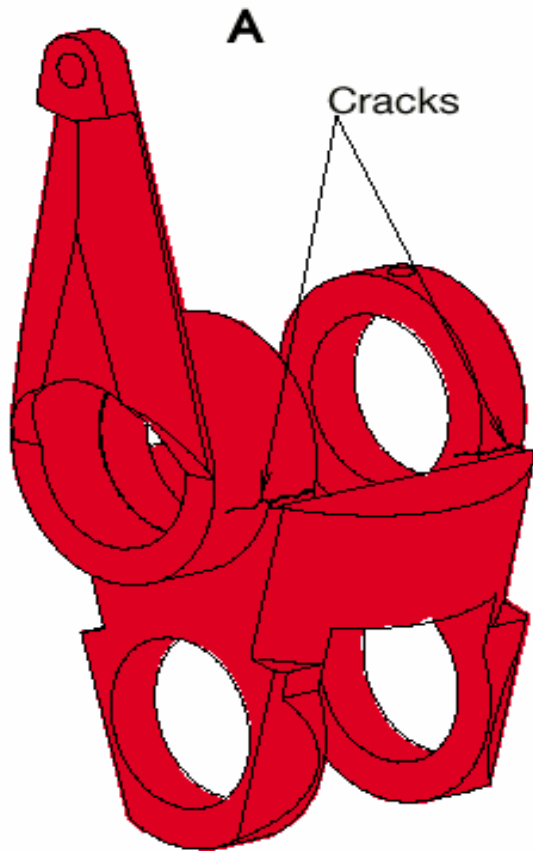
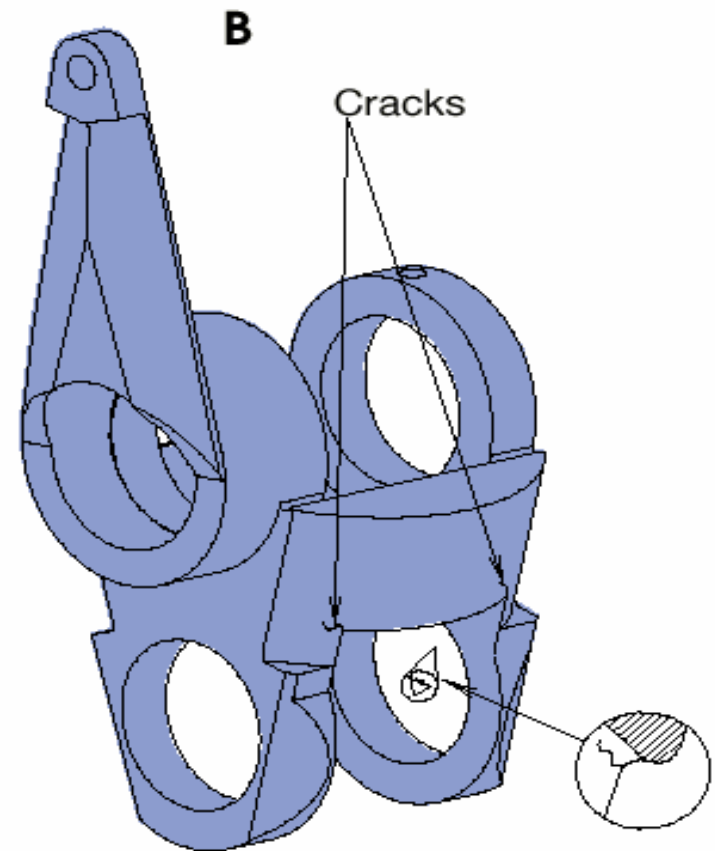
Reversing link for fuel pump roller guide

We have recently received reports on cracks in the reversing link for the fuel pump roller guide. The sketch in Enclosure 1 shows the appearance of the cracks.

The cracks as shown in Fig. B have mainly been found on the K90MC/MC-C types, Mark V or VI, and they were found after a relatively short time in service. The type of cracks indicated in Fig. A have only been reported in a few cases.

The cracks in Fig. B have primarily been located on the camshaft side and can be detected through the inspection cover in the camshaft housing. We recommend that, as a general precaution, you instruct your crews to inspect the reversing link at the first opportunity.

If a reversing link has not shifted to its correct position after a change of the engine rotation, and fuel injection takes place, this running condition leads to increased stresses in the areas where cracks have been detected.

Even if no cracks as shown in Fig. B are detected, it is still recommended to inspect for the types of cracks shown in Fig. A, when convenient. It is necessary to pull out the roller guide in order to do this.

If cracks are detected, we ask you to make a sketch of the extent of the cracks and forward it to the engine builder or MAN B&W Diesel, Copenhagen and, at the same time, to order replacement reversing links. The new reversing links are modified with larger roundings in the relevant areas.

If such a running condition is repeatedly detected in your vessel, we recommend that you contact the engine builder or MAN B&W Diesel, Copenhagen, for a condition check of the complete manoeuvring system.
