Service Experience 2006, ME and MC Engines

MAN B&W Diesel A/S, Copenhagen , Denmark

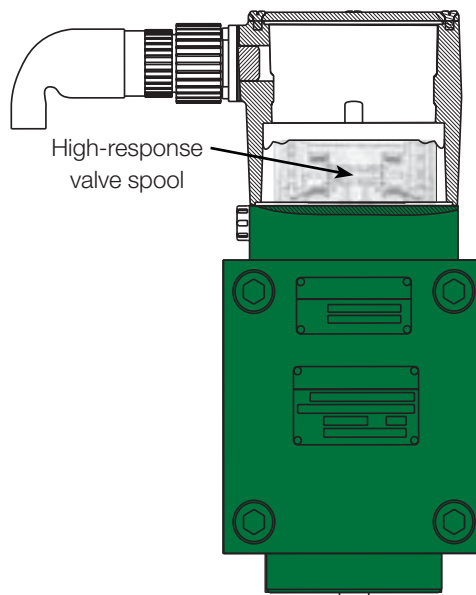
Fig. 16: ELVA valve, location of high-response valve spool

Early service experience proved that low ambient temperatures, as often experienced during shop tests in the winter season, gave rise to sticking high-response valve spools in the ELVA valve due to low hydraulic oil temperatures. The diameter of the spool was reduced in order to obtain correct functioning of the high-response valve as shown in Fig. 16.

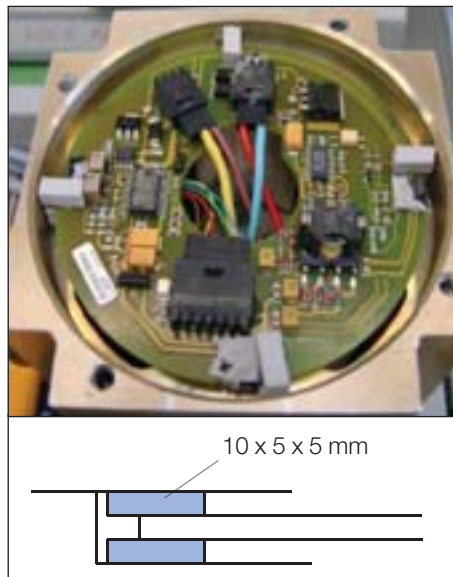
Fig. 20: FIVA valve, resilient mounting of PCB

In general, the FIVA valves have seen much fewer vibration-related troubles than the ELFI and ELVA valves. A resilient mounting design, Fig. 20, has been applied from the beginning and an extended vibration testing (up to 1 kHz) has been used, Fig. 21.

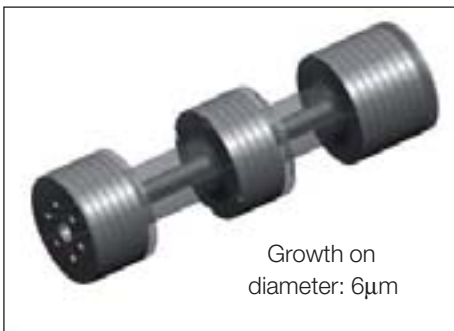
Fig. 22: FIVA valve, growth of main spool

In a few cases, we have seen growth of the main spool in the FIVA valve. Fig. 22 shows a main spool where the diameter has grown 6 micron. The reason has been put down to improper heat treatment of the main spool and the process has been corrected.

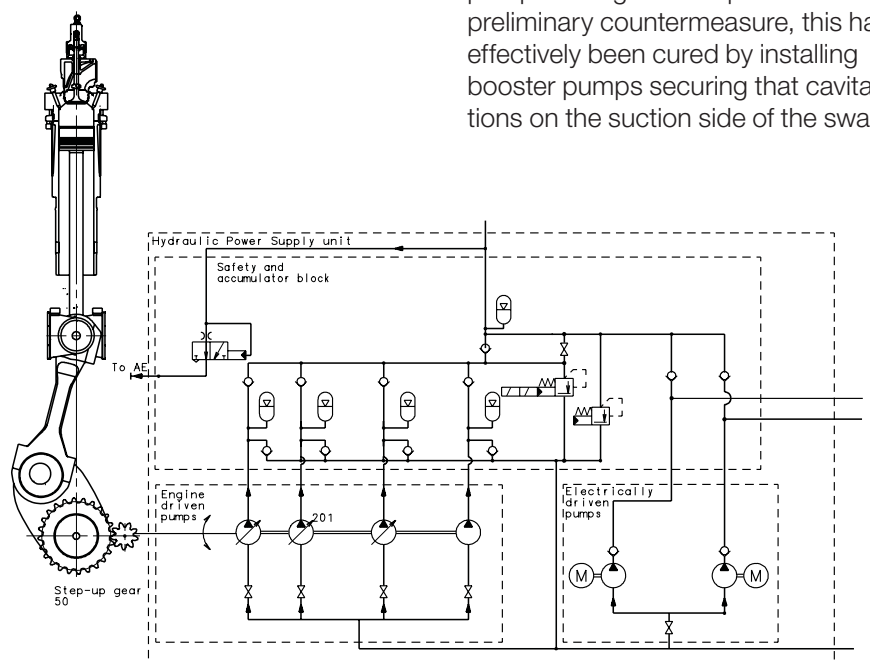
Fig. 27: Hydraulic power supply diagram

The hydraulic power supply system, Fig. 27, features, as standard, a number of engine-driven pumps and electrically driven start-up pumps. The engine-driven pumps are axial piston pumps (swash plate types), and the flow is controlled by a proportional valve. On some K98 engines, we have initially seen problems with noise from these pumps during astern operation. As a preliminary countermeasure, this has effectively been cured by installing booster pumps securing that cavitations on the suction side of the swash

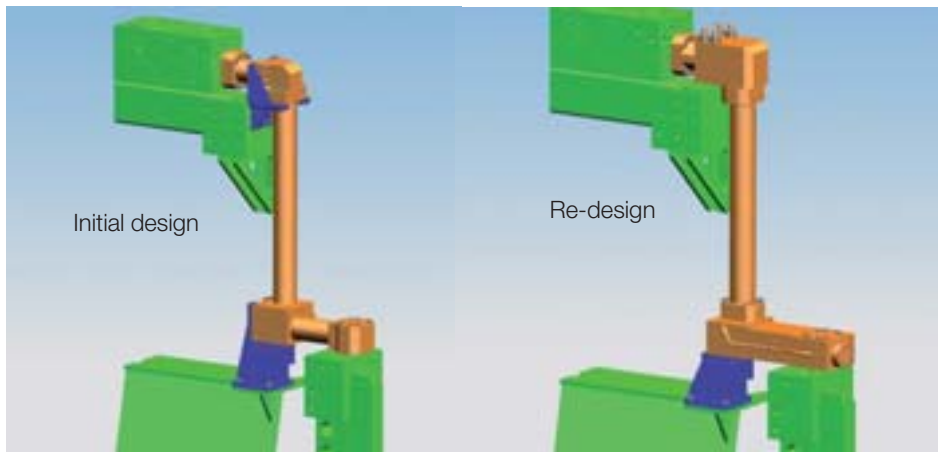
Fig. 29: Double-wall piping re-design on 6S90ME-C

HCU and the HPS has been redesigned, Fig. 29. Disintegration of the horizontal parts at the HCU and HPS was experienced at a shop test when the outer pipe was pressurised. Rectification was carried out and verified during the shop test on the first 6S90ME-C engine.

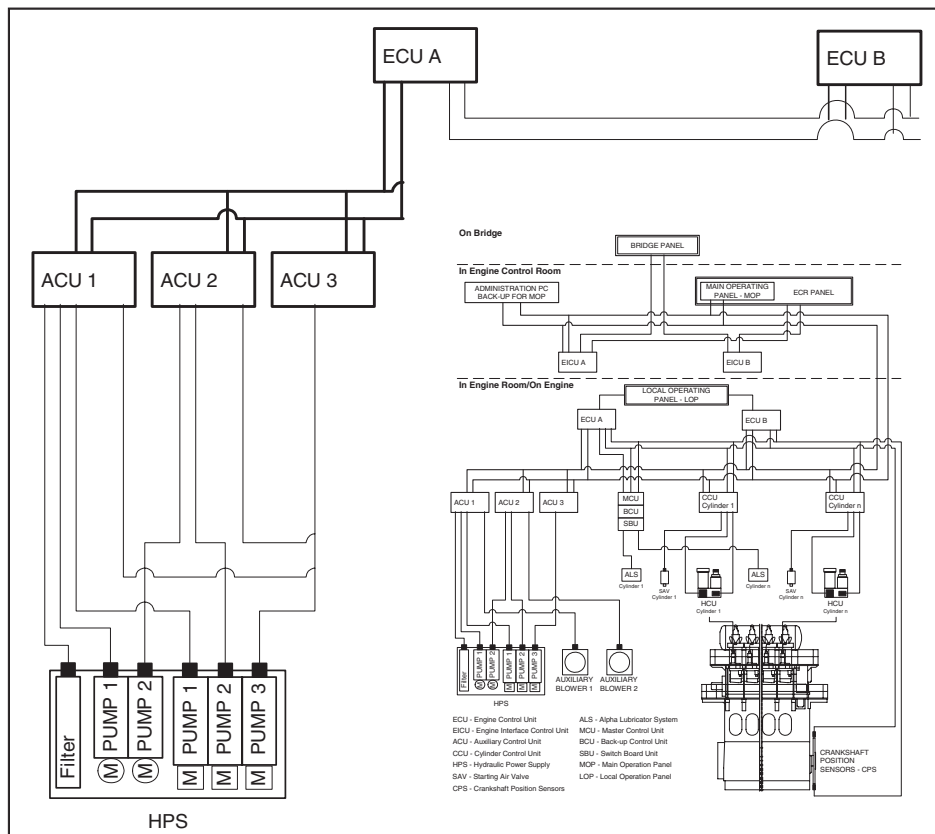
Fig. 38: ME-system, control diagram (initial version)

The incident occurred on an ME engine with four (4) engine-driven hydraulic pumps. Control of one of these pumps was lost. When this happened, the swash plate for the uncontrolled pump went to 'full ahead'. In the original version of the instruction book, a system consisting of only three (3) engine-driven pumps is shown, Fig. 38. Each of

these pumps are controlled by an ACU (Auxiliary Control Unit). However, the control of a system with four or more engine-driven pumps is not described.

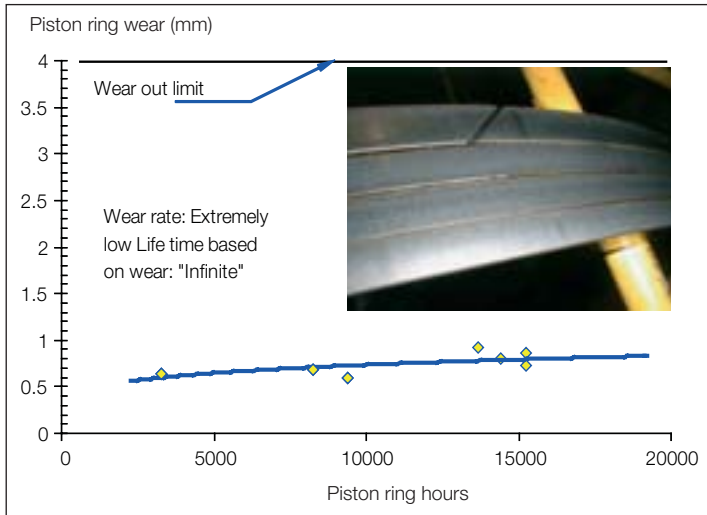
Fig. 42: Piston ring wear measurements, prototype 6S90MC-C (M/T Maria A. Angelicoussis)

6S90MC-C engine), piston overhauls have been carried out successively from 8,000 hours and upward, see Fig. 42. The piston ring wear is extremely low, and from this point of view indicates 'infinite lifetime'.

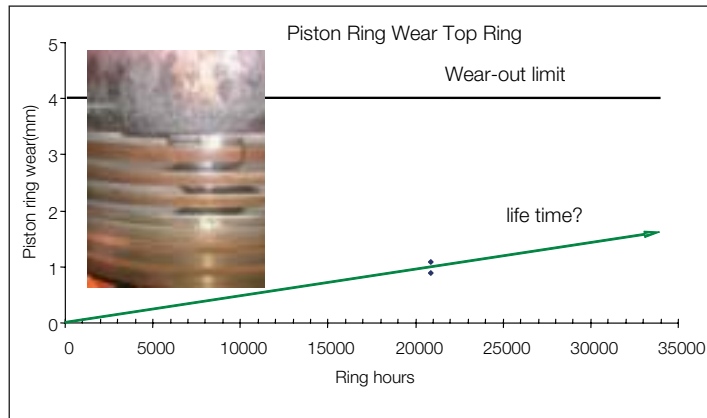
Fig. 43: Piston ring wear measurements, 6S90MC-C (M/T Kos)

The vessels *M/T Kos* and *M/T Astro Cygnus* are also both equipped with Hyundai-built 6S90MC-C engines. In these engines, the pistons have been pulled between 20,000-21,000 hours and 22,000-24,000 hours, respectively. The pulling of pistons on both these engines was caused by 'internal coking' of the pistons. The reason for this was fuel oil contamination of the system oil,

in both cases caused by leaking fuel pumps. Apart from this specific problem, both engines have shown excellent cylinder condition with low piston ring wear rates, Fig. 43.

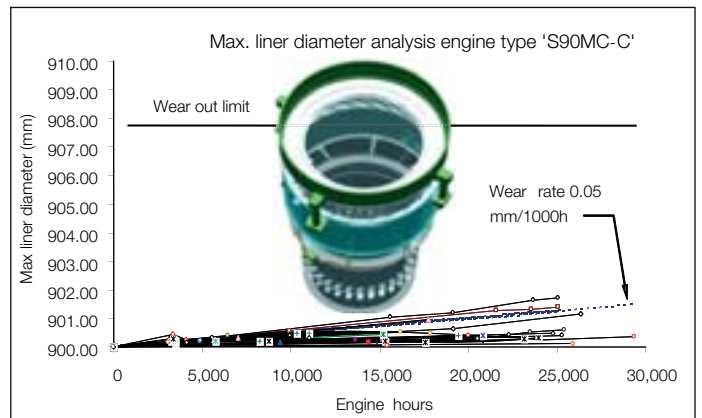
Fig. 45: 6S90MC-C, cylinder liner wear

1. Cylinder liner wear rates: 0.02-0.07 mm/1,000 hours (Fig. 45)
2. Piston ring wear rates: Predicted lifetime: 50,000 hours (Fig. 46)
3. Piston ring groove wear rates: Predicted time between reconditioning: 40,000 hours (Fig. 47)

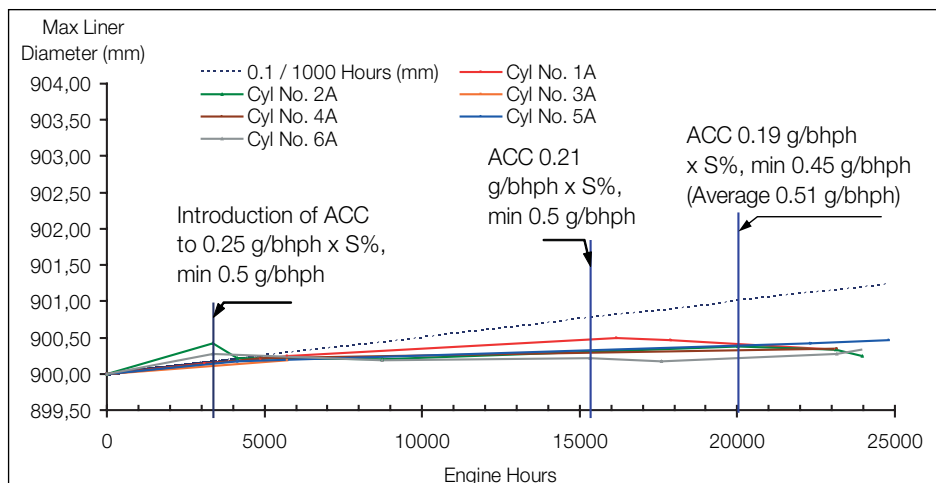
Fig. 44: Cylinder liner wear, cylinder oil reduction test, 6S90MC-C (M/T Astro Cygnus)

The engine onboard *M/T Astro Cygnus* has been a 'test-vehicle' for the further cylinder oil consumption testing according to the so-called Alpha ACC principle (ACC=Adaptive Cylinder oil Control). As can be seen in Fig. 44, this test has been extremely successful and it indicates further potential for reduction in the cylinder oil consumption.

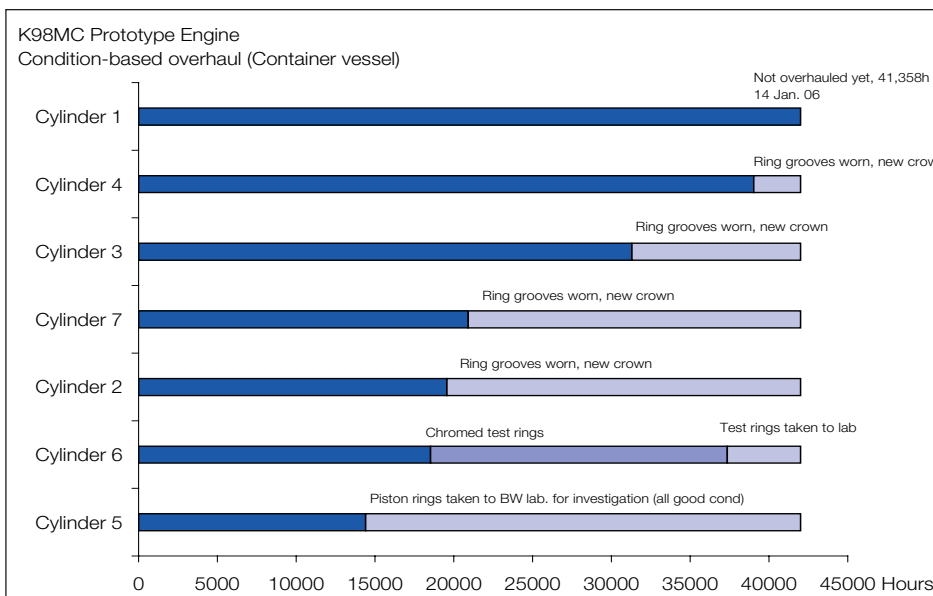
Fig. 52: 7K98MC, condition-based overhaul

For container carrier operators another, more condition-based philosophy, will pay off. Such philosophy is practised on the K98MC prototype engine on board *M/V Antwerpen Express*. Fig. 52 shows

that in this engine, unit No. 1 has still not been overhauled after more than 41,000 hours of operation.

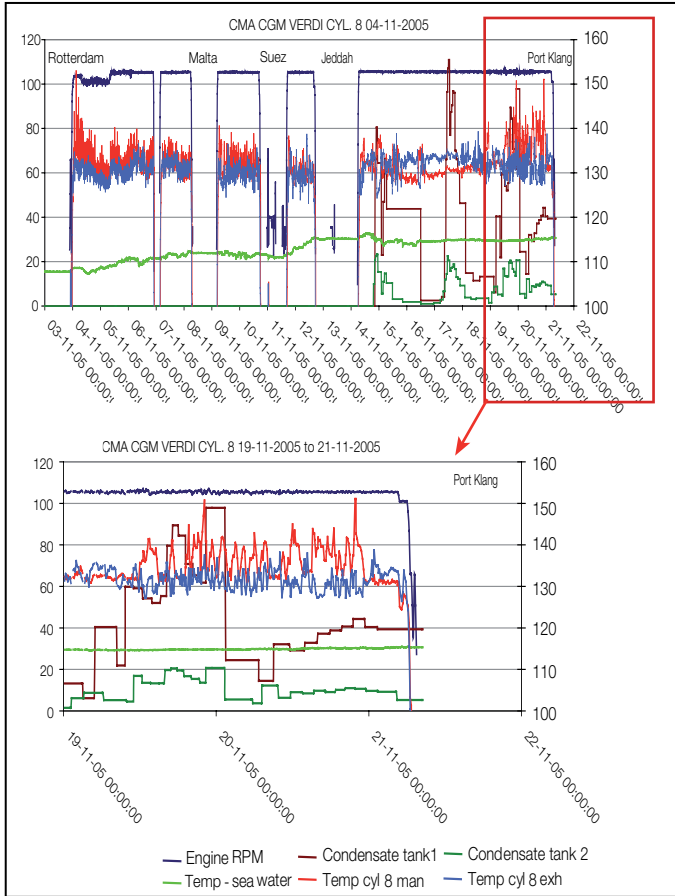
Fig. 57: Log data from first voyage

Running-in of cylinder unit 8 rings was recorded. A couple of weeks' recordings showed elevated and unstable liner temperatures, Fig. 57. The alu-coat ring package will seal up much quicker in a cylinder unit. No drain was recorded until the Indian Ocean, where the seawater reached 30°C. During the passage from Jeddah to Port Klang, three periods with drain were recorded. It should be noted that there is no drain from the volume after the water mist catcher. Nevertheless, each of the three incidents gave elevated liner temperatures, the last one above the alarm limit of 150 degrees. Because of the alarm, the chief engineer increased the lube oil dosage by 50% in cylinder

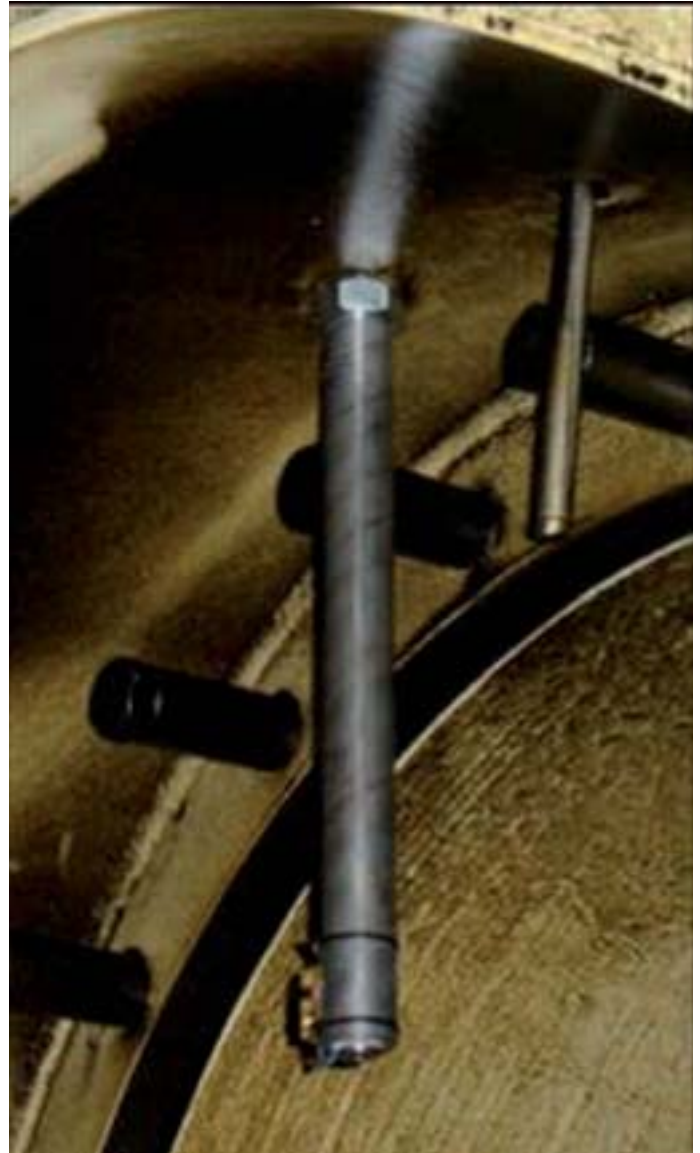
Fig. 59: Water mist sensor

The records showed that no plain water is passing the water mist catcher, but the situation with drain from the cooler casing is nevertheless dangerous. Further sensor installation will enlighten us with regard to mist carry-over, Fig. 59

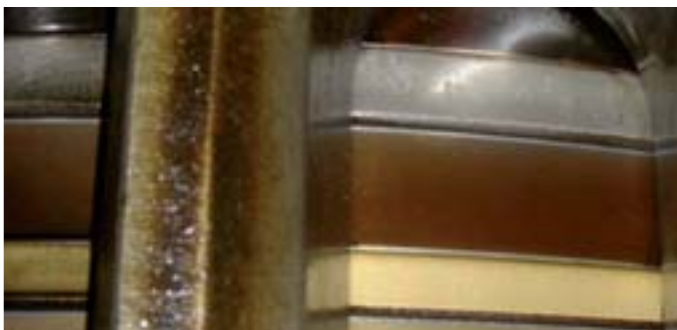
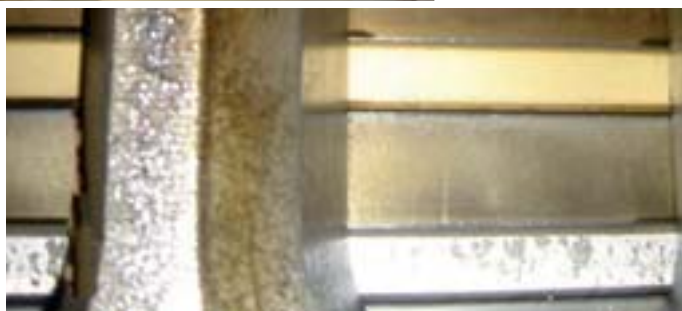
Fig. 58: Cylinder unit 8 rings, Port Klang

unit 8 and in the last hours before Port Klang, the liner temperature was stabilised as a result. In Port Klang, the rings of cylinder unit 8 were photographed through the scavenge port and minor damage to the hard-coat could be seen, see Fig. 58. Later records showed a stable cylinder unit 8.

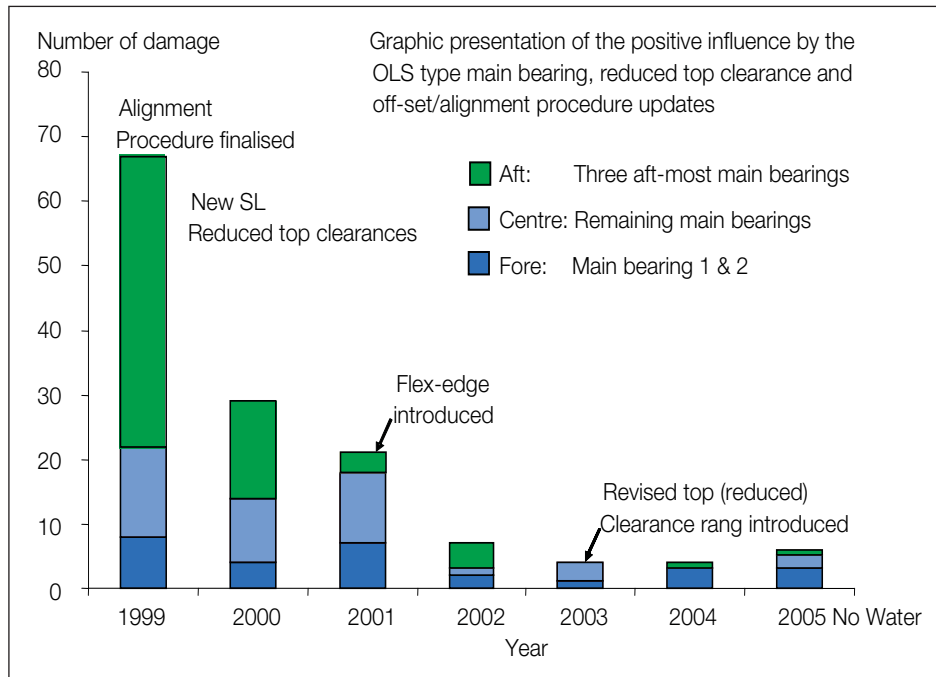
Fig. 60: Main bearing damage statistic

Since the last Meeting of Licensees in 2002, the positive development with respect to main bearing damage has continued. Despite the heavy increase in the number of main bearings on MC/MC-C engines, the number of reported damage remains at a constant low level, Fig. 60.

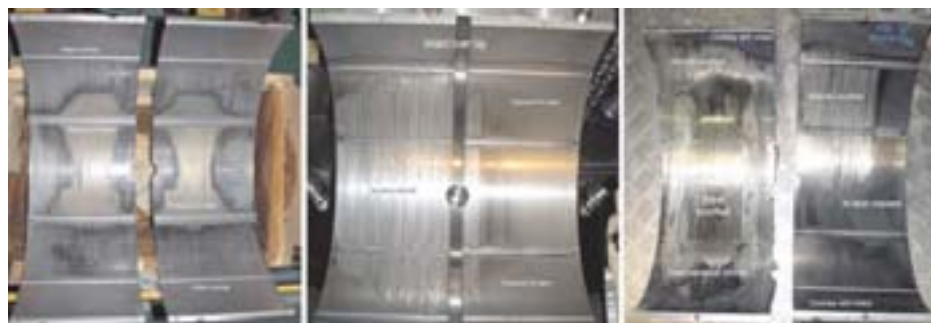
Fig. 61: Crosshead bearing overlay corrosion

For AlSn40 crosshead bearings, we have had a number of reports (nine (9) altogether) where overlay corrosion

has been found. In most cases, this has taken place on bearings where an interlayer of nickel has been exposed. It is well-known that the nickel has bad tribological properties and that a risk of scuffing between the bearing shell and crosshead pin is present, Fig. 61

In all cases of overlay corrosion, excessive water in the system oil has been detected. If the oil system becomes contaminated with an amount of water

exceeding our limit of 0.2% (0.5% for short periods), corrosion may start. A water content higher than 1% could lead to critical damage within few days of operation. A service letter has been sent out in order to inform (reinforce) about this phenomenon. In this service letter, the lead content level in the system oil has also been devised as an early method of detecting overlay corrosion of crosshead bearings, Fig. 62.

Partially corroded overlay, not yet scuffed
Overlay completely corroded, away, Ni 100% exposed, partial scuffing between Ni-layer and pin
Overlay completely corroded, away, partly scuffing between Ni-layer and pin, partly steel-to-steel

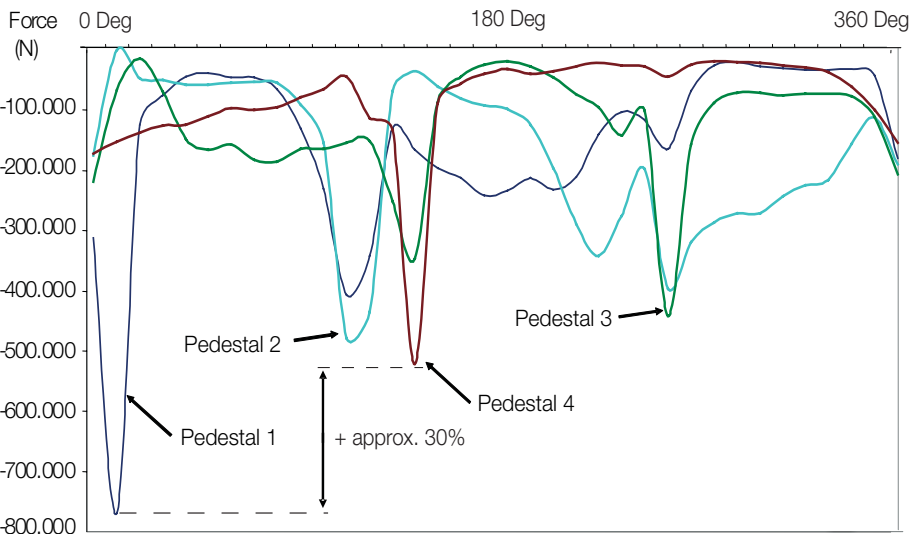
Fig. 64: Camshaft bearing pedestal loads

Cracks in the camshaft housing for a number of K98MC-C engines have been detected over the last six months. At the time of writing, six (6) engines have been affected. In all cases but one, the cracks were found in the camshaft bearing pedestal No. 1. Analyses have shown that bearing pedestal No. 1 is approx. 30% more loaded than other camshaft housing bearing pedestals, Fig. 64.

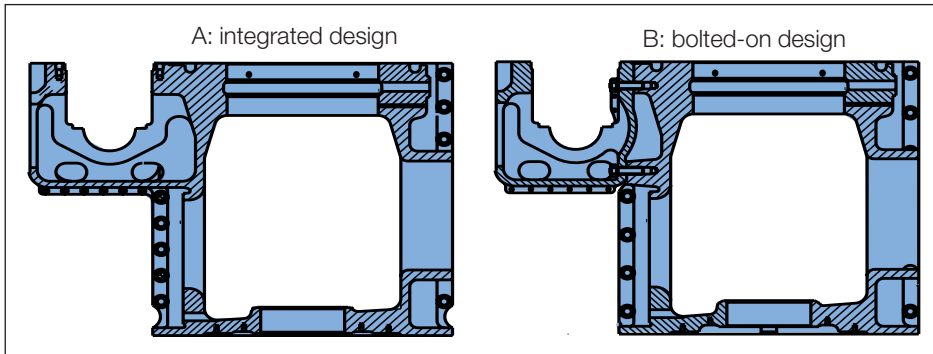
Fig. 67: Cylinder frame camshaft housing design

two (2) different designs for camshaft housings on the K98 engines, Fig. 67:

Cracks have been detected in both cases. However, repair methods differ somewhat. The following scenarios have been considered:
