Service Experience 2008, MAN B&W Engines ME/ME-C and MC/MC-C Engine Series

MAN Diesel • Copenhagen, Denmark

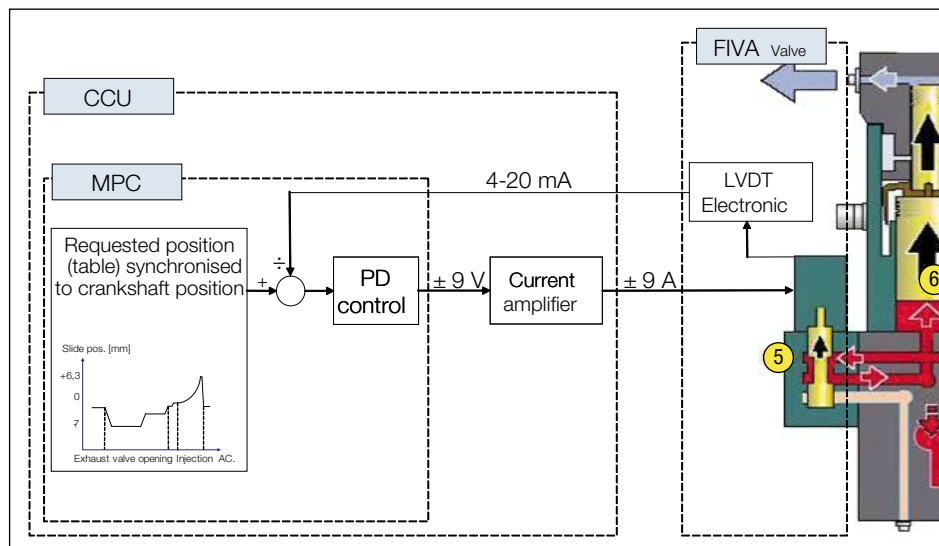
Fig. 8.3: FIVA valve position control

The feedback loop of the FIVA valve position control, Fig. 8.3, has caused untimed injection and untimed exhaust valve operation owing to various reasons. These reasons are related to the FIVA valve itself in some cases, and in other cases to the part of the feedback loop in the multi purpose controller (MPC), see multi purpose controller chapter.

In the original version, the electronics on the printed circuit board (PCB) in the Curtiss Wright FIVA valve showed thermal instability causing untimed actuation of the valve. The reason was an analogue voltage regulator generating

an excessive amount of heat raising the temperature by 35°C on the PCB. In some cases, this caused a temperature shutdown of the LVDT converter in the feedback loop, resulting in the above-described unstable function of the FIVA valve. The solution was to exchange the analogue voltage regulator with a switch mode regulator, Fig. 8.4. Hereby, the temperature of the PCB was lowered by approx. 35°C.

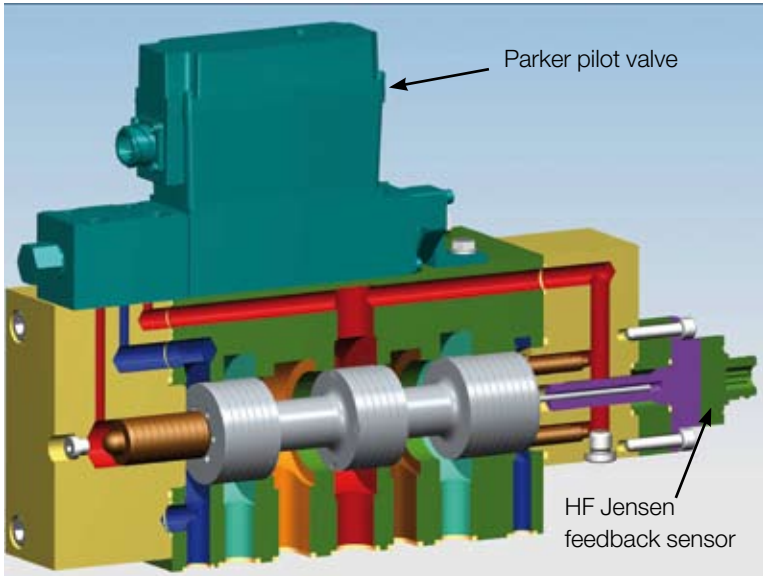
Fig. 8.7: MAN B&W FIVA valve

The MAN B&W FIVA valve can be seen in Fig. 8.7. It consists of a valve main body on which the Parker pilot valve and the H. F. Jensen feedback sensor are mounted. For the Parker valve, we

have seen a number of units failing because of:

- A: Broken bushing for the pilot slide, Fig. 8.8a. This item was rectified during the prototype testing period
- B: Earthing failure owing to damage of a flexible wire strip inside the valve, Fig. 8.8b
- C: Malfunction owing to failing operational amplifier, Fig. 8.8c

- A: Breakage of the rod in the sensor. The rod in the sensor has been redesigned, Fig. 8.9a
- B: Broken or loose connection between the print board and the external connector (type: Canon), Fig. 8.9b. Redesign of the connection has solved the problem.

Parker valves with certain serial numbers have been replaced in service.

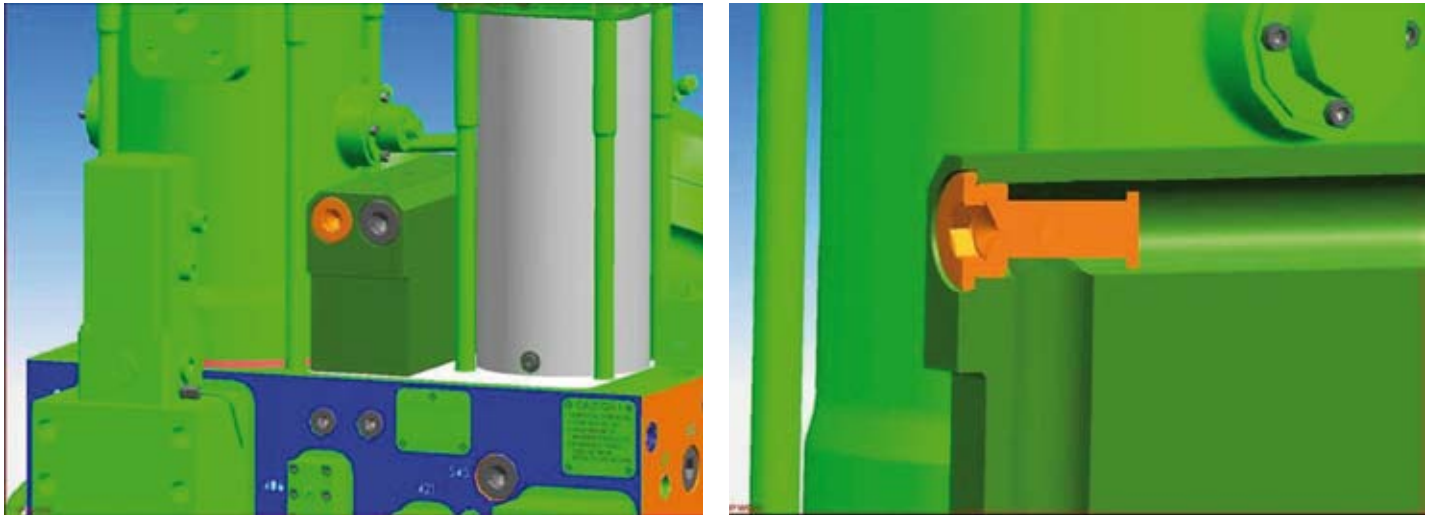
Fig. 8.12: Orifice in the drain line from the FIVA valve

Cavitation in the exhaust valve actuation system has been seen in the exhaust valve top part, Fig. 8.11a, as well as in the exhaust actuator top cover, Fig. 8.11b.

Furthermore, damage to the oil inlet non-return valves on the actuator top cover indicates excessive pressure fluctuations in the exhaust valve actuation system.

Introduction of ring orifice corresponding to a 20 mm orifice in the hydraulic system for exhaust valve on K98ME-C

An orifice in the drain line from the FIVA valve, Fig. 8.12, has been introduced to reduce the acceleration of the actuator piston and hereby eliminating cavitation on the actuation side.

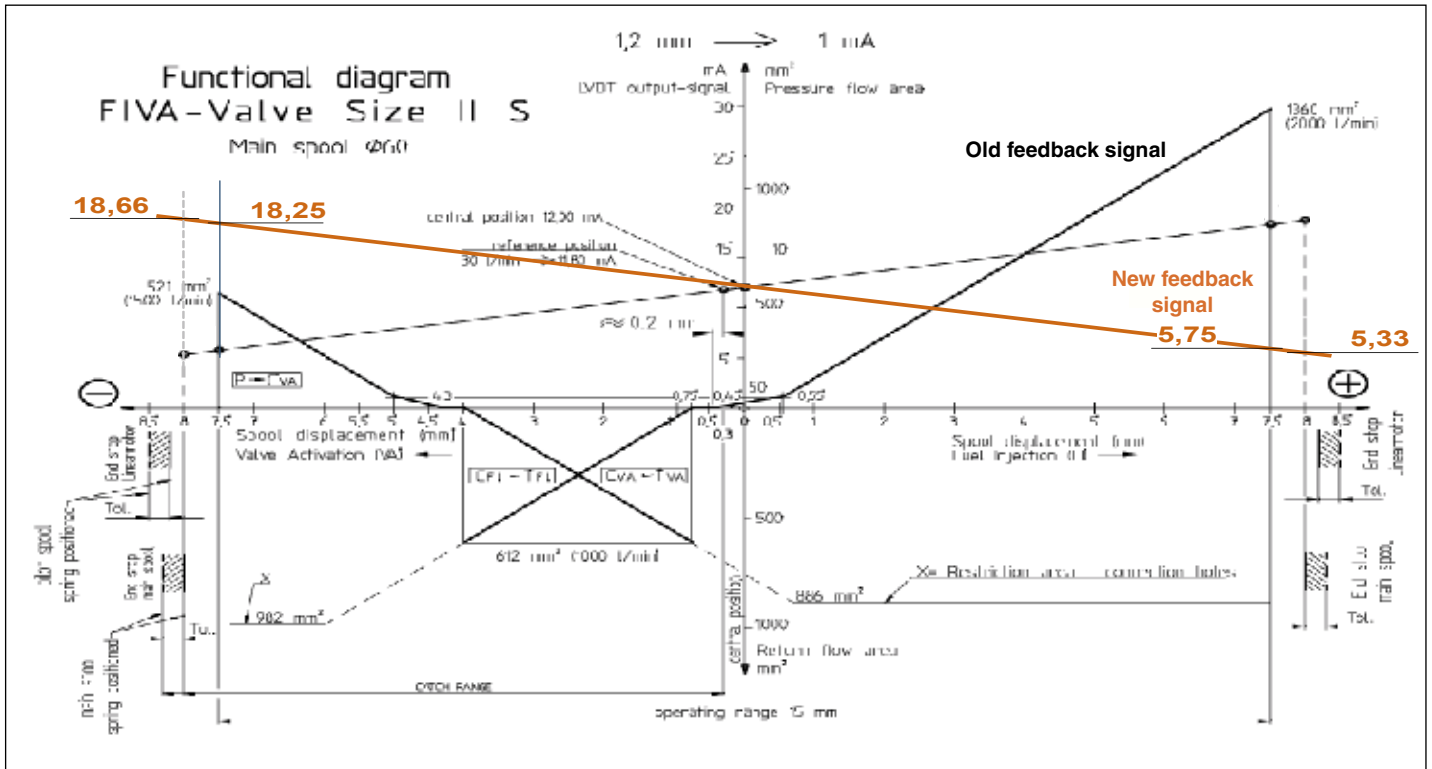
Fig. 8.16: FIVA valve flow area diagram

Secondly, it was concluded from tests that the reason why the error in the feedback loop of the MPC caused an untimed injection was that the feedback signal froze on a low value. When the closed loop control tried to rectify the position of the main slide in the FIVA valve, it moved the main slide towards

fuel injection and continued to do so until injection (untimed) was accomplished. This was done because of the frozen low-value feedback signal.

Based on this knowledge, it was decided to invert the feedback signal, Fig. 8.16. By doing this, a frozen low value feedback signal will result in a FIVA main slide movement towards untimed opening of the exhaust valve. This is considered to be “failing into safe mode”.

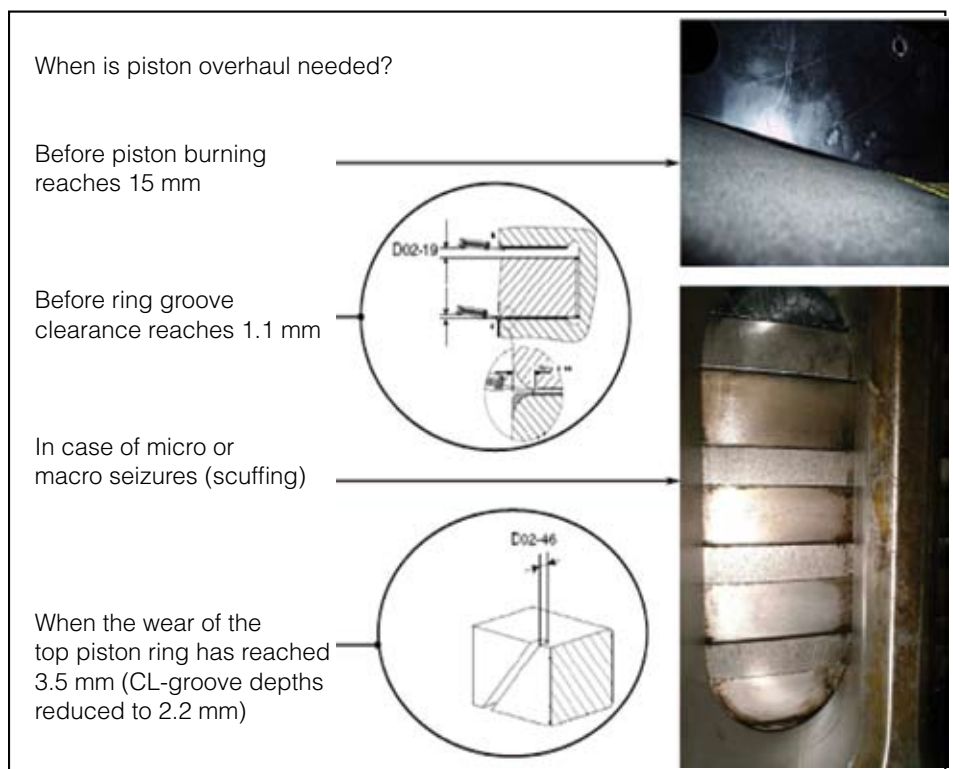
Fig. 8.23: K98 example. The four (4) important factors for piston overhaul

The most important factors for piston overhauls are, Fig. 8.23:

- Piston ring wear
- Max. amount of hot corrosion of piston top allowed on the centre part (where it is normally highest) is 9/12/15 mm on, respectively, 80/90/98-bore engines
- Ring groove clearance
Max. recommended clearance is 1.0 mm on the 80 and 90-bore engines, and 1.1 mm on 98-bore engines
- Sticking, broken or collapsed piston rings or leaking pistons
- Macro-seizures on piston ring running surfaces.

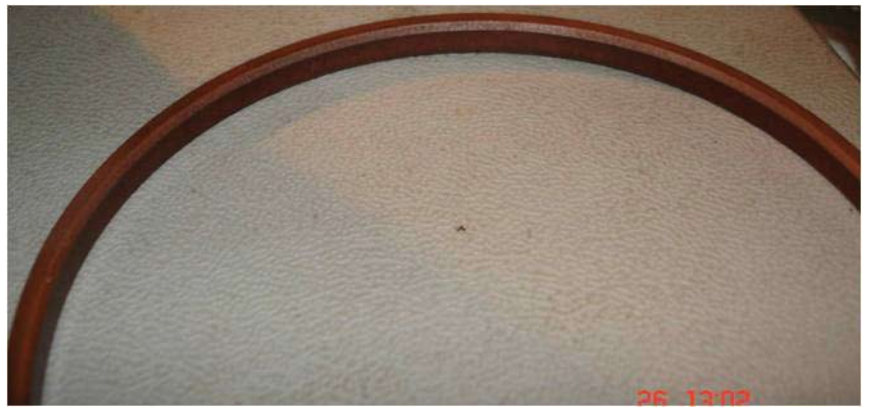
Fig. 8.34: Inspection of COL design

30,000-35,000 hours, based on results from several test units on 98, 90 and 60 bore engines. This illustrated by Fig. 8.34 showing an open-up inspection on a K98.

7K98MC: COL test unit, inspection after running hours 20,468 hours

Clean lubricated spindle guide and a sealing ring with a wear profile which well indicate running up to 30,000-35,000 hours

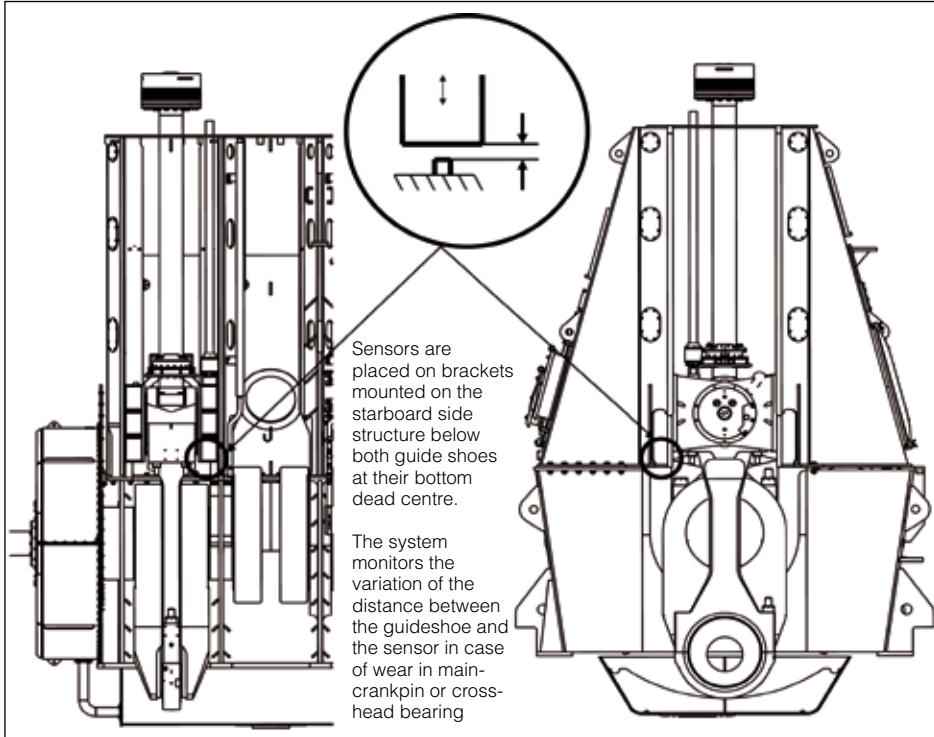
Fig. 8.38: Bearing Wear Monitoring (BWM), position of sensors

In principle, the BWM system monitors all the major bearings (main, crankpin and crosshead) by measuring the distance to the bottom dead centre of the crosshead, Fig. 8.38. The distance will decrease if wear occurs in one of the major bearings, and the BWM system can then give an alarm.

However, in a few cases we experienced severe damage causing long-term off-hire periods involving also costly repairs of the bedplate and/or the crankshaft. An example is shown in Fig. 8.37. In this case, the reason for the damage was incorrect assembly after an open-up inspection of a main bearing after sea trial. This sequence of events following open-up inspections of bearings is unfortunately being reported from time to time. We have therefore changed our instruction material, not calling for open-up inspection at regular intervals. In parallel, we have made so-called bearing wear monitoring (BWM) systems a standard on engines ordered in 2008. BWM systems can also be retrofitted on existing engines
