# Service Experience

MAN B&W Low Speed Diesel Engines

# Service Experience of MAN B&W Low Speed Diesel Engines

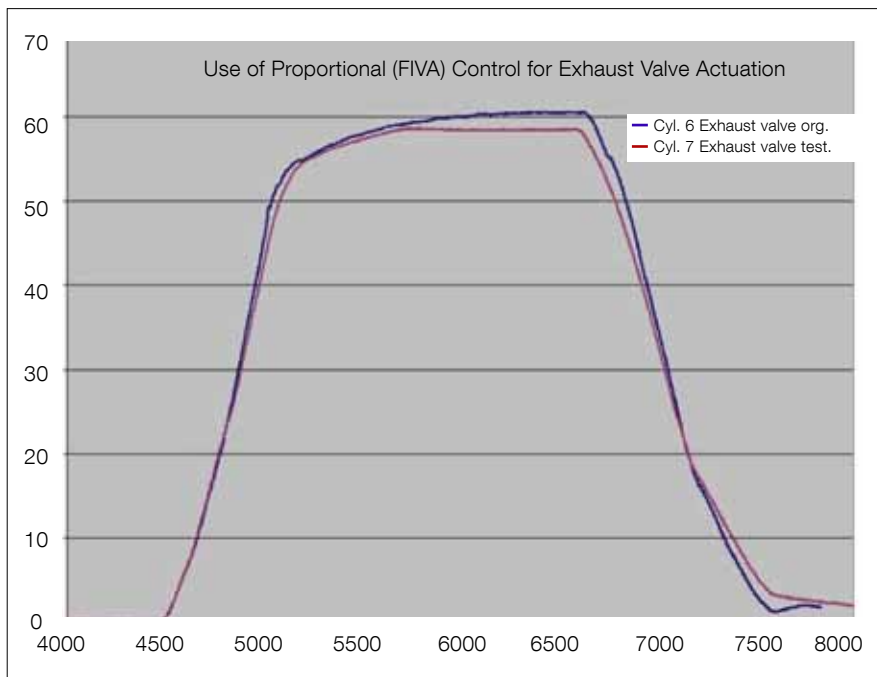
Fig. 2: Use of proportional (FIVA) control for exhaust valve actuation

presently ongoing. So far, we have only used the proportional control of the FIVA valve for injection rate shaping, but now we also use it in order to open and close the exhaust valve gently. Fig. 2 shows the original lifting curve and the modified lifting curve of the exhaust valve. No

big changes can be seen. However, the oil pressure fluctuations in the actuator system are modified to some extent, and we expect that this will reduce/eliminate the cavitation damage in the exhaust actuation system.

Service tests where the proportional feature of the FIVA valve is used are

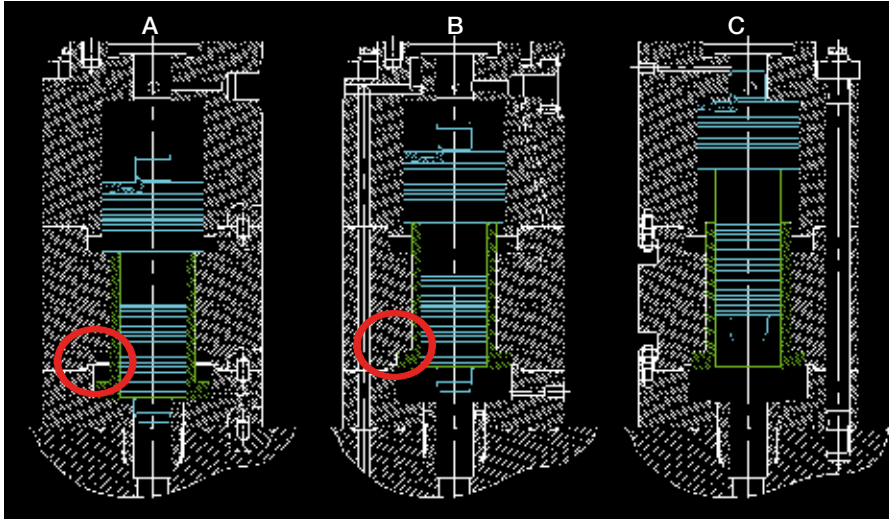
Fig. 3: Exhaust actuator

The exhaust actuator for the ME engines is a two-step actuator. The principle of function is shown in Fig. 3. Fig. 3 (A) shows both pistons (step 1 and step 2) in bottom position. Fig. 3 (B) illustrates

how the step 1 piston is stopped in the “damper” as the step 2 piston continues its movement upward. In Fig. 3 (C), the step 2 piston has arrived at its top position caught by another “damper”.

On a few actuators for the original 200 bar hydraulic system, we have seen breakage of the step 1 piston collar, Fig. 4. We are convinced that this problem relates to delayed “take-off” of the step 1 piston from the bottom position, Fig. 3 (A). This is caused by a “glue” effect, which exists from time to time. When the step 1 piston is delayed it will create very high pressures in the “damper” chamber and hereby increased load on the piston collar is generated. Various means to avoid the “glue” effect can be introduced by generating a force by the oil pressure under the step 1 piston. An example of retrofit is illustrated in Fig. 5. Such design modifications will eliminate the trouble with step 1 piston breakage.

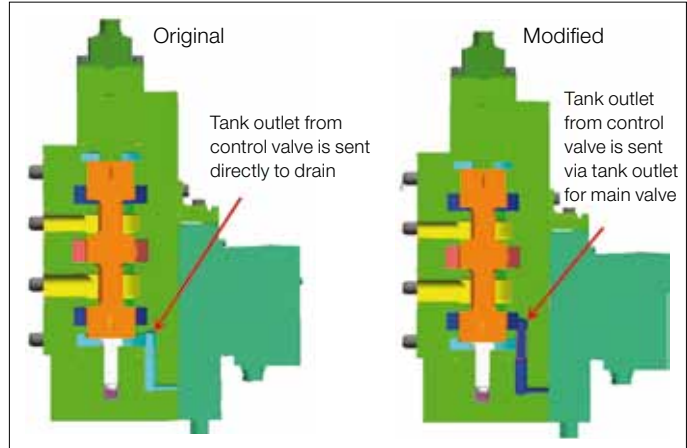
Fig. 8: MAN B&W FIVA: Cavitation countermeasure test 1

The cavitation damage on the Parker spools is mainly related to the tank ports for the pilot step. We have therefore designed two (2) service tests, which are currently accumulating hours on two (2) 12K98ME plants. Fig. 8 shows the test

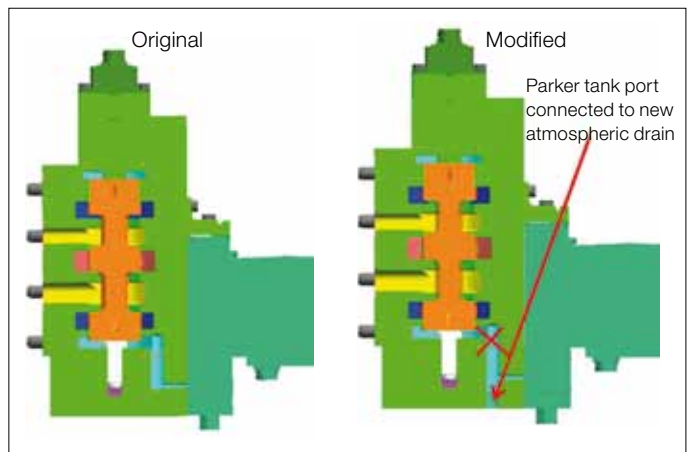
Fig. 9: MAN B&W FIVA: Cavitation countermeasure test 2

FIVA with the pilot tank port connected to the FIVA main spool pressurised tank port. Fig. 9 shows the other FIVA valve with the pilot tank port connected to a completely pressure-less drain.

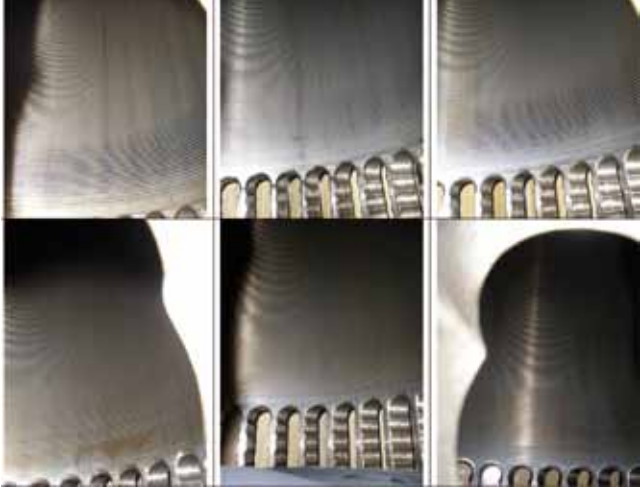
Fig. 17: Pitch-honed liner

Scavenge port inspection has been carried out after 1,842 running hours. The results can be seen in Figs. 15 and 16 for piston ring and piston skirt condition, respectively. Fig. 17 shows the pitch-honed liner from the scavenge ports. All inspection areas indicate that

very successful running-in has taken place and that the cylinder condition for all units is excellent.

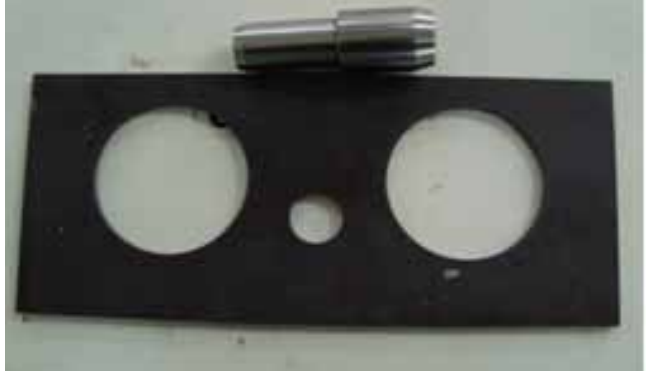
Fig. 20: High-friction shim and guide pin

A new main bearing design concept has been introduced on the 7K80ME-C9. The result of this new design concept is improved productivity during machining of the bedplate. Figs. 20 to 23 show the results of the overhaul inspection of main bearing No. 5 after 3,800 hours.

The inspection results indicate excellent condition with respect to contact surfaces, with signs of relative movements as well as very good main bearing shell load imprints.

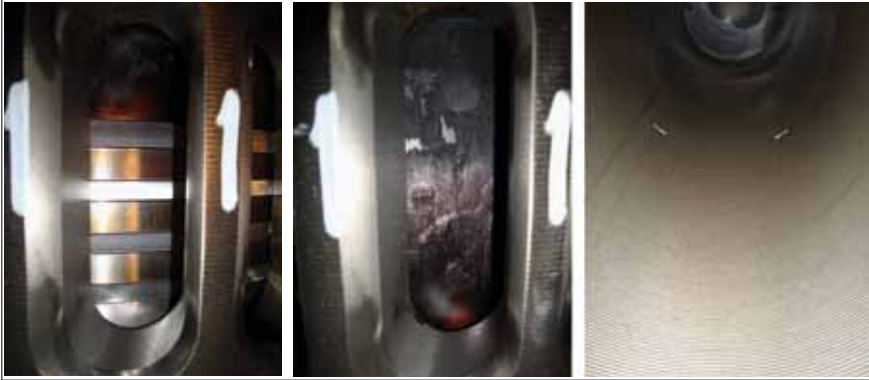
Fig. 24: Scavenge port inspection

At the time of writing, two 6S40ME-B9 and two 8S35ME-B9 engines are in service. A scavenge port inspection was made after 2,574 hours of operation on the 6S40ME-B9 prototype. Fig. 24 shows pictures from this inspection.

Running hours:	2,574
Condition:	Good. No signs of abnormal wear or micro-seizures. No alu-coating left
Present cylinder oil dosage:	0.75 g/kWh
Recommended cylinder oil dosage:	Keep lubricating according to the cylinder oil test by following service letter SL09-507
CL groove:	Not accessible
Topland:	Light deposits

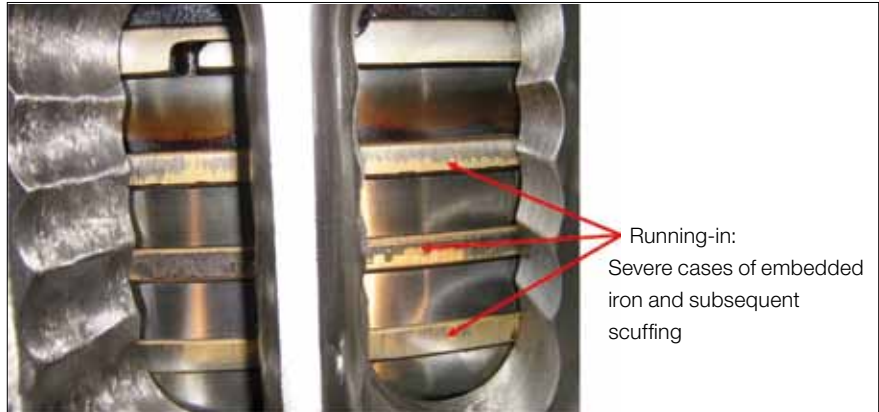
Fig. 29: Increased focus on piston ring quality and liner surface quality

Lately, we have had to focus on running-in problems, typically at running hours between 500 and 1,000. The reason for the running-in problems is the piston ring quality in combination with the cylinder liner surface quality. Fig. 29 shows a severe case of running-in problems due to embedded iron on

liner machining was checked and re-honing was carried out in case of off-spec. condition.

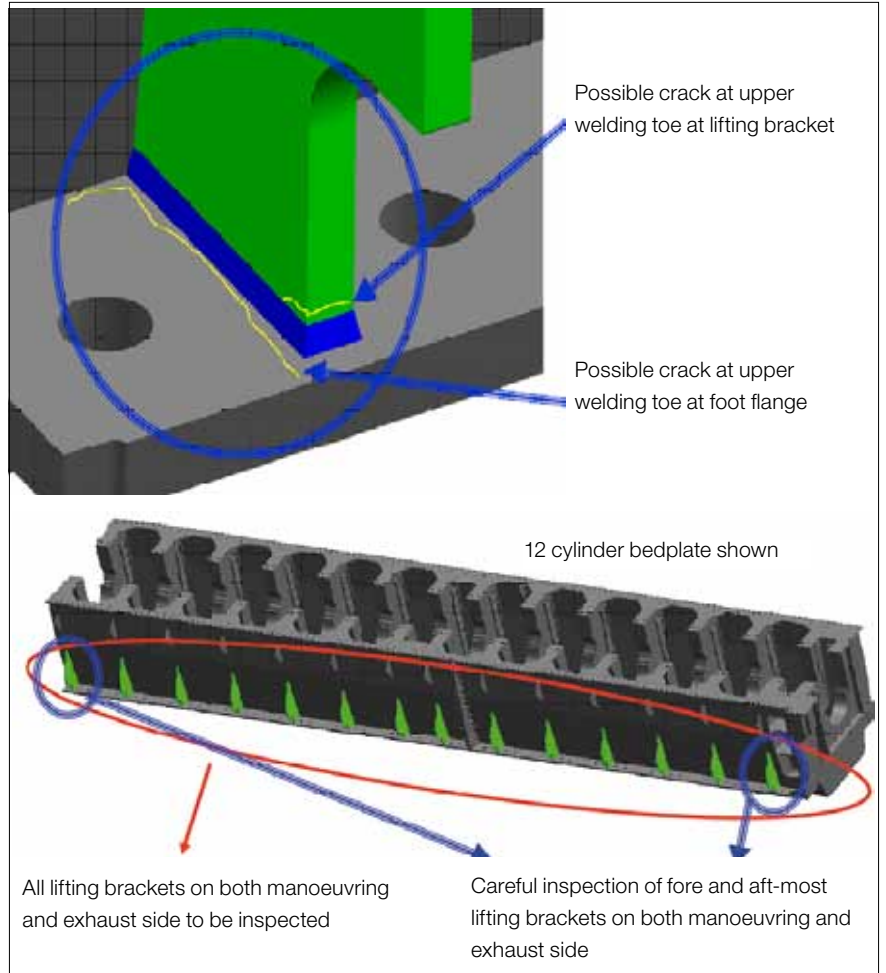
Fig. 36: Circular letter: K98 lifting bracket cracks

In 2008, cracks in the lifting bracket on K98 bedplates were discovered on engines produced 5-7 years earlier, see Fig. 35. Soon after the first cracks were discovered, a so-called 'Circular Letter' was issued to all owners/operators of K98 engines, see Fig. 36. In this letter we asked for help to inspect for lifting bracket cracks. Furthermore, we informed about preventive countermeasures, which were burr grinding of the weld seams on the aftmost and foremost brackets. Also, a repair procedure was developed when the cracks first occurred. A modified bracket profile has been designed for new engines, see Fig. 37.

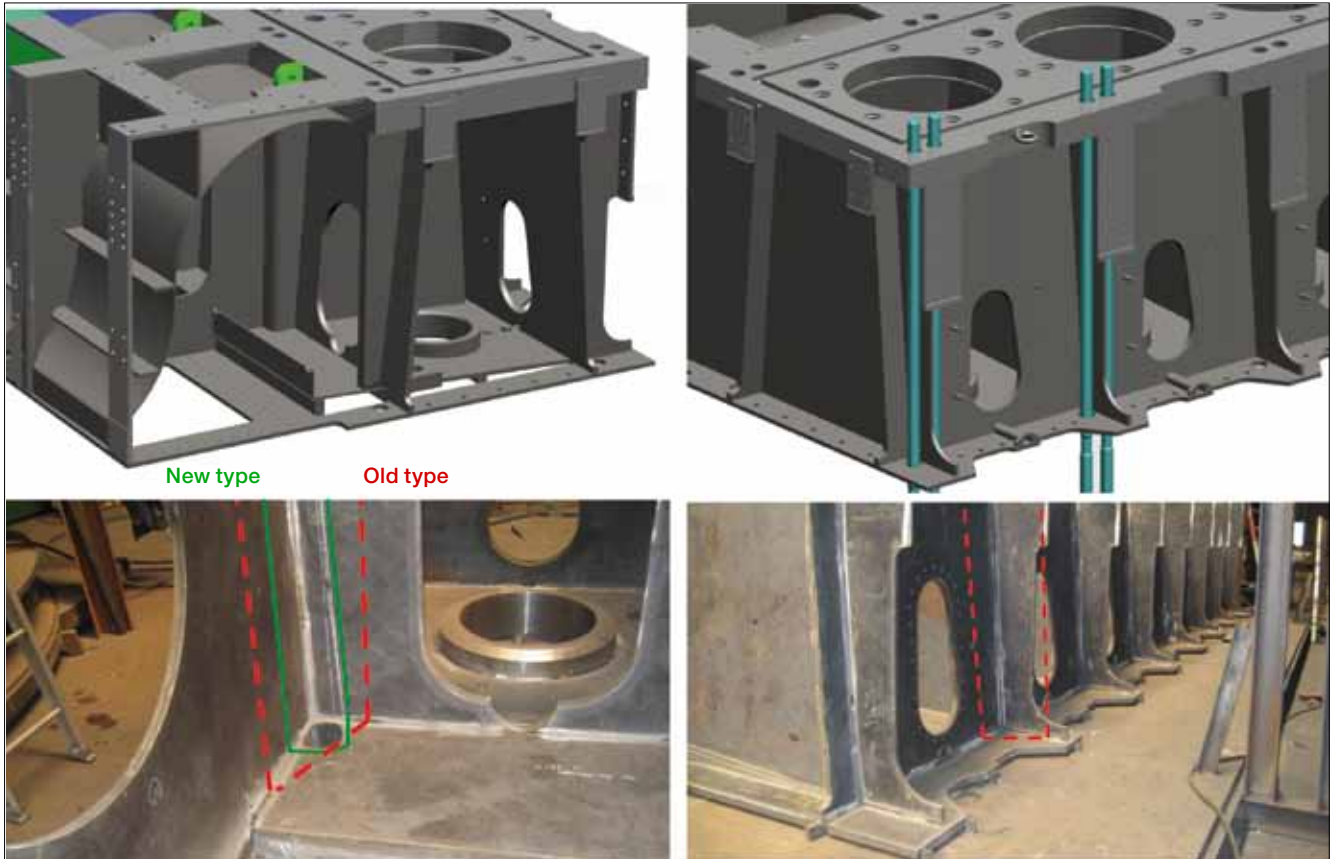
Thin, bent stay bolt cover in exhaust side. **New type/old type**  
 Fig. 40: Welded cylinder frame: old and new type stay bolt cover designs

Pump side stay bolt cover omitted. Stay bolt visible

We are confident that the crack problems related to the stay bolt cover plates have now been eliminated. For engines in service with first generation welded cylinder frames, repair work is in progress.

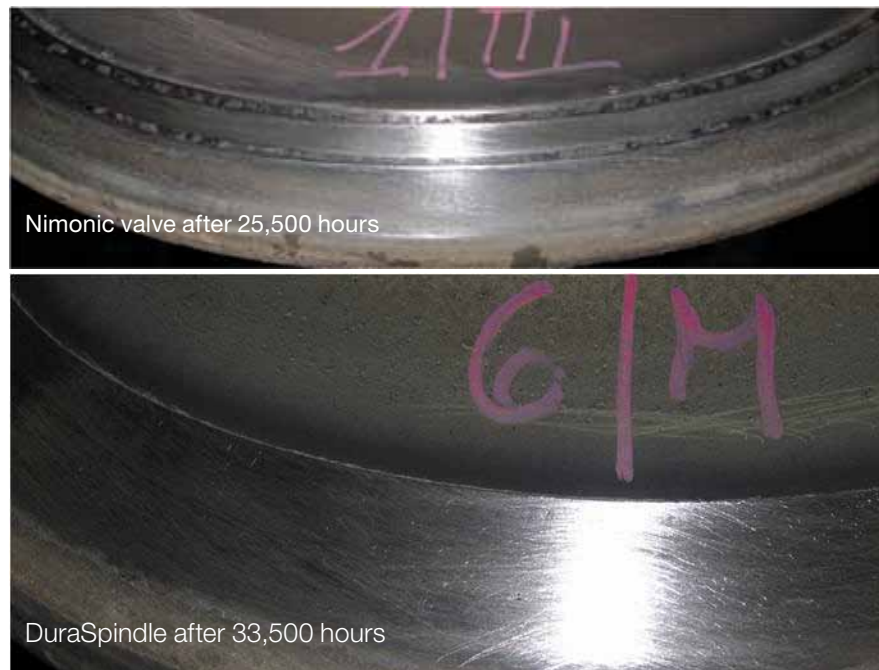
Fig. 44: W-seat in combination with Nimonic spindle and DuraSpindle on an S60MC

For the exhaust valve, the use of W-seat, see Fig. 43, and either Nimonic valve spindle or DuraSpindle has improved the overhaul intervals to run more than 32,000 hours. Fig. 44 shows examples of an excellent condition without overhaul with combinations of a W-seat/nimonic spindle and a W-seat/DuraSpindle achieved on an S60MC engine after 25,500 hours and 33,900 hours, respectively.

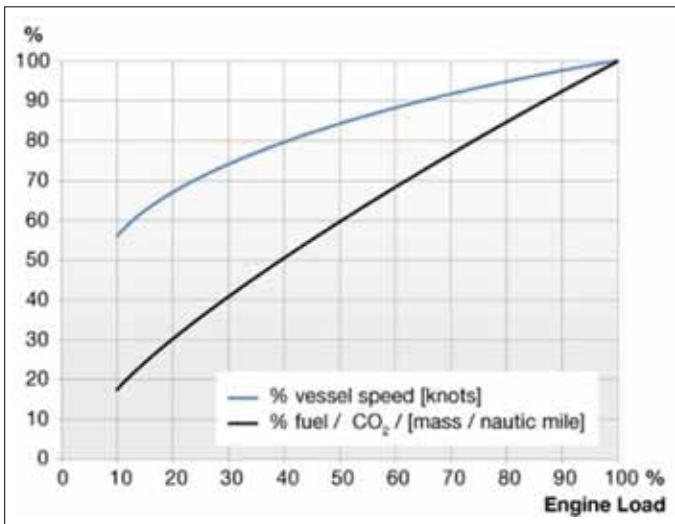
Fig. 56: Low load operation

Slow steaming has also become very relevant due to the financial situation in the world. Also on this topic, we have issued service letters relevant for MAN B&W low speed engines, SL08-501/SBE, Ref. [6], and SL09-511/MTS, Ref. [7]. The reason for the desire for slow steaming can be seen in Fig. 56.

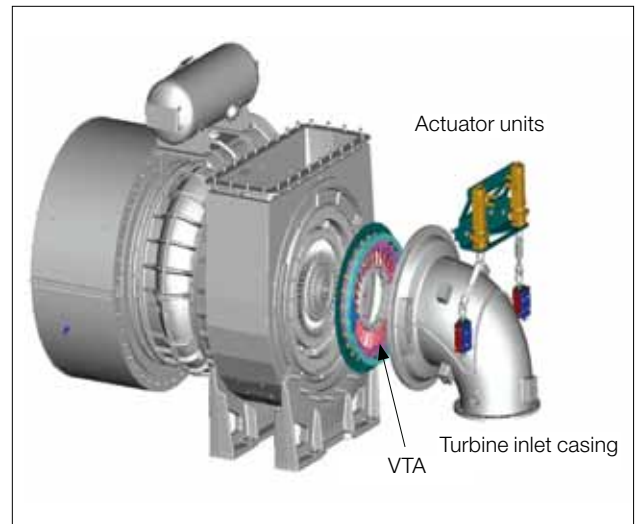
Fig. 57: Turbocharger with variable turbine area (VTA)

The first VTA turbocharger has been in service for well over 10,000 hours on a 6S46MC-C engine on a vessel operating on heavy fuel. Service experience has been very good and the test continues. More details with respect to service experience can be found in the Worldwide Turbocharger Conference 2009 paper, Ref. [8].

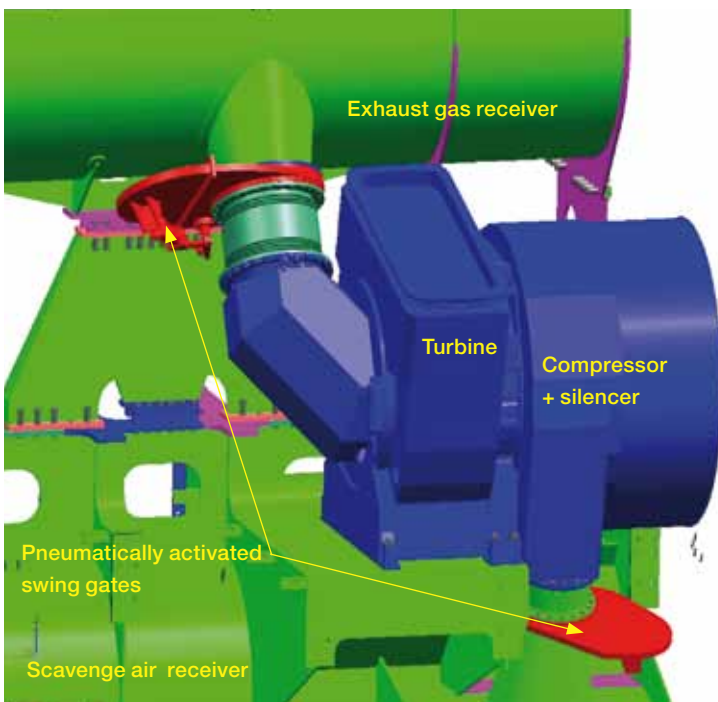
Fig. 61: Pneumatically activated swing gates

A flexible T/C cut-out system assisted by an arrangement of so-called swing-gate valves, Fig. 61, has been successfully tested on a 12K98ME engine with three turbochargers. The middle turbocharger was retrofitted with swing-gate valves.

turbocharger were both in normal, good condition.
