Service experience

MAN Energy Solutions

Two-stroke technologies

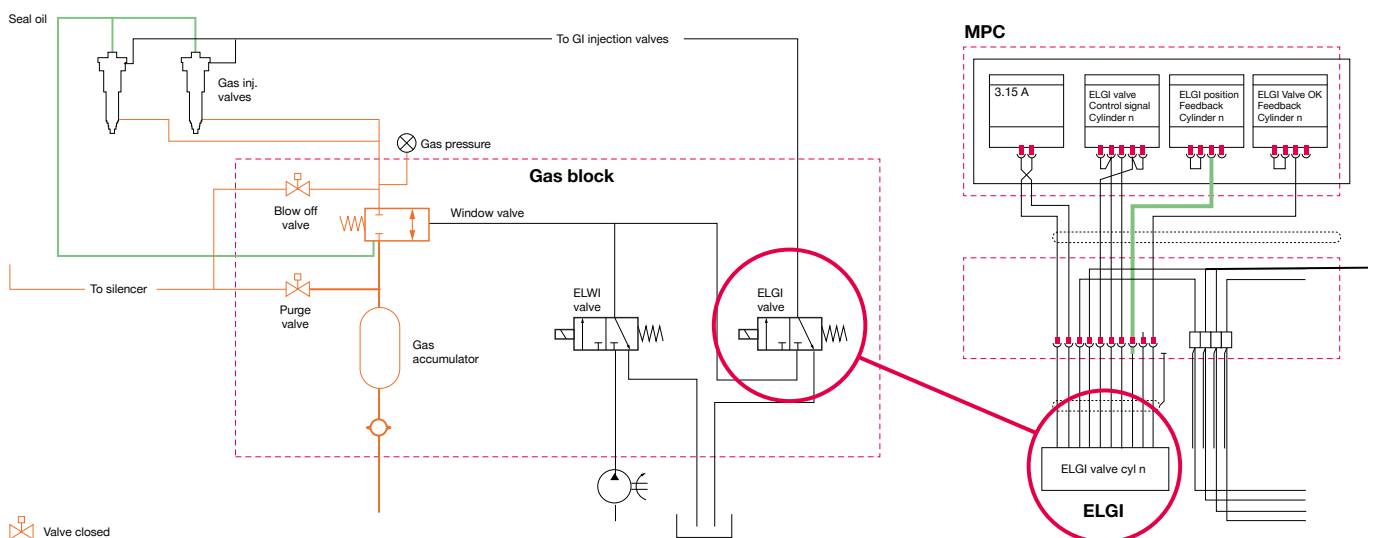
Fig. 1: Position feedback supervision of the ELGI valve

In 2017, we experienced a few cases of overheating of the gas-block on the ME-GI engines after gas purging. On one of the vessels, engine operation continued on liquid fuel while the crew tried to restart gas operation without trouble shooting. An electronic gas injection (ELGI) valve stuck in open position resulted in overheating of the gas-block and damage to various seals. In order to avoid this, we introduced the new engine control system (ECS) software with supervision of the ELGI position feedback. This made it impossible to restart gas operation before the ELGI valve was exchanged or rectified, see Fig. 1. Since this modification was introduced (at the time of writing it is one and a half year ago) no further incidents have occurred.

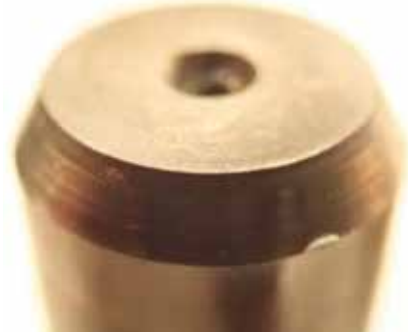
Fig. 6: Spindle tip with lapping marks still visible after 8,000 operating hours

Based on recent inspection of the gas injection valves (GIVs) it has been concluded that the service lifetime of these can be increased. Extremely low wear of the spindle seat was confirmed after approx. 8,000 operating hours and the lapping marks were still visible on the seat (see Fig. 6). We believe that an increase from 16,000 hours to 32,000 hours is possible, and a further increase in lifetime may be possible.

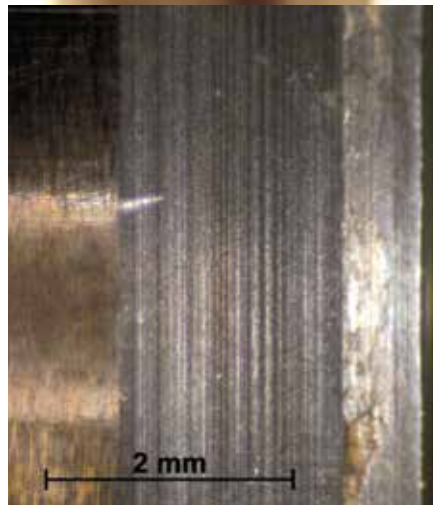
The GIV nozzles have been in focus since a few hundred hours of operation were obtained on the first ME-GI engines in service. Cracks were observed in the nozzles within a short period of operation, see Fig. 7.

Fig. 7: Cracks in the GIV nozzle

With today's updated GIV, the short nozzle version made of tool steel (S40Cr5Mo1V) in Fig. 8, we are able to obtain a lifetime of 8,000 hours as stipulated in our lists of guiding overhaul intervals.

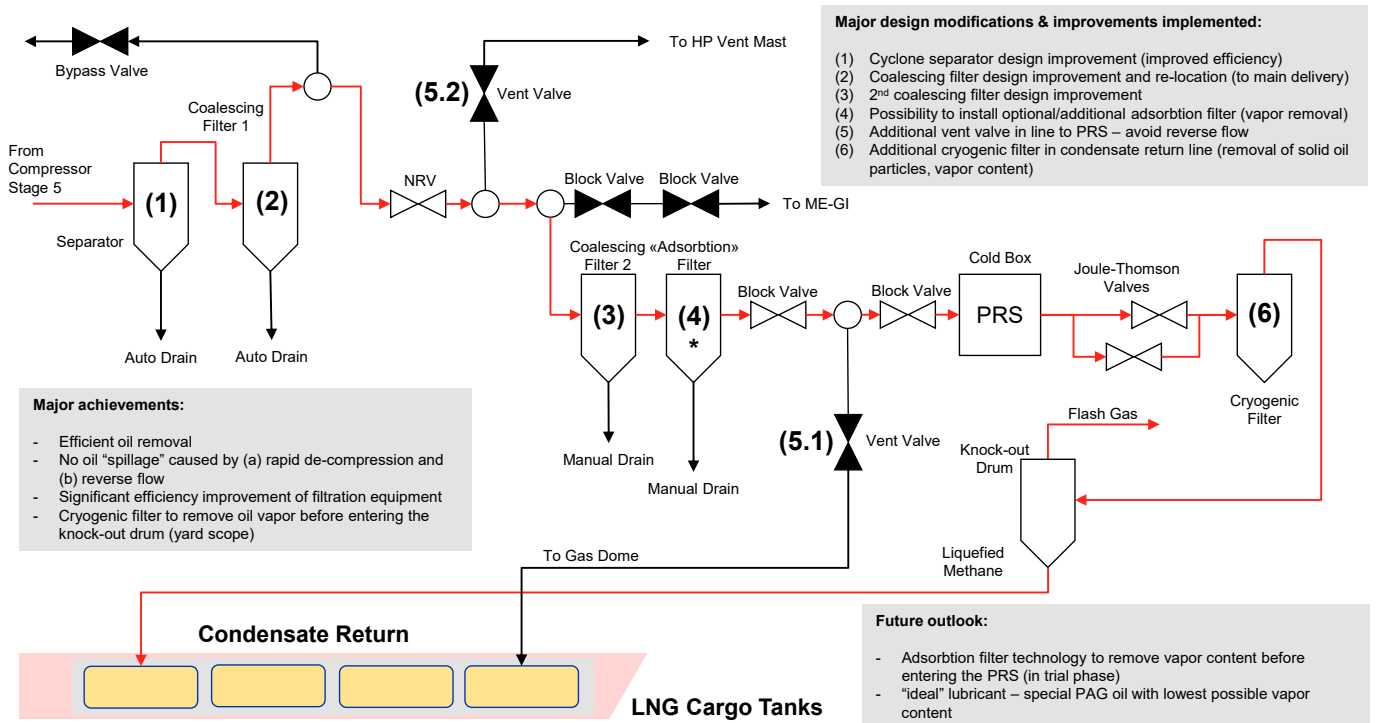
Fig. 16: Oil trap system before the LNG tanks

Furthermore, oil transfer from the compressor to the LNG tanks has been seen. The solution is installation of an oil trap system before the BOG returns to the LNG tanks, see Fig. 16.

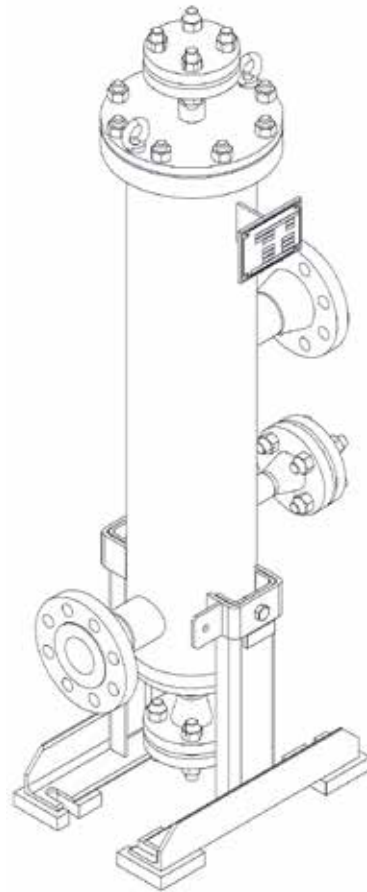
Fig. 21: The cryogenic 10 micron filter should be installed before the HP pumps

In some cases the LNG high-pressure (HP) pumps have had a limited service time because the cold end of the pumps has been worn. The wear has been caused by contamination of gas and piping and the solution is an installation of a cryogenic 10 micron filter in front of the HP pumps, see Fig. 21.

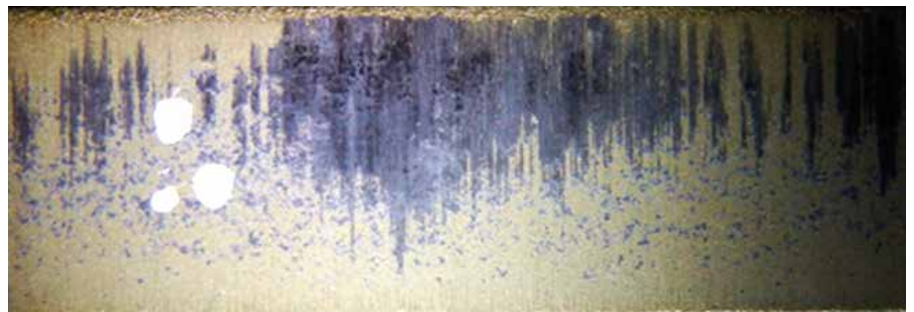
Fig. 28: Piston ring running surface where the hard coating (CM1) has penetrated the running-in alucoat

In the early days, the majority of scuffing occurred in the period just after the alucoat had been worn off. This led us to focus on the roughness of the CM1 layer, which is specified as “as-sprayed.” Pictures, where the CM1 layer has penetrated the alucoat, (Fig. 28) showed many small dots indicating a too high surface roughness.

This phenomenon is known to cause scuffing. In addition, some defects were discovered in the coating matrix with un-molten particles, which may potentially weaken the coating matrix.

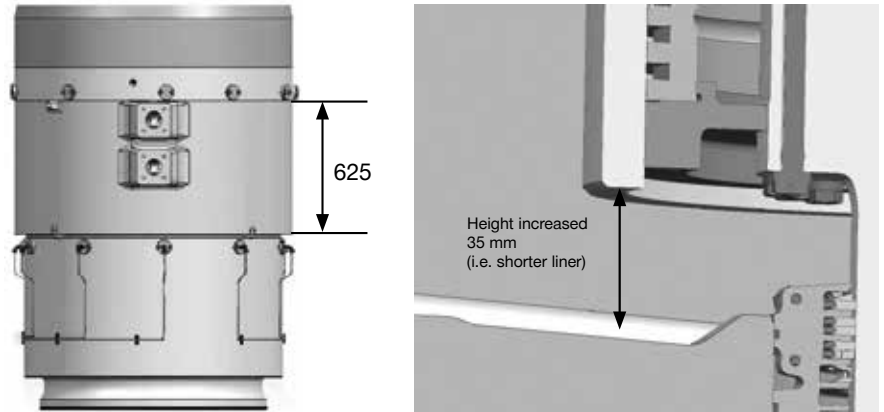
Fig. 30: Left: cylinder liner cooling jacket height; Right: clearance between liner and scavenge bottom

Four main design changes were introduced on the cylinder liners for the G95 engines. In the first inspections of the cylinder liner surface hard contact marks were found as indicated in Fig. 29.

Firstly, reducing the inner diameter of the PC-ring solved the upper contact problem and increased the clearance between the O-ring and the cylinder frame at the lower contact point, which resulted in an increased PC-ring efficiency. Secondly, a longer liner cooling jacket was introduced to improve both the liner deformation and the cooling of the piston rings, see Fig. 30 (left side). As a third countermeasure the airflow path below the liner was

improved to reduce the air speed between the scavenge box bottom and liner as shown in Fig. 30 (right side).

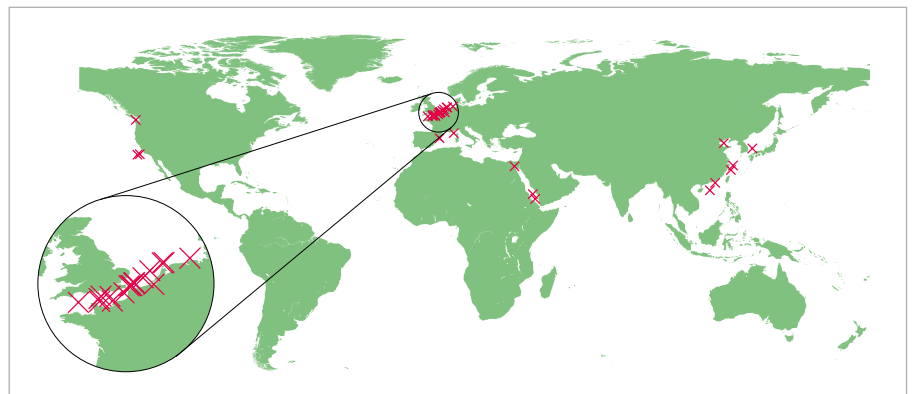
Fig. 35: Location of scuffing incidents in 2018

Fig. 35 displays the locations of all scuffing incidents in 2018 for which the start of the incident could be clearly identified. About 70% of all scuffing incidents happened inside an Emission Controlled Area (ECA). Furthermore, scuffing has not only occurred in the European ECAs, but also in the Asian and American ECAs.

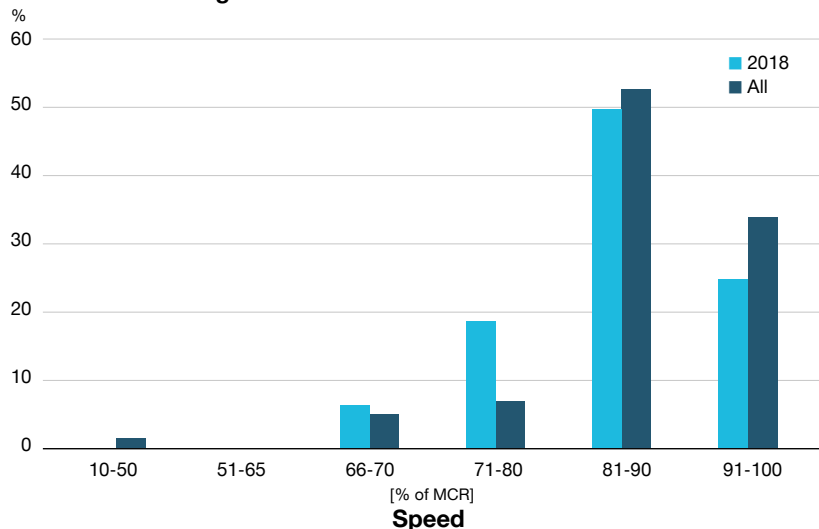
Fig. 36: Scuffing events 2018, grouped according to engine speed

engine speed is above 80% MCR speed, but there is no strong indication that scuffing happens solely at high engine load or speed as shown in Fig. 36.

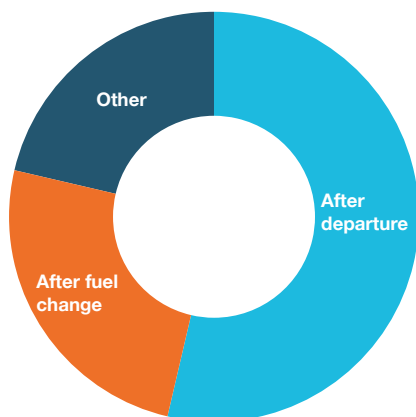
Fig. 37: Scuffing incidents in 2018, grouped according to the cause of the incident

A large fraction of all scuffing cases typically starts shortly after departure from a harbour, where load-up of the main engine takes place. More precisely, 55% of all scuffing cases occurred within the first 12 hours after departure. Besides the scuffing incidents occurring shortly after departure, there is another group of scuffing incidents, which take place after a fuel changeover from high- to low-sulphur fuel. In 2018, 25% of all scuffing cases took place within just 12 hours after such a fuel changeover, as shown in Fig. 37.

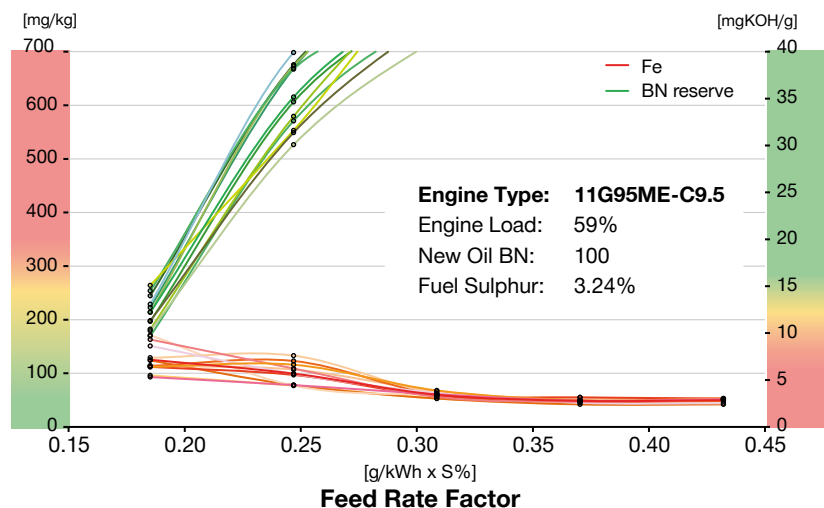
Fig. 39: Feed rate sweep test

which consists of a stepwise reduction of the cylinder oil feed rate, one step every 24 hours while also taking drain oil samples. Once analysed, a graph can be drawn that shows the correlation between feed rate factor, the iron content and the BN of the drain oil. Fig. 39 shows the sweep test results that when using a BN100 cylinder oil a very low FRF is needed to control the cold corrosion.

One of the typical reasons for liner scuffing is liner bore polish, which may occur when using a too high feed rate and an oil with too high BN.

To optimise the G95ME-C9.5 operation, the operators were recommended to switch to BN70 oil instead of BN100 to ensure that the risk of bore polish was reduced, as many incidents had happened during manoeuvring. A temporary increase of the minimum feed rate from 0.6 to 0.8 g/kWh was also recommended. Once the new LCDv2 features were introduced with the new ECS 1609-6, the guiding minimum was again reduced to the normal 0.6 g/kWh. When using BN70, the FRF often remained low. Cold corrosive wear could only be observed when shutting down the LDCL cooling system and refraining from increasing the part-load temperature. However, liner

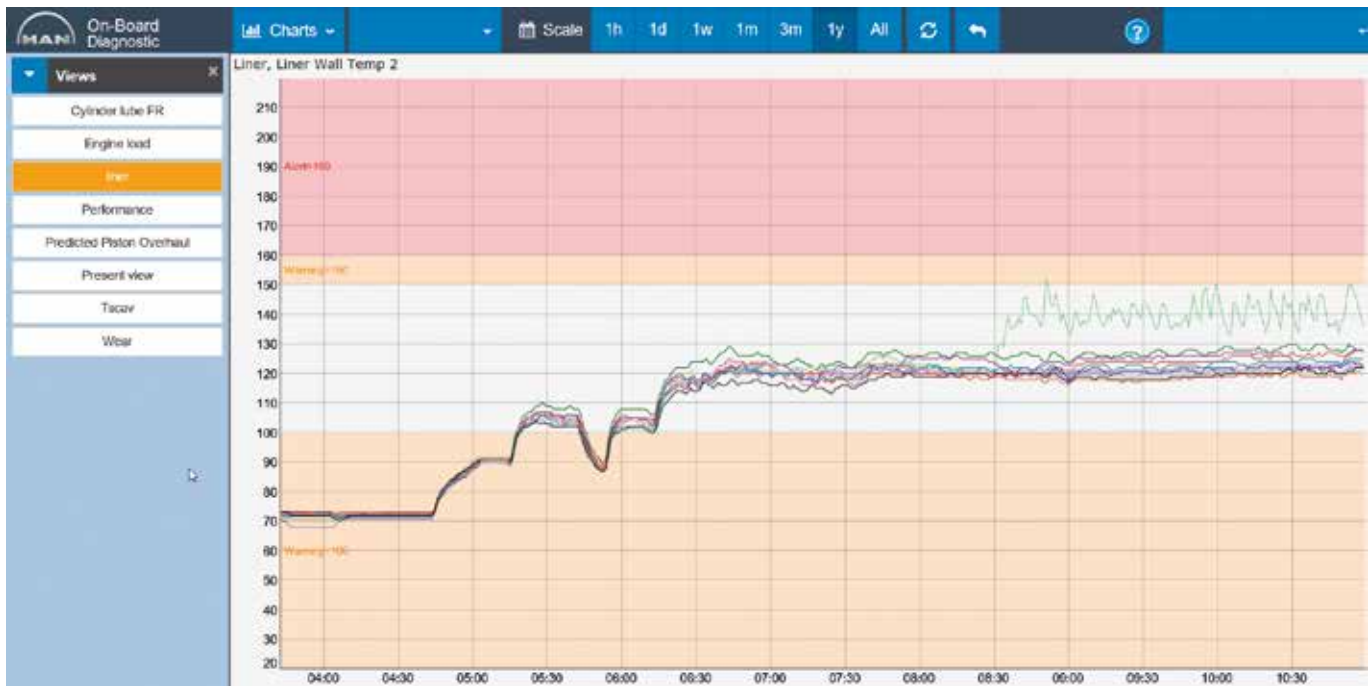
Fig. 47: OBD liner wall graph, during scuffing

occurred 8 October 2018. Once the incident was reported, the liner wall information could be used to confirm the incident (Fig. 47) and engine

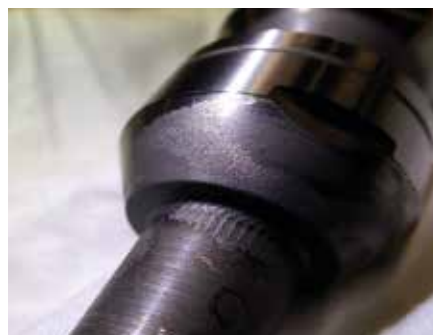
Fig. 58: Cavitation on PEVA slide version I

One of the more long-lasting and repetitive issues is PEVA feedback failure alarms, also referred to in Table 2, third inspection. This issue only pertained during ME manoeuvring, and it was concluded that cavitation and sticking of the PEVA main slide was the cause.

Fig. 58 shows the cavitation damage on the PEVA slide and Fig. 59 shows the damage on corresponding counterpart of the PEVA housing.

As a rapid test, the PEVAs were cleaned and the slide was rotated 180 degrees, thus, the area with cavitation was no longer directly exposed to the flow from the hydraulic pressure port. After assembly, the engine was tested and no alarms have been returned since then. The design was updated immediately because of the findings and the test vessel received a replacement valve with an updated slide, which is now running to accumulate hours. In order to assist with the production of control valve slides, the PEVAs had another slide design than normally for control valves from the beginning.

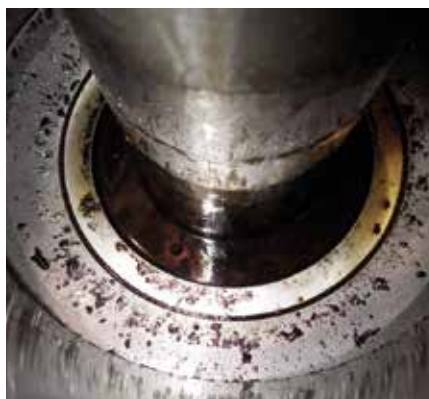
Fig. 62: Air spring chamber

The stem seal was worn down by 23% during the clocked running hours. As a result, the amount of coke deposits inside the spindle guide and air spring chamber were higher than normal. A cause of ring wear can be a too small amount of oil in the controlled oil level (COL) and therefore a lack of preservation of the ring during operation. This may be solved by tuning the safety valve which controls the air

Figs. 62 and 63 display the increased debris in the air spring chamber and the amount of coke deposits in the

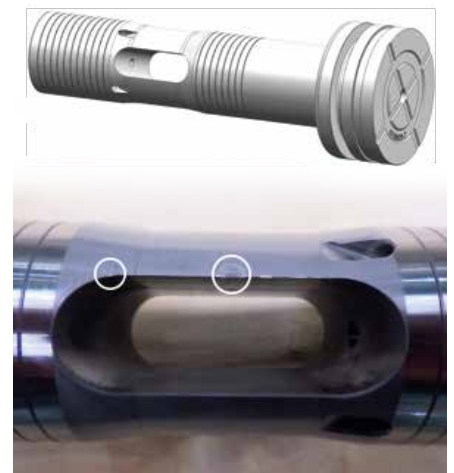
Fig. 67: Inlet hole of suction valve

At an early stage, we saw peel-off of coated material from the inlet hole opening of the suction valve (shown with circles on Fig. 67). The previous design had sharp edges in the oval opening of the suction valve. When the plunger went through a nitrating process, the entire sharp edge around the opening would be fully nitrated and not just surface-coated. This edge would be extremely brittle and not able to withstand the flexing of the plunger

experienced during an injection. The issue has been solved by rounding the edge in the oval opening.

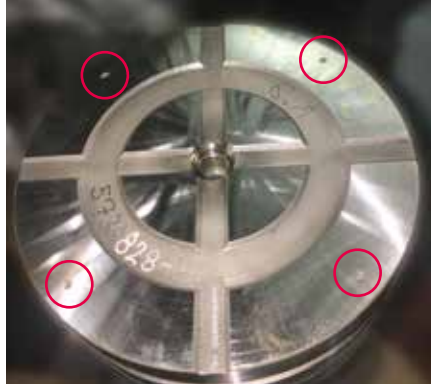
Fig. 68: Cavitation marks on the hydraulic plunger top

Cavitation marks appeared on top of the hydraulic plunger. The marks clearly occurred 90 degrees apart, see Fig. 68. This confirms our suspicion about too few pressure relief grooves on top of the hydraulic plunger.

Design changes have been implemented to solve the issue on future designs. Additional relief grooves have been created, see the illustration in Fig. 69.

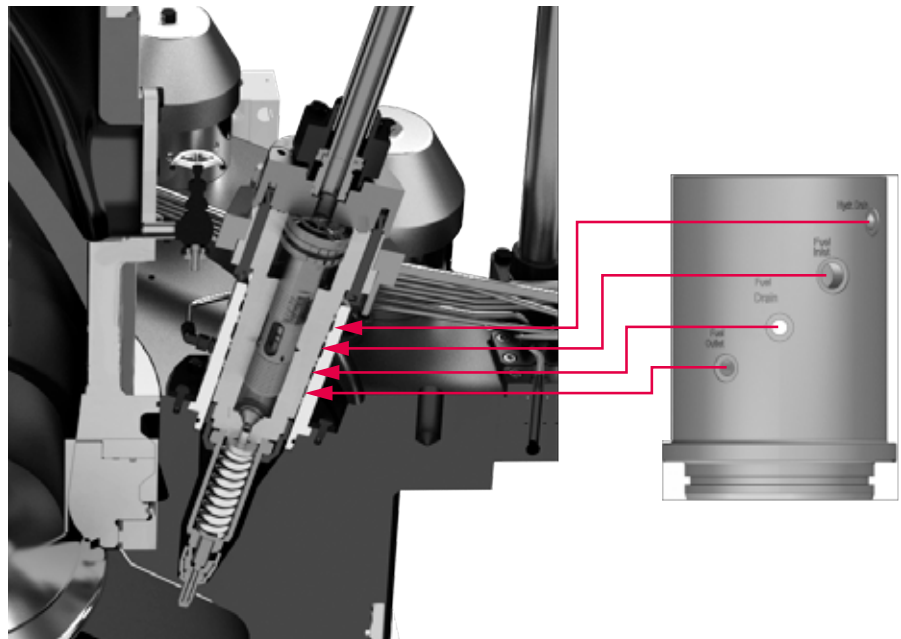
Fig. 70: FBIV design in the cylinder cover

The test vessel where the TCEV/FBIV testing was conducted experienced a breakdown at sea due to a broken O-ring. The failure pointed at additional challenges related to the FBIV design.

The FBIV is mounted in a sleeve, which is protruding from the cylinder cover, see Fig. 70. This sleeve has a relief hole to prevent pressure build-up in case the fuel valve does not seal properly against the seat in the fuel valve pocket.

When the O-ring snapped, the fuel outlet compartment had access to fuel oil return and fuel was spraying up against the exhaust valve housing. Subsequently, the crew attempted to overhaul the FBIV, which resulted in a complete failure of the FBIV due to a

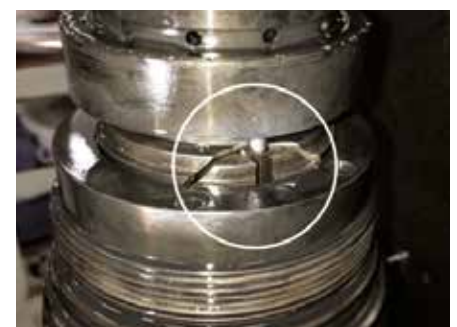
Fig. 71: Wrong assembly of fuel valve part and pump barrel

This incident revealed the vulnerability of the design related to assembly of the fuel valve part and the pump barrel. Guide pins, which can be difficult to align, can create an uneven load distribution between thrust piece and barrel. In this case the mentioned components were crushed, see Fig. 71.

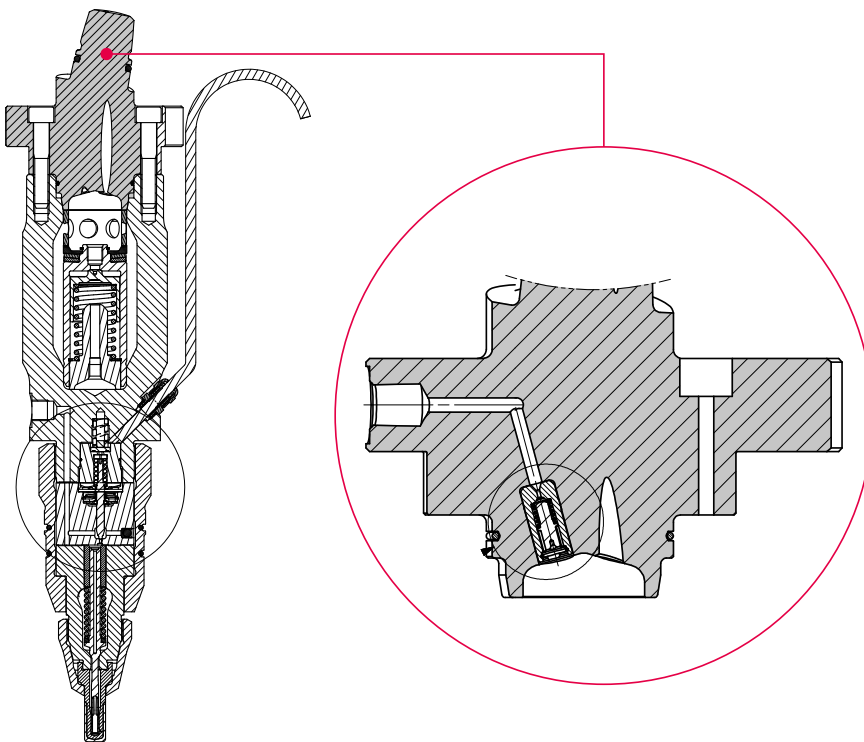
Fig. 76: Redesigned recirculation valve

shop test that only one pump in operation is not sufficient to build-up the rail pressure to the start level specified by the ECS. The reason was that the common flow through the circulation valves of the CR valves, Fig. 76, was larger than the nominal delivery supply of one CR pump. The manufacturer of CR injection valves was asked to redesign the recirculation to reduce the flow. This modification was made during the prototype shop test at Makita.

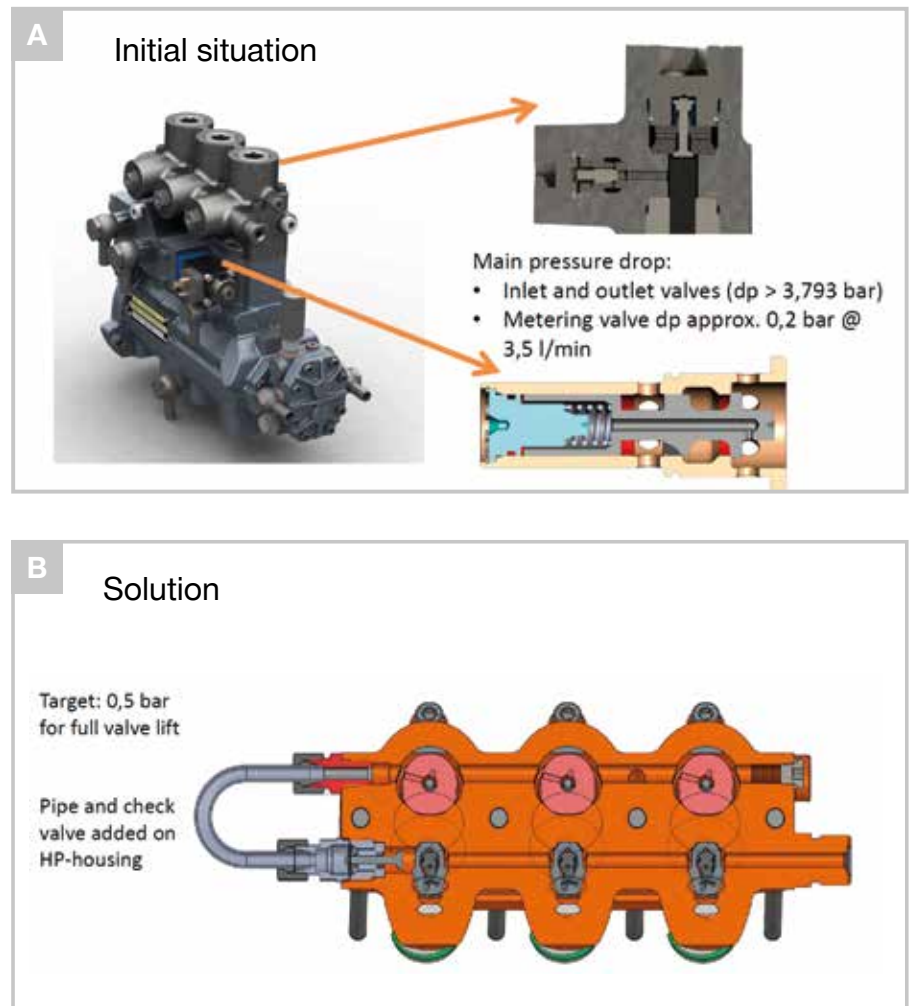
Fig. 77: High-pressure pump redesign

In the process of redesigning the recirculation valve it was discovered that the pressure drop of approximately 4 bar across the stopped HP pump was too large (see Fig. 77A). Consequently, the HP pump manufacturer was asked to reduce the pressure drop across the pump which they solved by inserting an external bypass line in series with a built-in upstream non-return valve (Fig. 77B).

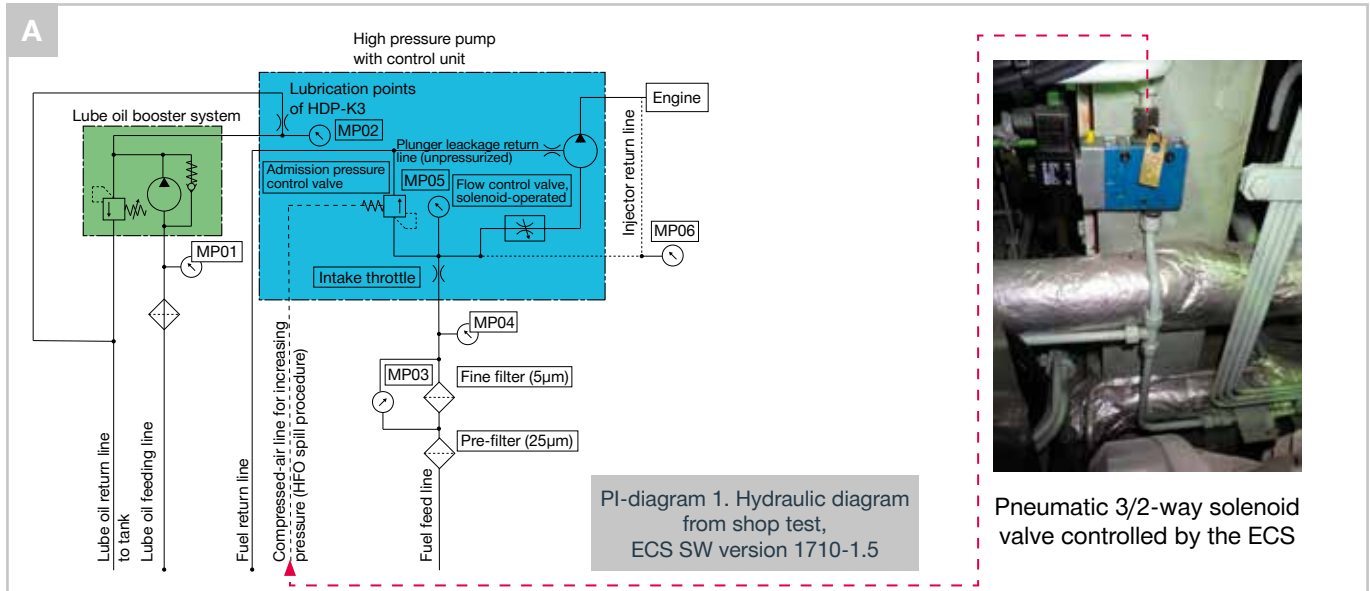
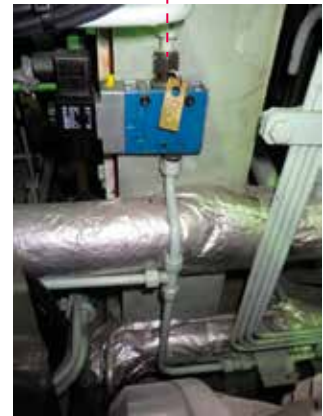
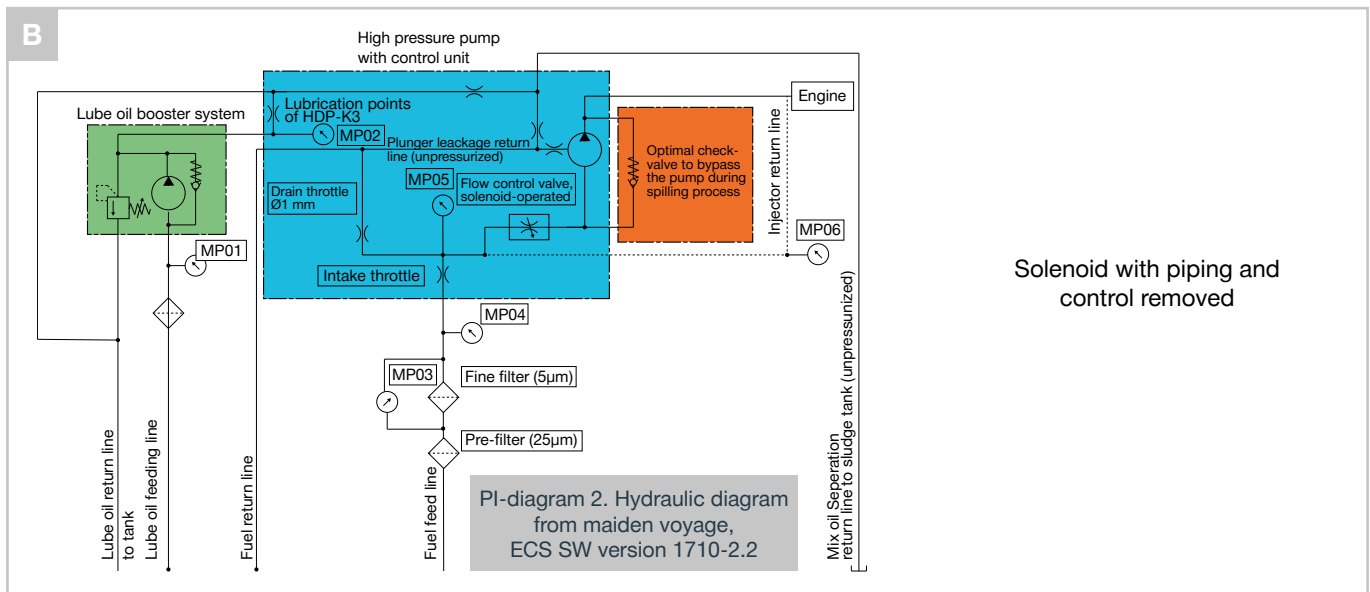
Fig. 78A and B: Control diagrams for the high-pressure pump

Apart from experience gained during shop test, the intake throttle, Fig. 78A, in combination with a standard two-stage fuel supply system used in HFO applications, caused too low pressure in the inlet manifold of the engine.

The low-pressure problem was experienced during sea trial, and it was temporarily solved by increasing the spring force within the intake throttle. The permanent solution was to replace the intake throttle with an orifice with fixed bore (Fig. 78B).

Originally, the HP pump was delivered with pneumatic activation (closing) of the intake throttle (Fig. 78A) to enhance fuel circulation through the stopped pump. With the fixed bore orifice as the permanent successor to the pressure control valve, the pneumatic activation had no function and it was omitted in the final layout (Fig. 78B).

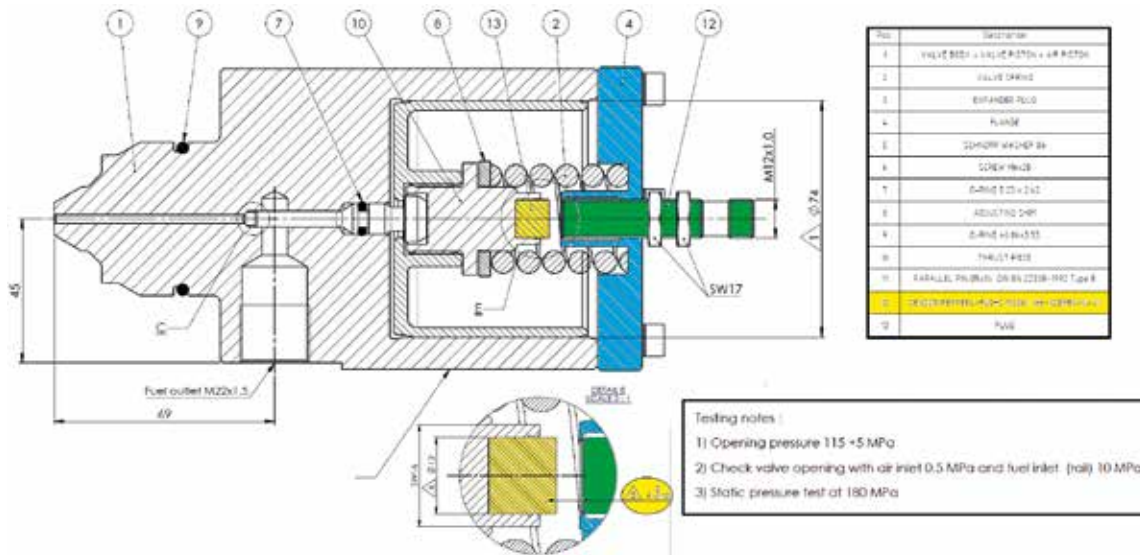
Fig. 79: Combi valve redesign

An issue occurring for an engine running with open COMBI valve was discovered during the preliminary test run. The COMBI valve opened as intended at high rail pressure, but the normal reset function of the COMBI valve did not function correctly. The COMBI valve is reset correctly by stopping the engine and reducing the rail pressure to a level below the COMBI valve reset value (<240 bar). Consequently, it was suggested to include digital position monitoring of

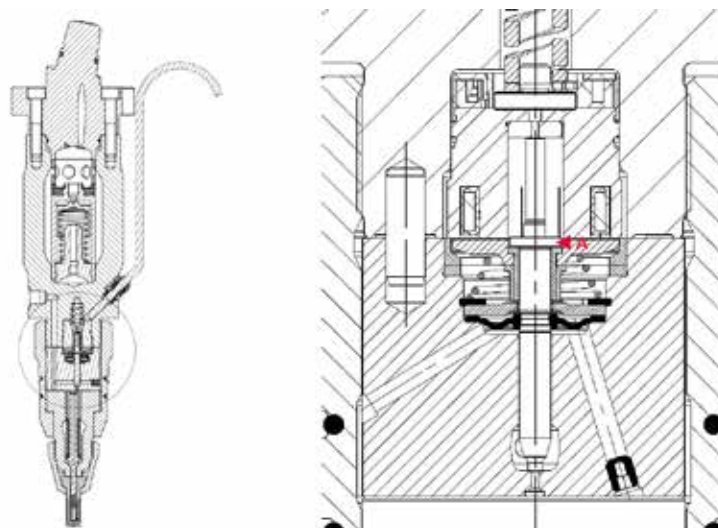
Fig. 80: CR injection valve and control valve

Numerous intermittent driver shutdown alarms occurred during the maiden voyage. The shutdown condition was reset automatically within a few seconds. The extensive troubleshooting finally pointed at a faulty CR injector instead of the driver module, which initially was suspected to be the root cause. At an open-up

inspection, breakage of the control valve piston collar/shoulder (Fig. 80, pos. A) was discovered. As it could be expected, the disturbance in the magnetic flux caused by the collar breakage gave current transient peaks in the driver outlet channel. These current peaks were detected by the driver supervision as a fault condition.

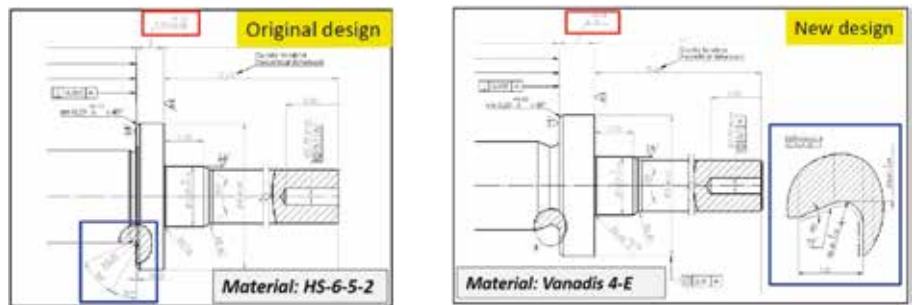
Fig. 82: Modified design of CR injection control valve collar

A finite element (FE) calculation was performed to understand the reason behind the rupture. The following modifications have been introduced (Fig. 82) based on the results:

- Shoulder thickness increased to 2 mm
- Relief radius changed to 0.4 mm
- Material changed from HS-6-5-2 to Vanadis 4E
- The fatigue limit of Vanadis 4E is twice that of HS-6-5-2.

A complete set of CR injection valves with the improved control valve piston collar was produced, delivered on board and installed in the engine by the end of November 2018. By mid-March 2019 the batch of new injection valves will have been in service for 1,100-1,200 hours. No problems have been reported within the service period.

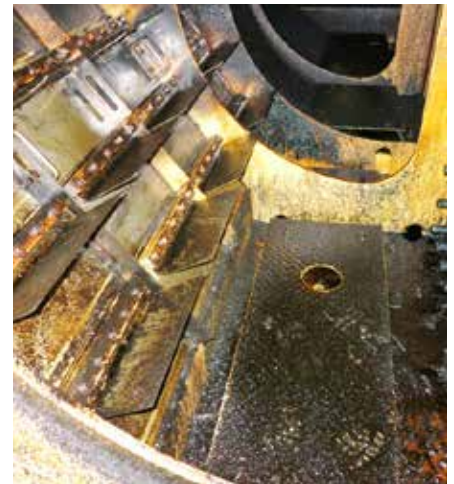
Fig. 84: Sludge and dirt accumulation in the scavenging receiver when operating with EGR

The amount of sludge and dirt accumulated in the scavenge air receiver is increased in EGR operation compared to operation without EGR, Fig. 84. The feedback from owners operating continuously with EGR or EcoEGR is that the cleaning interval has been slightly reduced.
