# Breakdown and subsequent drift towards danger of the bulk carrier *ID Integrity*

Coral Sea | 18 to 23 May 2012

**ATSB Transport Safety Report**  
Marine Occurrence Investigation  
294-MO-2012-005  
Final – 22 August 2013

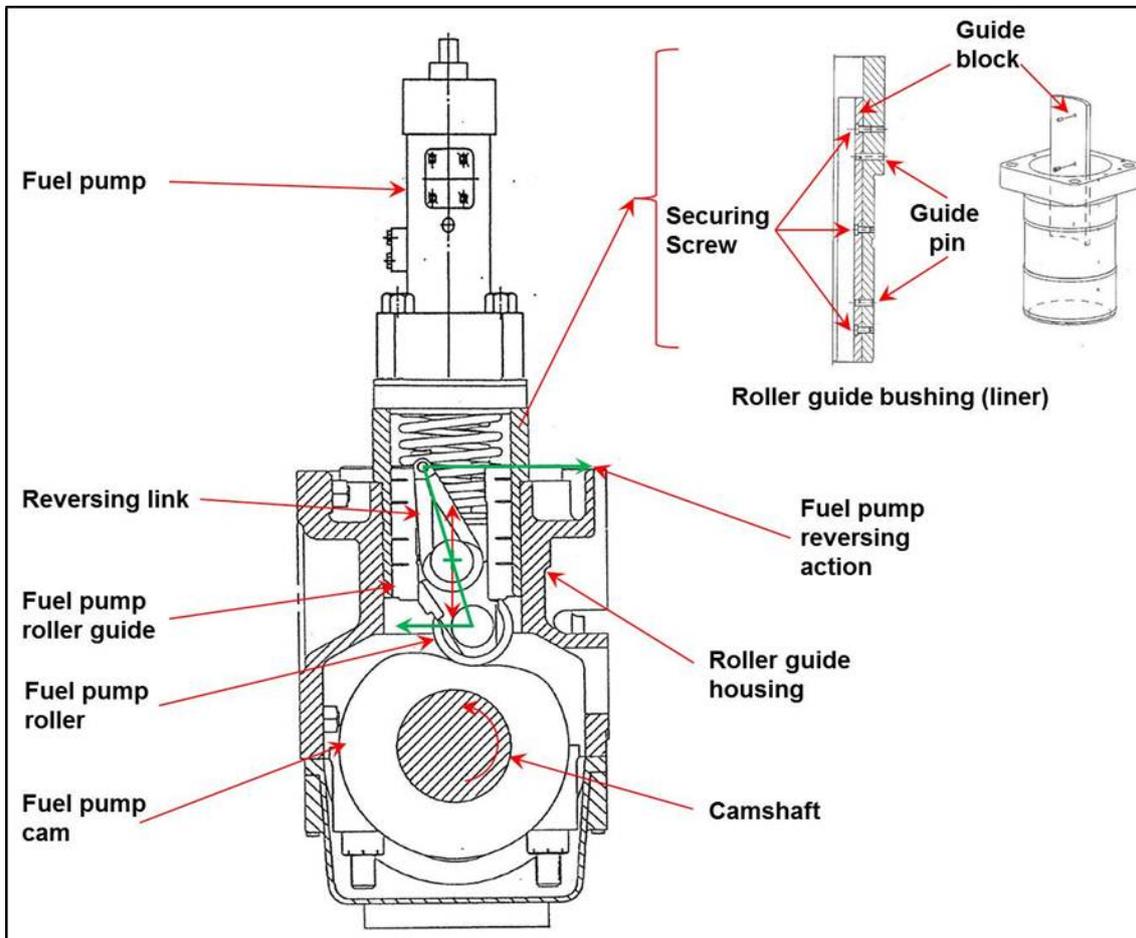
**Figure 9: MAN B&W fuel pump, cam, roller, guide and reversing arrangement**

Each main engine cylinder has its own fuel pump mounted on the roller guide housing over the camshaft segment corresponding to that cylinder. Rotating motion of the camshaft is converted to vertical reciprocating motion in the fuel pump through the fuel pump roller and guide (Figure 9).

The fuel pump roller guide slides in a guide bushing (liner) which is fastened in the roller guide housing. The guide bushing includes a guide block (plate) which prevents the roller guide from turning about the vertical axis of the fuel pump during reversing of the engine.
