# **Service Bulletin**

# **RTA-28**

Technical Information to all the Owners of Sulzer RTA – Type Diesel Engines equipped with DENIS-1 and DENIS-5 ENGINE CONTROL SYSTEMS

# Improvement of the Engine Control System

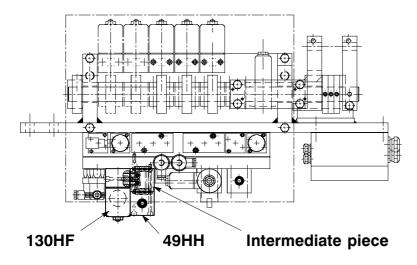
The solenoid valve 130HF will be energized as soon as the pressure switch PS2001S indicates a low main bearing oil pressure.

The 3/2-way solenoid valve is only required on engines which drive a generator.
