MWH CrystalCoat

An Impermeable Mineral-Metal Multiphase Coating

MÄRKISCHES WERK

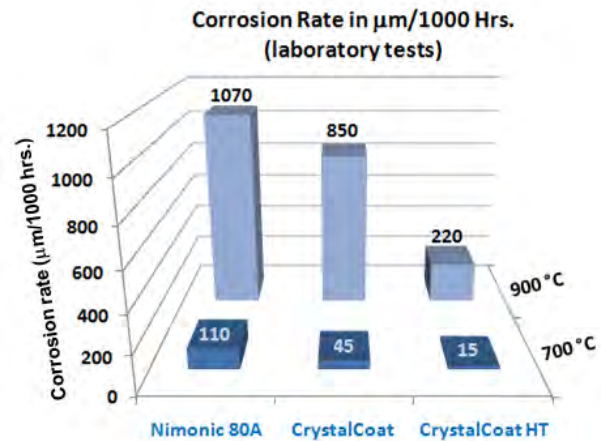
Figure 5 -- Measured corrosion rates of Nimonic 80A, CrystalCoat, and CrystalCoat HT in laboratory testing. Hot-gas corrosion tests were performed at 700 and 900 °C.

The measured corrosion rates of CrystalCoat and CrystalCoat HT, as well as Nimonic 80A, are shown in Figure 5. Although these corrosion rates were measured using the laboratory procedure described previously, these results provide a good indicator of the improved resistance to hot-gas corrosion achievable with CrystalCoat and CrystalCoat HT.

conditions. These results are generally in good agreement with the laboratory measurements presented in Figure 5, and suggest that the instantaneous localized temperature on the face of the valve spindles could reach around 800 °C. However, the lower corrosion rate of CrystalCoat is most likely not sufficient to provide hot-gas corrosion protection on a 2-stroke valve spindle over the long term. Based on these measurements, a 1mm (1000 μ m) thick CrystalCoat coating could only be expected to protect the face of a 2-stroke valve spindle for approximately 5000hrs on this engine. Hence, the higher-temperature CrystalCoat HT coating is recommended for application on 2-stroke valve spindles.

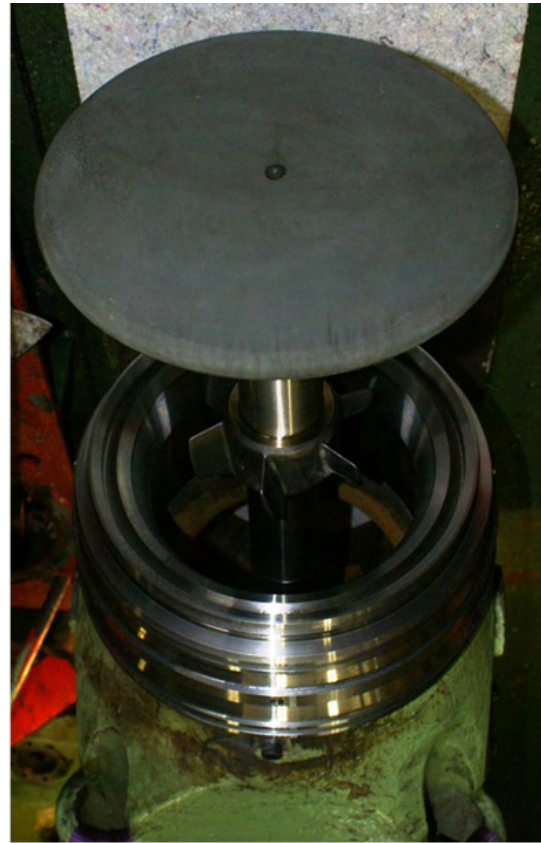
Figure 11 – Picture of the MC50 Nimonic 80A valve spindle with 600 μ m thick CrystalCoat coating on the valve face and outer diameter, prior to initial engine installation.

Field validation of CrystalCoat for 2-Stroke engine applications was conducted on an MC50 valve spindle. Two new Nimonic 80A spindles, one with the valve face coated with CrystalCoat, and one uncoated, were installed on two cylinders of a 6 L50 MC marine propulsion engine. The coated valve is shown on Figure 11, prior to its initial installation in the engine.

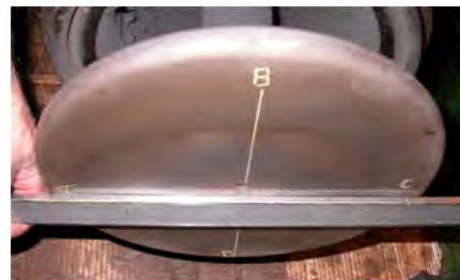
Figure 14 – Illustration of the valve face “burnt depth” (corrosion depth) measurement procedure on 2-stroke valve spindles.

The “burnt depth” measurement procedure on the face of the 50MC valves was performed on the field employing a vernier caliper and an iron ruler, as shown in Figure 14. This is the standard procedure recommended by the engine manufacturer. Since the coated and uncoated valve spindles had not accumulated identical running times (due to varying service intervals on different cylinders of the engine), the “burnt depth” measurements were converted to corrosion rates (corrosion depth / operating time), and are presented in Figure 15. The upper range of the corrosion rate for the Nimonic 80A valve face on Figure 15 assumes that the average notch depth in between the “cobblestones” is 500 μ m.

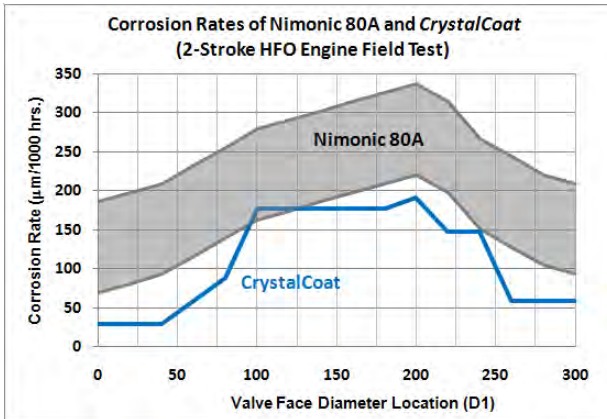
Figure 15 – Comparison of measured corrosion rates in µm/1000hrs, along the face of the Nimonic 80A and CrystalCoat 50MC valve spindles.

These field validation results demonstrate that CrystalCoat can be used to protect the face of a 2-stroke valve spindle. Furthermore, CrystalCoat shows a moderately lower corrosion rate than Nimonic 80A (CrystalCoat corrosion rate is about ½ that of Nimonic 80A) under these
